Report: TAB REPORT
Function: Test, Adjust, & Balance
Date1: 09/13/2022

09-12 GERBES #615-124 - COLUMBIA, MO

Project: 09-12 GERBES #615-124 - COLUMBIA, MO

Project Summary

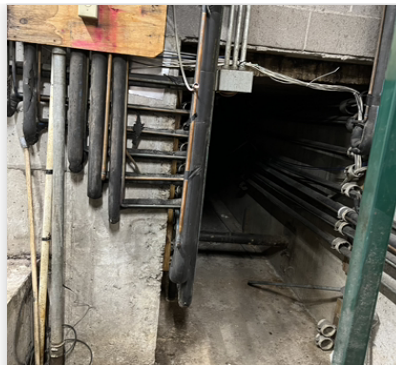
Returntunnel.jpeg

Oa intake and return air damper were closed and opened up by Adil recently prior to TAB. There is also a tunnel return.

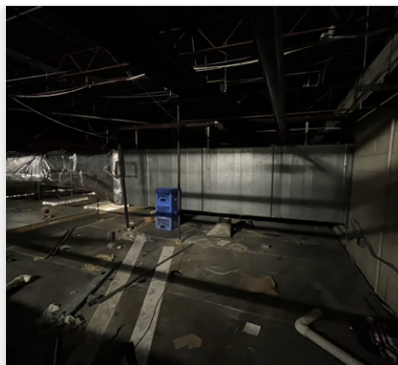
Abovecooler.jpeg

duct. After slowing down the vibration decreased significantly. It appears the cause for this vibration is the small duct size at the discharge of the AHU where air is the most turbulent. The duct at the connection to the AHU is not accessible for direct measurement, but on the duct is written 43"x36.75". That duct size would require 3400 FPM at 37,000 CFM and 2300 FPM at 25,000 CFM both of which are very high. Rule of thumb on systems of this size is 1000-1200 FPM. The duct then expands to 96x50 where it passes through the wall above the cooler, and then transitions to 96x32. These two duct sizes are acceptable. It was confirmed that at the connection of the AHU there is a flexible connector for vibration isolation. The vibration seems to be worst where the duct is secured to and passes through the wall. Vibration was not noted down stream at all. If further reduction is required an additional flexible connector prior to duct entering wall is recommended.

3. The outside air damper should be closed from it's current position of around 40% to 20%.
4. The vibration is much improved, but if it continues to be a nuisance, recommend installing another flexible connector on the supply duct in the mechanical room before the duct goes through the wall.
