**Report: TAB REPORT
Function: Test, Adjust, & Balance
Date: 07/03/2024**

**PROJECT
07-01-24 PIZZA HUT CEDAR FALLS, IA**

Summary and Recommendations

The purpose of the visit to the Pizza Hut in Cedar Falls, IA was to address complaints of condensation on the ceiling.

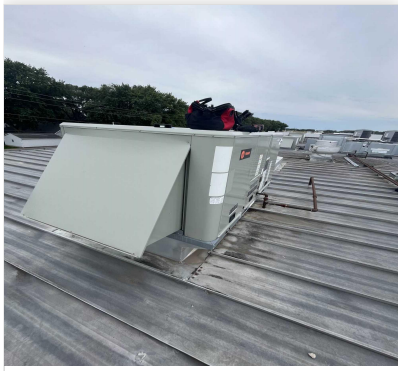
Issue Name : RTU-1 economizer not functional
Description : Economizer for RTU-1 is not functional. Damper was manually set but will remain open even during unoccupied hours. Recommend servicing so that the damper will open to the minimum position during occupied hours and close during unoccupied hours.

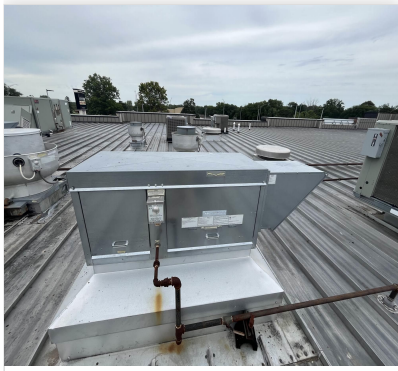
MAU-1

Issue Name : MUA intake filter is dirty
Description : MUA intake filter is clogged. Recommend replacement. MUA belt was loose on arrival, tightened and adjusted motor for tension. Resulting in increase of only 21CFM. 308CFM initial reading, 329 final
Created By : National TAB **Assigned To :** National TAB - Dylan Crisman
Status : Open
Priority : High **Asset Tag :** MUA1
Originated Date : 07/02/2024 - Dylan Crisman - National TAB

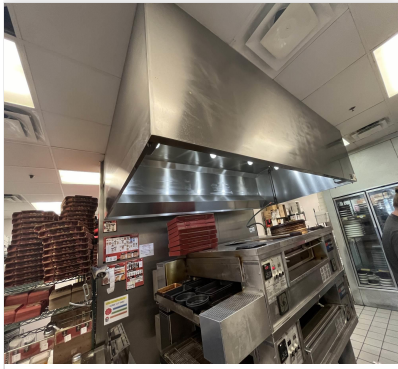
HOOD-1

Issue Name : MUA PSP Plenum is clogged
Description : MUA airflow is high and the discharge pressure indicates that the top of the PSP is dirty. The PSP needs to be dropped down and then the top thoroughly cleaned. It should be cleaned approximately every 2 years minimum.
Created By : National TAB **Assigned To :** National TAB - Dylan Crisman
Status : Open
Priority : Urgent **Asset Tag :** MUA1
Originated Date : 07/03/2024 - Dylan Crisman - National TAB
