**National TAB
1329 E. KEMPER ROAD
SUITE 4210
CINCINNATI, OH 45246**

**Report: TAB REPORT
Function: Test, Adjust, & Balance
Date: 05/20/2024**

**PROJECT
05-13-24 FREDDY'S - Independence, MO**

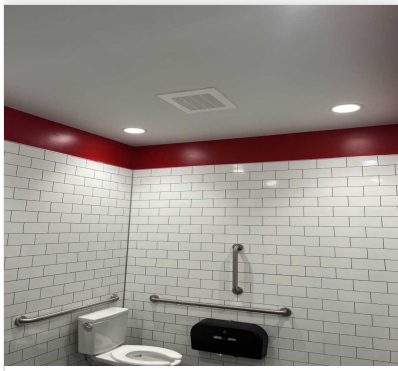
EF-1

Issue Name : EF1/EF2 for restrooms are overamping
Description : Units are overamping at 0.52 of 0.40 FLA for EF2 and 0.40 of 0.22A on EF1. There is no way to reduce amperage on the units as they don't have speed control. Recommend checking the wiring.
Created By : National TAB **Assigned To :** National TAB - Jacob Davidson
Status : Open
Priority : Urgent **Asset Tag :**
Originated Date : 05/13/2024 - Jacob Davidson - National TAB
