Report: TAB Report
Function: Test, Adjust, & Balance
Date: 02/25/2026
Completed By: National TAB

PROJECT
02-16-26 CHOPT COLUMBIA, SC

Founders Table Restaurant Group

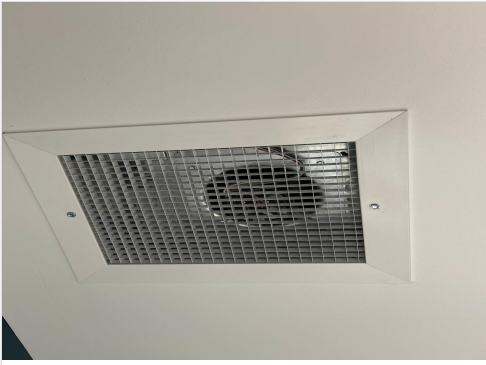
Unit Data - PHOTO LOG

Test Data		
	Design	Actual
CFM	75	70
Fan RPM	-	DD
Fan Rotation	-	CCW
Motor RPM	-	DD
System SetPt	-	MAX
RL Voltage	-	NA
RL Amperage	-	0.34
Fan Discharge SP	-	ATMO
