TAB PUNCHLIST - Nov 27, 2024

L04604_Raymore FSU (MO)

1918 West Foxwood Drive, Raymore, Missouri

L1020004604

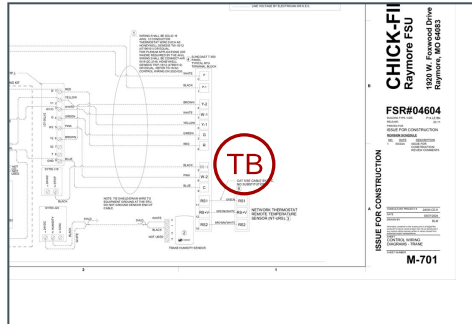
Temperature sensor is specified as CAT5/5E with no exceptions. Humidity sensor wiring to be single 18/2 sensor cable W221P-2003NT only. Must seek approval for change.

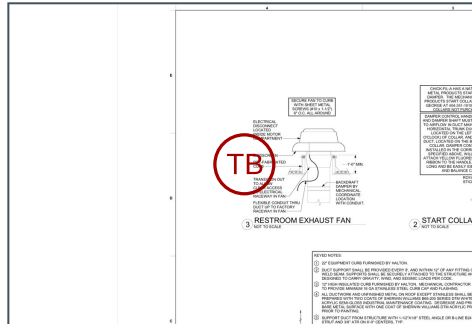
M-501

Exhaust fan electrical penetration is to be rigid through the roof membrane and/or local disconnect box is to be sealed from outside elements. Seek approval for current setup.
