Report: TAB REPORT
Function: Test, Adjust, & Balance
Date: 07/24/2023

06-24-24 WALGREENS #1769 - DENVER, CO

Project: 06-24-24 WALGREENS #1769 - DENVER, CO

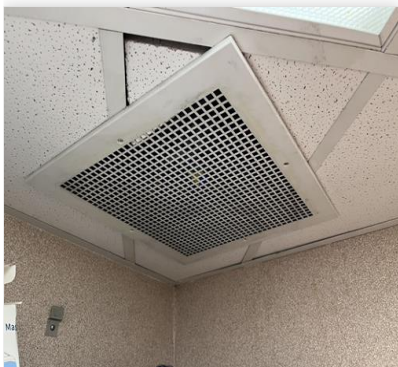
EF1
07/25/2023

Issue Name : EF1 Not Functional
Description : EF1 in the manager's office is not functional. The thermostat on the wall appears to be working as it sends 120V to the fan when needed, however the fan motor does not respond. Appears motor replacement is necessary, cleaning also recommended.

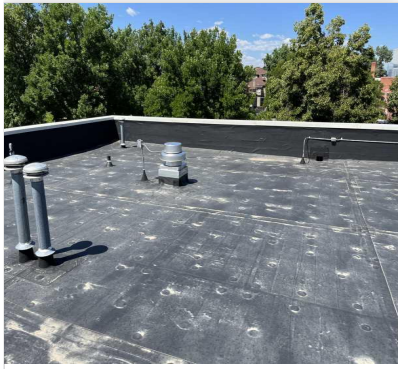
EF2
07/25/2023

Issue Name : EF2 No Backdraft Damper
Description : No backdraft damper was found in the EF2 ductwork. Recommend installing to prevent drafting into the restrooms when the fan is not running.
Created By : National TAB **Assigned To :** National TAB - Stephen Tassinaro
Status : Open
Priority : Medium **Asset Tag :**
Originated Date : 07/25/2023 - Stephen Tassinaro - National TAB

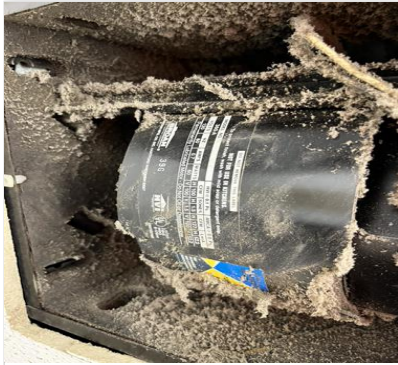
EF3(1)
07/25/2023

Issue Name : EF3 Dirty and Low Flow
Description : EF3 in the employee room is exhausting 30CFM out of 100CFM design. Fan found to be functional but clogged with dirt and debris. Thorough cleaning recommended.
Created By : National TAB **Assigned To :** National TAB - Stephen Tassinaro
Status : Open
Priority : Urgent **Asset Tag :**
Originated Date : 07/24/2023 - Stephen Tassinaro - National TAB

Notes:
FAN RUNNING BUT DIRTY AND IN NEED OF CLEANING.
