**Report: TAB REPORT**  
**Function: Test, Adjust, & Balance**  
**Date: 06/26/2024**

## 06-24-24 WALGREENS #1769 - DENVER, CO

2000 E COLFAX AVE

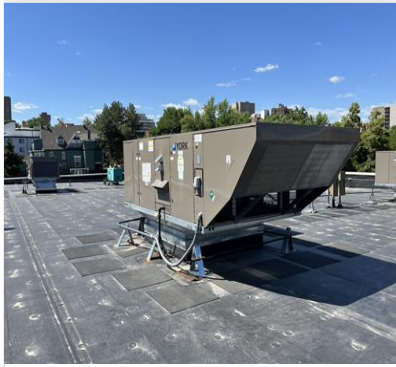
**RTU1**  
**07/25/2023**

- **06/17/2024    National TAB - Stephen Tassinaro**
  - MERV 8 filters now installed in all units, but they are dirty and due for replacement.

**Issue Name :** RTU Final Filters  
**Description :** Recommended to install the appropriate sized MERV 8 or better throwaway filters in the RTUs for improved filtration.  
**Created By :** National TAB                      **Assigned To :** National TAB - Stephen Tassinaro  
**Status :** Open  
**Priority :** Medium                      **Asset Tag :**  
**Originated Date :** 07/20/2023 - Stephen Tassinaro - National TAB

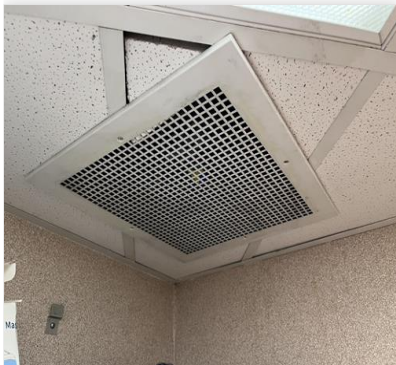
**EF1**  
**07/25/2023**

**Issue Name :** EF1 Not Functional  
**Description :** EF1 in the manager's office is not functional. The thermostat on the wall appears to be working as it sends 120V to the fan when needed, however the fan motor does not respond. Appears motor replacement is necessary, cleaning also recommended.
