Report: TAB REPORT
Function: Test, Adjust, & Balance
Date: 07/24/2023

06-24-24 WALGREENS #1769 - DENVER, CO

Project: 06-24-24 WALGREENS #1769 - DENVER, CO

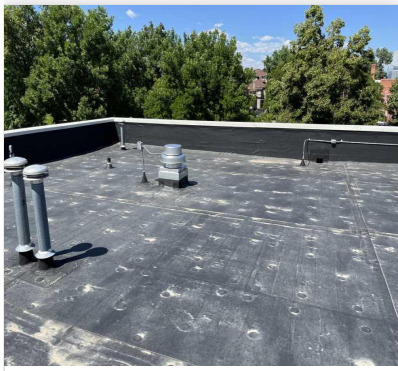
EF2
07/25/2023

Issue Name : EF2 No Backdraft Damper
Description : No backdraft damper was found in the EF2 ductwork. Recommend installing to prevent drafting into the restrooms when the fan is not running.
Created By : National TAB **Assigned To :** National TAB - Stephen Tassinaro
Status : Open
Priority : Medium **Asset Tag :**
Originated Date : 07/25/2023 - Stephen Tassinaro - National TAB
