**Report: TAB REPORT**  
**Function: Test, Adjust, & Balance**  
**Date: 07/24/2023**

## 06-24-24 WALGREENS #1769 - DENVER, CO

Project: 06-24-24 WALGREENS #1769 - DENVER, CO

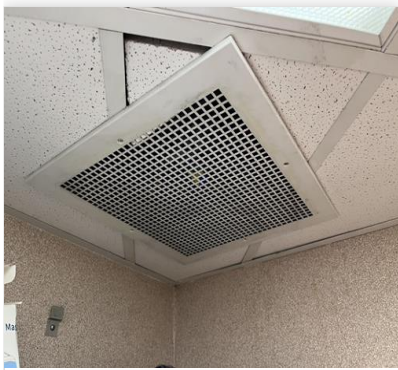
EF-1

**Issue Name :** EF1 Not Functional  
**Description :** EF1 in the manager's office is not functional. The thermostat on the wall appears to be working as it sends 120V to the fan when needed, however the fan motor does not respond. Appears motor replacement is necessary, cleaning also recommended.  
**Created By :** National TAB                      **Assigned To :** National TAB - Stephen Tassinaro  
**Status :** Open  
**Priority :** Urgent                                      **Asset Tag :**  
**Originated Date :** 07/20/2023 - Stephen Tassinaro - National TAB

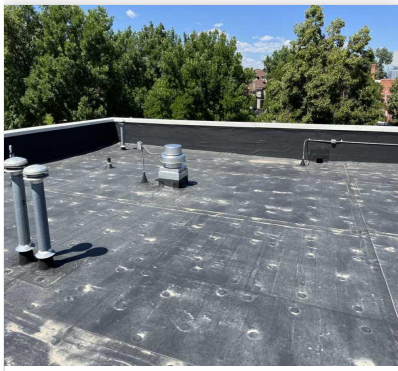
EF-2

**Issue Name :** EF2 No Backdraft Damper  
**Description :** No backdraft damper was found in the EF2 ductwork. Recommend installing to prevent drafting into the restrooms when the fan is not running.  
**Created By :** National TAB                      **Assigned To :** National TAB - Stephen Tassinaro  
**Status :** Open  
**Priority :** Medium                                      **Asset Tag :**  
**Originated Date :** 07/25/2023 - Stephen Tassinaro - National TAB

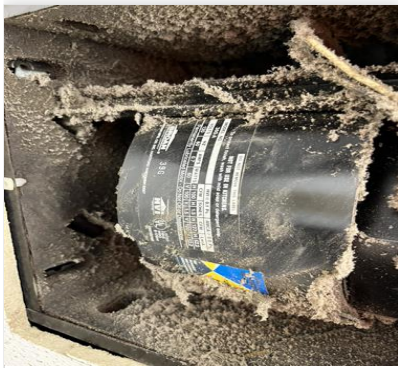
EF-3

**Issue Name :** EF3 Dirty and Low Flow  
**Description :** EF3 in the employee room is exhausting 30CFM out of 100CFM design. Fan found to be functional but clogged with dirt and debris. Thorough cleaning recommended.  
**Created By :** National TAB                      **Assigned To :** National TAB - Stephen Tassinaro  
**Status :** Open  
**Priority :** **Urgent**                                      **Asset Tag :**  
**Originated Date :** 07/24/2023 - Stephen Tassinaro - National TAB
