**National TAB
1329 E. KEMPER ROAD
SUITE 4210
CINCINNATI, OH 45246**

**Report: TAB REPORT
Function: Test, Adjust, & Balance
Date: 06/08/2023**

**PROJECT
05-29-23 CULVERS - APPLETON, WI**

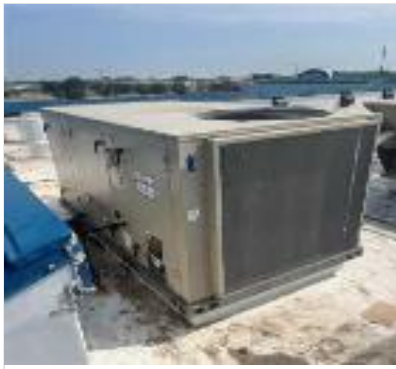
RTU_1
06/07/2023

RTU-1: RTU-1 is a 5-ton direct drive unit that serves the Kitchen and BOH. Supply airflow was initially measured at 1547 cfm. Two kitchen diffusers were found dampened shut, these were opened. The fan speed was increased, and total airflow was measured at 1927 cfm. The outside air damper was initially found set to 10% but was opened to 14% (308 cfm) in order to set a 15% ratio of OA to Supply airflow and bring building pressure positive.

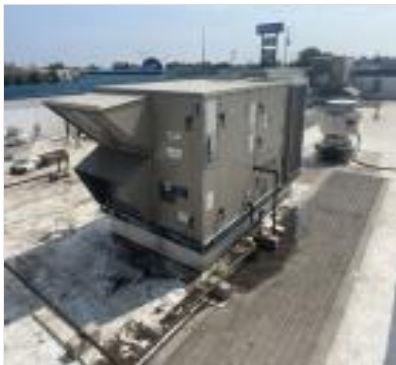
RTU-2(1)
06/07/2023

RTU-2: RTU-2 is a 10-ton belt driven unit that serves six diffusers located in the serving counter area / drive-thru, and one diffuser on the cookline. Its airflow was measured at 3395 cfm and the motor is operating just below full load amperage (FLA), fan speed cannot be increased. This airflow is slightly below design. Its OA damper was initially found shut but was opened and set to a 20% OA to supply ratio to relieve negative building pressure. The

supply drop for this unit is in the middle of the kitchen but the unit serves diffusers at the customer serving counter, creating long duct runs. The return static pressure for the unit was slightly high and the unit is served by two 16" round returns. The dampers on these returns were verified open. Adding an additional return may relieve return pressure and increase supply airflow. Recommend consulting National Tab if any changes to the ductwork are made to improve supply airflow.

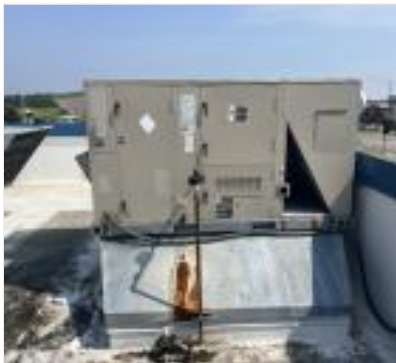
RTU-3
06/07/2023

RTU-3: RTU-3 serves the Dining area and was initially measured at 4635 cfm. The motor was found overramping and was slowed to bring the motor below FLA. This put the total supply airflow at 4239 cfm. The OA damper was initially found shut and was opened to provide a 20% ratio of OA to supply airflow. The OA damper needed to be set to 47% in the prodigy board to open 1," suggesting it is not calibrated properly. The damper was recalibrated and responded correctly, but still does not seem to be opening to the proper position based on percentage. Regardless, the proper position was marked on the actuator with permanent marker and the damper is opening to the correct position.

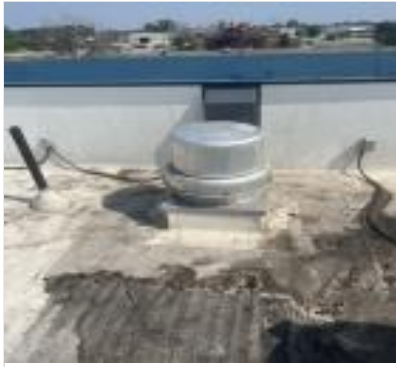
PRV-1
06/07/2023

PRV-1: PRV-1 serves the customer restrooms and was not operating on arrival. The belt was found damaged and the electrical disconnect turned off. A new belt was installed, and the fan runs but is spinning in the incorrect direction. Recommend rotation is corrected and the fan powered on. The building was balanced positive enough that once the fan is operational, it should not have a significant impact on the net pressure.

[1] Once PRV-1 is operational, building net airflow should still be near +160cfm.

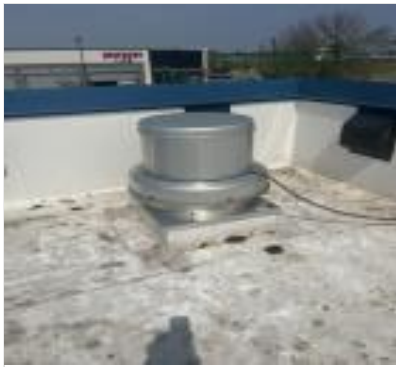
PRV-5
06/07/2023

PRV-5: This fan serves the back mechanical room where the walk-in cooler is located. It operates based on a thermostat and activates when the room reaches a certain temperature. When the fan is activated, a louvre in the room opens to bring fresh air into the space and reduce the temperature. Once the thermostat is satisfied, the fan turns off and the louvre closes. When PRV-5 is operational, most often on warmer days, it pulls from the store space and causes the store to go negative. We recommend that the door to this room is kept shut so that when PRV-5 is activated, it only pulls from the louvre and not the store. This will prevent already treated air from being exhausted and prevent the store from becoming negatively pressurized and pulling untreated air into the store space.

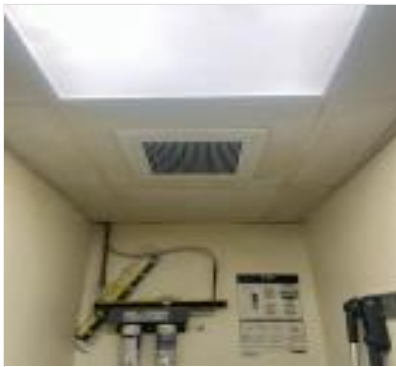
EF-1
06/07/2023

EF-1: EF-1 is a small ceiling fan located in the front mop closet. The fan was found to be operational.
