Report: TAB REPORT
Function: Test, Adjust, & Balance
Date: 06/08/2023

PROJECT
05-29-23 CULVERS - APPLETON, WI

3631 E CALUMET ST

APPLETON, WI 54915

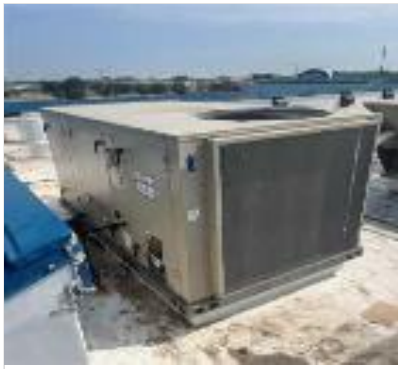
RTU_1
06/07/2023

RTU-1: RTU-1 is a 5-ton direct drive unit that serves the Kitchen and BOH. Supply airflow was initially measured at 1547 cfm. Two kitchen diffusers were found dampened shut, these were opened. The fan speed was increased, and total airflow was measured at 1927 cfm. The outside air damper was initially found set to 10% but was opened to 14% (308 cfm) in order to set a 15% ratio of OA to Supply airflow and bring building pressure positive.

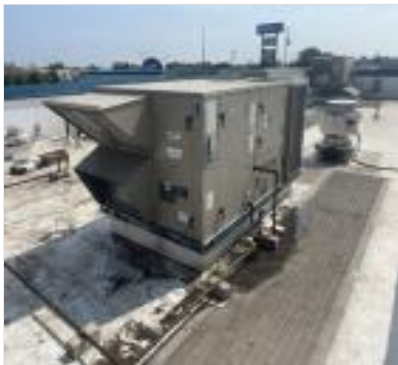
RTU-2(1)
06/07/2023

RTU-2: RTU-2 is a 10-ton belt driven unit that serves six diffusers located in the serving counter area / drive-thru, and one diffuser on the cookline. Its airflow was measured at 3395 cfm and the motor is operating just below full load amperage (FLA), fan speed cannot be increased. This airflow is slightly below design. Its OA damper was initially found shut but was opened and set to a 20% OA to supply ratio to relieve negative building pressure. The

supply drop for this unit is in the middle of the kitchen but the unit serves diffusers at the customer serving counter, creating long duct runs. The return static pressure for the unit was slightly high and the unit is served by two 16" round returns. The dampers on these returns were verified open. Adding an additional return may relieve return pressure and increase supply airflow. Recommend consulting National Tab if any changes to the ductwork are made to improve supply airflow.

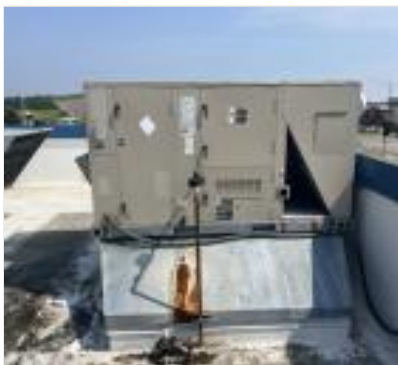
RTU-3
06/07/2023

RTU-3: RTU-3 serves the Dining area and was initially measured at 4635 cfm. The motor was found overamping and was slowed to bring the motor below FLA. This put the total supply airflow at 4239 cfm. The OA damper was initially found shut and was opened to provide a 20% ratio of OA to supply airflow. The OA damper needed to be set to 47% in the prodigy board to open 1," suggesting it is not calibrated properly. The damper was recalibrated and responded correctly, but still does not seem to be opening to the proper position based on percentage. Regardless, the proper position was marked on the actuator with permanent marker and the damper is opening to the correct position.

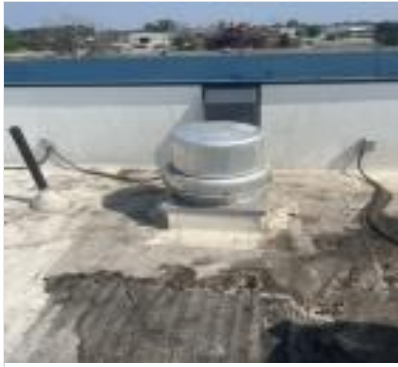
PRV-1
06/07/2023

PRV-1: PRV-1 serves the customer restrooms and was not operating on arrival. The belt was found damaged and the electrical disconnect turned off. A new belt was installed, and the fan runs but is spinning in the incorrect direction. Recommend rotation is corrected and the fan powered on. The building was balanced positive enough that once the fan is operational, it should not have a significant impact on the net pressure.

[1] Once PRV-1 is operational, building net airflow should still be near +160cfm.

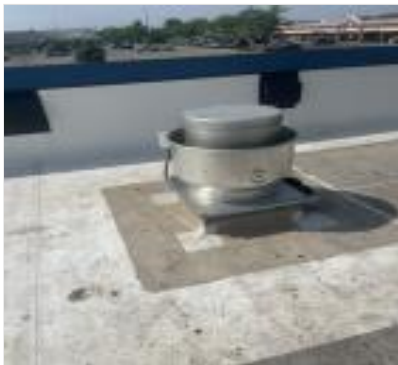
PRV-3
06/07/2023

PRV-2 and PRV-3: These fans serve HD-1 and HD-2 respectively. They are installed properly, and airflow is at design. There is some significant grease staining surrounding PRV-2 but we assume this was caused by the previous fan as the new fan appears clean and the grease drain/trap is properly installed.

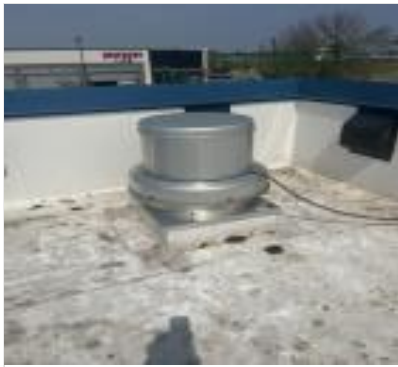
PRV-5
06/07/2023

PRV-5: This fan serves the back mechanical room where the walk-in cooler is located. It operates based on a thermostat and activates when the room reaches a certain temperature. When the fan is activated, a louvre in the room opens to bring fresh air into the space and reduce the temperature. Once the thermostat is satisfied, the fan turns off and the louvre closes. When PRV-5 is operational, most often on warmer days, it pulls from the store space and causes the store to go negative. We recommend that the door to this room is kept shut so that when PRV-5 is activated, it only pulls from the louvre and not the store. This will prevent already treated air from being exhausted and prevent the store from becoming negatively pressurized and pulling untreated air into the store space.

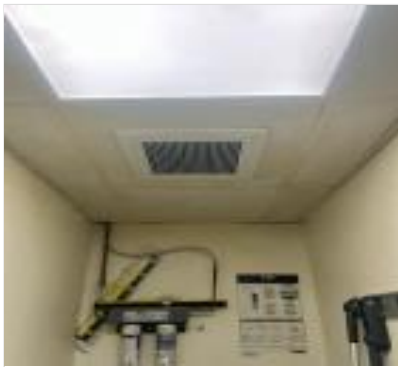
EF-1
06/07/2023

EF-1: EF-1 is a small ceiling fan located in the front mop closet. The fan was found to be operational.
