Report: TAB Report
Function: Test, Adjust, & Balance
Date: 10/22/2025
Completed By: National TAB

PROJECT
01-12-26 QT #0585 OMAHA, NE

Project: 01-12-26 QT #0585 OMAHA, NE

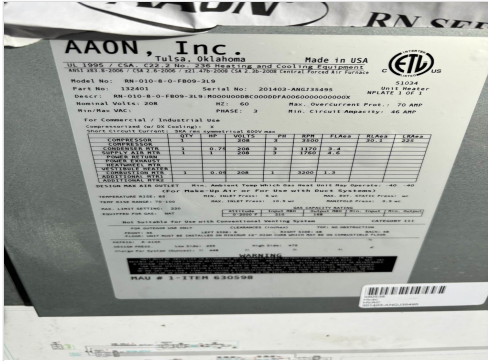
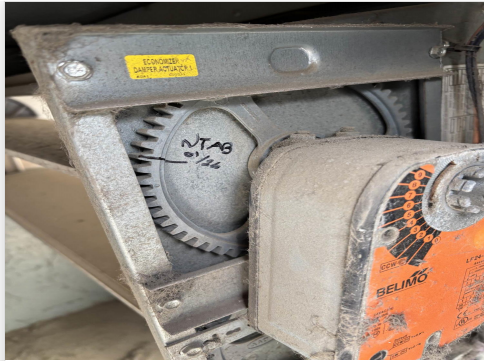
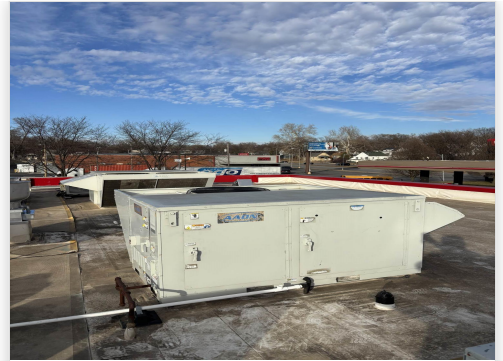
- UNIT IS LOW ON AIRFLOW. SET OA PROPORTIONAL TO SUPPLY.
- RETURN DAMPER BLADE BROKEN IN MA COMPARTMENT.
- ECONOMIZER ACTUATOR IS NOT ATTACHED TO DAMPER BLADES. DAMPER POSITION SET MANUALLY.

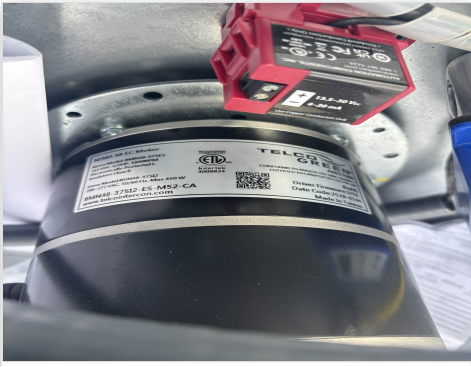
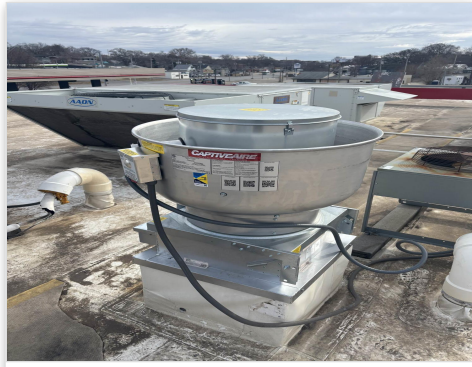
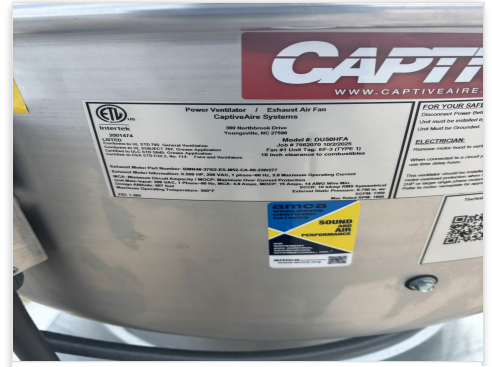
- FAN IS MISSING BELT. NO AIRFLOW.
- MOTOR COVER NOT SECURELY FASTENED.
