Report: TAB Report
Function: Test, Adjust, & Balance
Date: 10/22/2025
Completed By: National TAB

PROJECT
01-12-26 QT #0585 OMAHA, NE

4720 HAMILTON STREET

QUIKTRIP
4705 SOUTH 129TH EAST AVENUE
TULSA, OK 74134

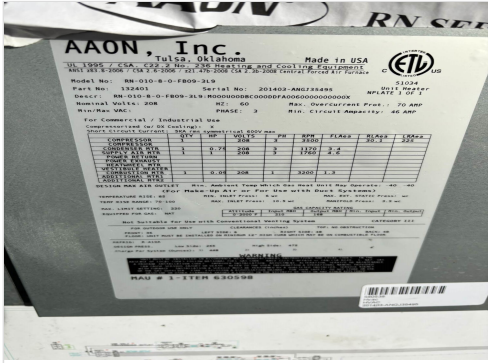
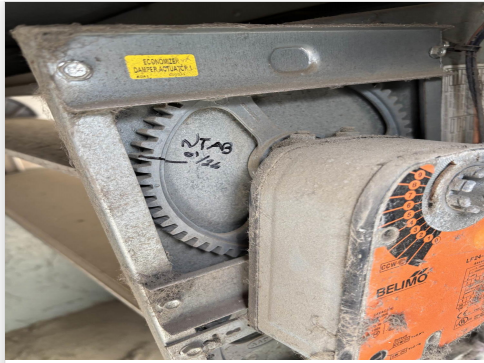
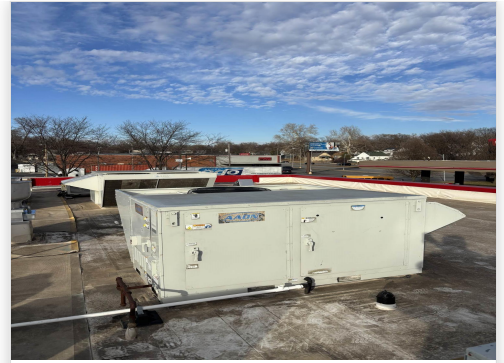
- UNIT IS LOW ON AIRFLOW. SET OA PROPORTIONAL TO SUPPLY.
- RETURN DAMPER BLADE BROKEN IN MA COMPARTMENT.
- ECONOMIZER ACTUATOR IS NOT ATTACHED TO DAMPER BLADES. DAMPER POSITION SET MANUALLY.
