**Report: TAB REPORT
Function: Test, Adjust, & Balance
Date: 02/16/2026
Completed By: National TAB**

M'Lady Nissan Dealership (Crystal Lake, IL)

Project: M'Lady Nissan Dealership (Crystal Lake, IL)

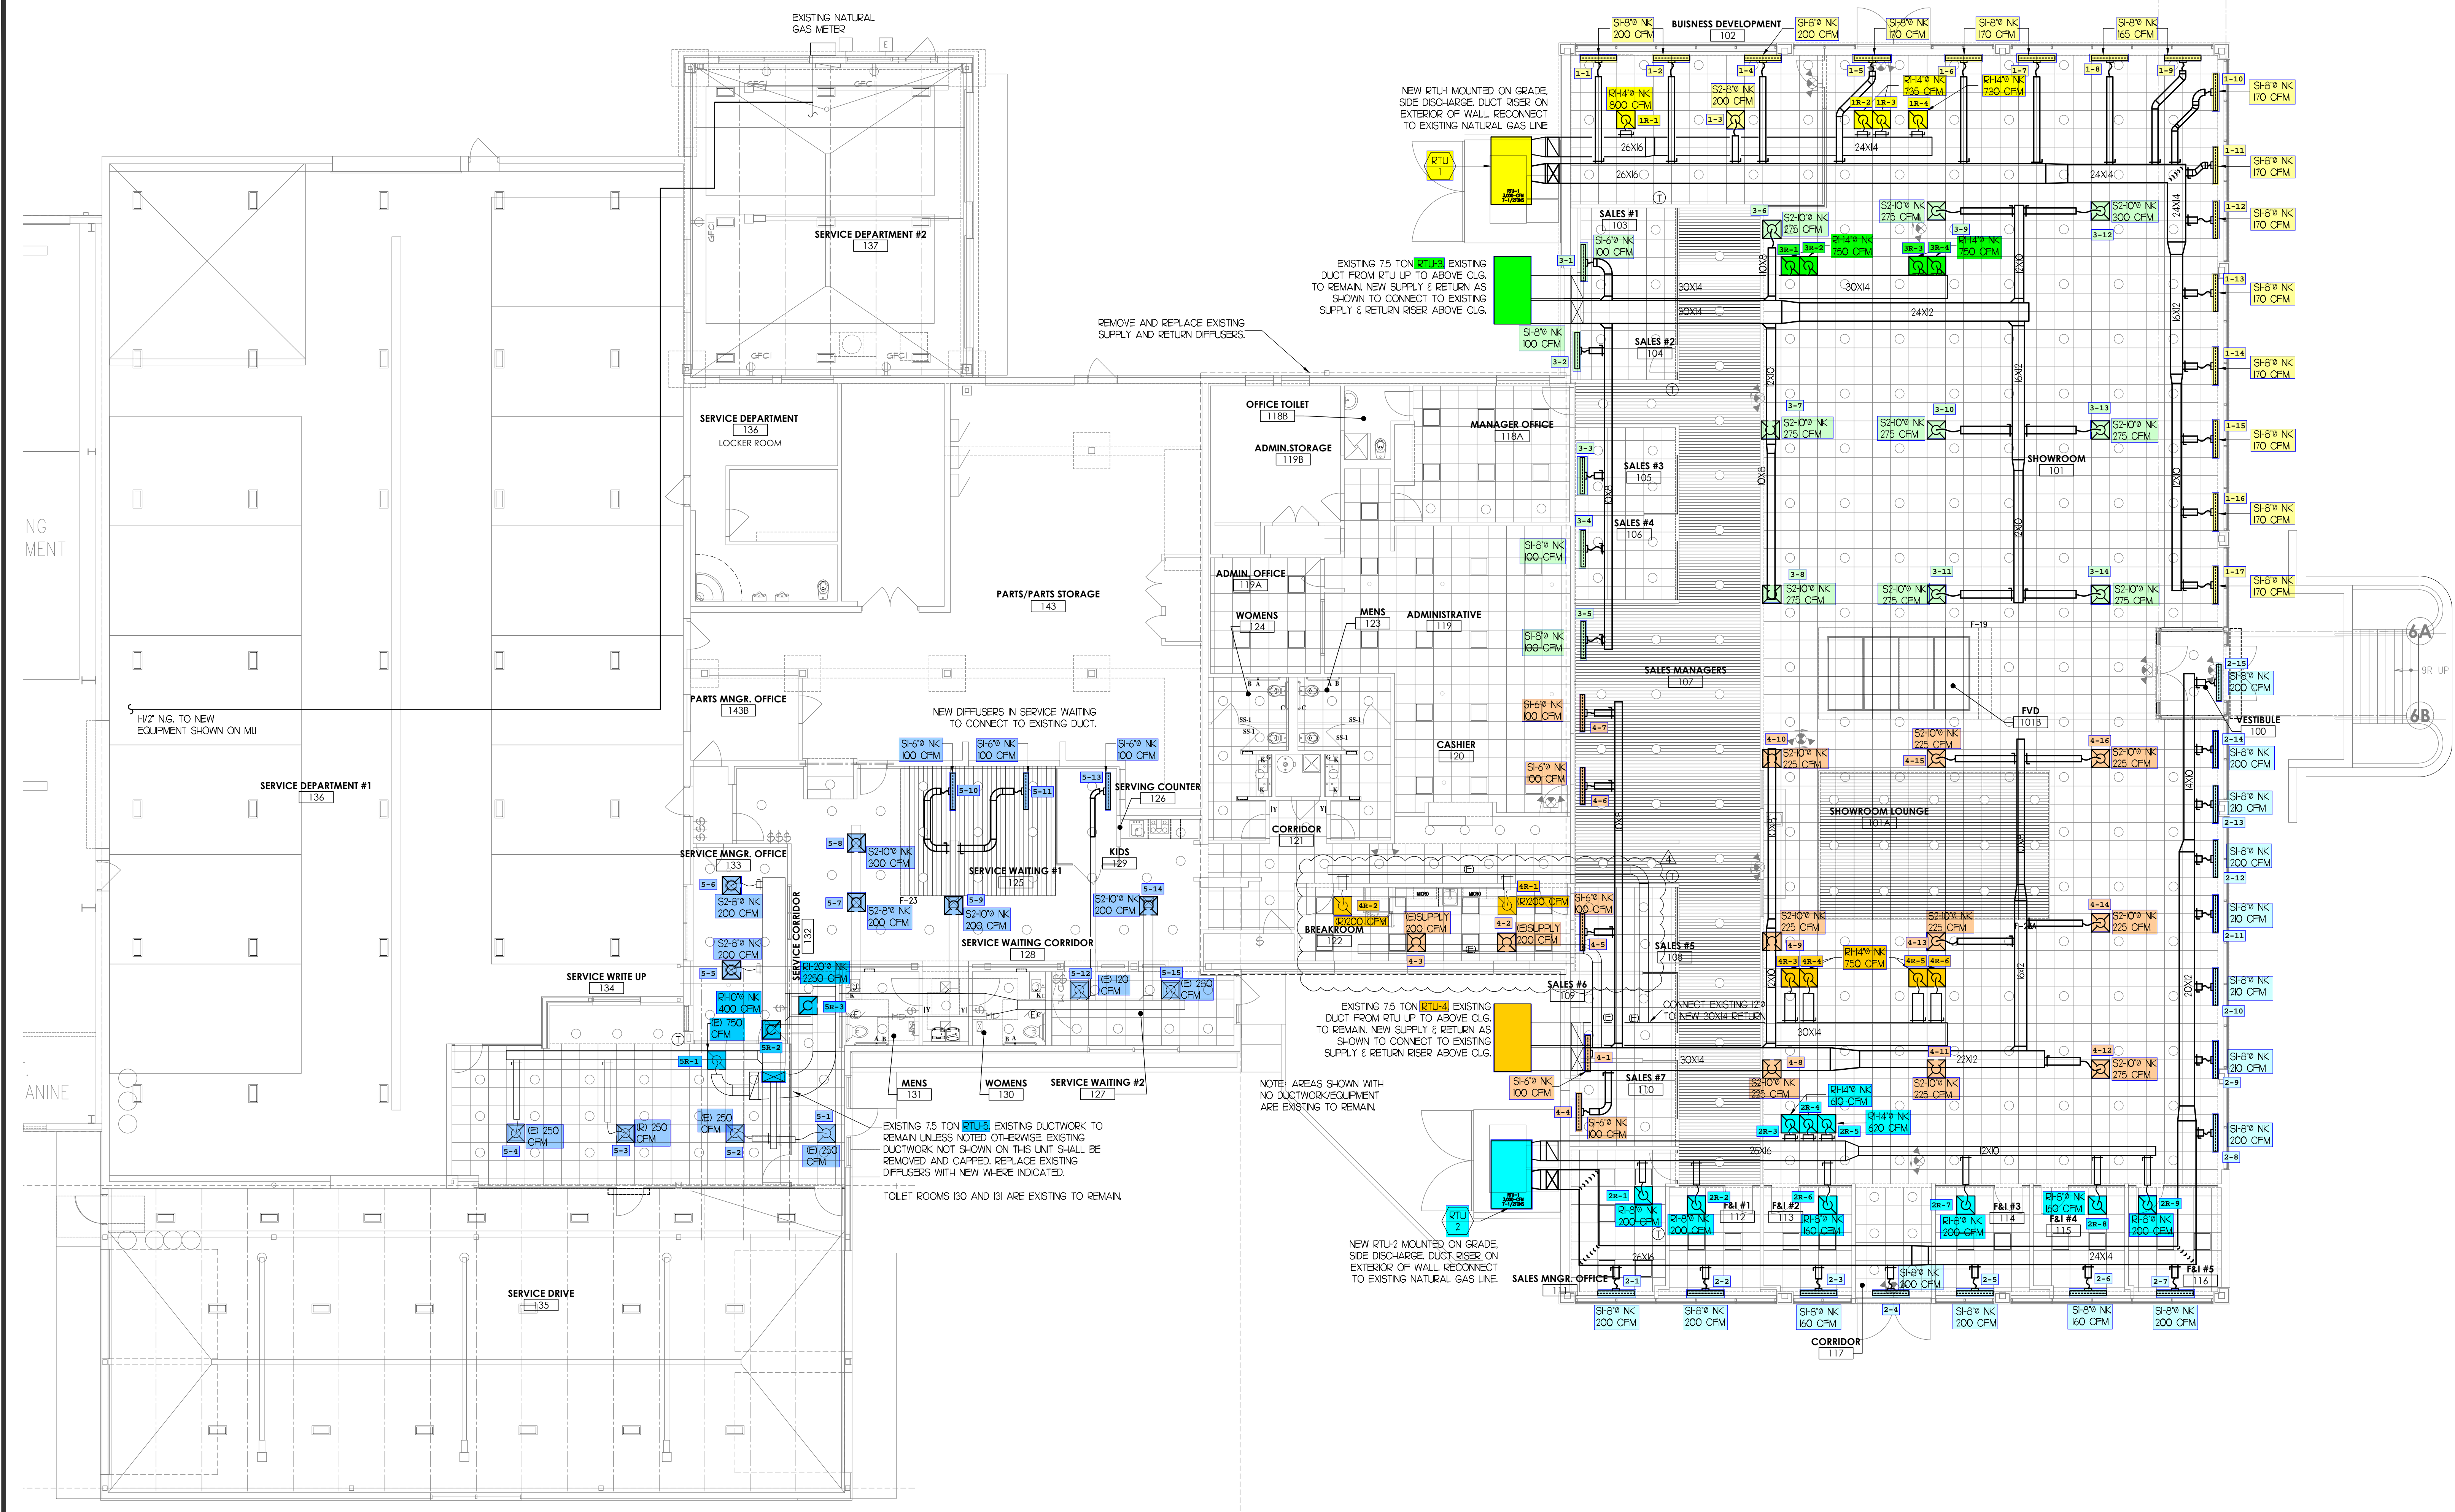
PARTIAL MECHANICAL PLAN
SCALE: 1/8"=1'-0"

Asset	Notes	Date	Written By
SGRD17	Diffuser Deleted. Only 15 Linear diffusers and one 2x2 supply diffuser found on duct network air distributed to surrounding diffusers.	02/11/2026	Dylan Crisman

Issue Name : Diffusers on RTU-4 8-11-12 missing
Description : Diffusers 4-8,4-11,4-12 are missing on site, noted in plans to show where they should be installed.
Created By : National TAB **Assigned To :** National TAB - Dylan Crisman
Status : Open
Priority : **Urgent** **Asset Tag :**
Originated Date : 02/16/2026 - Dylan Crisman - National TAB
