Report: TAB REPORT
Function: Test, Adjust, & Balance
Date: 05/23/2024

05-20-24 FREDDY'S - EDMOND, OK (REVIVE)

Project: 05-20-24 FREDDY'S - EDMOND, OK (REVIVE)

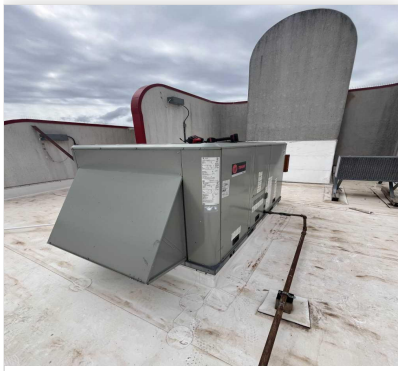
RTU's 1 and 3 are missing outside air intakes. This is creating a return path through the kitchen that is making the hood capture issues worse. Installing these and balancing the outside air should help reduce this effect.

Issue Name : RTU-1/RTU-2/RTU-3 final filters dirty
Description : Final filters for all 3 RTUs are dirty. Recommend replacing with correct 20x25x2 merv 8 rated pleated filters. RTU-1 kitchen unit OA section is very dirty, recommend cleaning.
Created By : National TAB **Assigned To :** National TAB - Dylan Crisman
Status : Open
Priority : Low **Asset Tag :**
Originated Date : 05/22/2024 - Dylan Crisman - National TAB

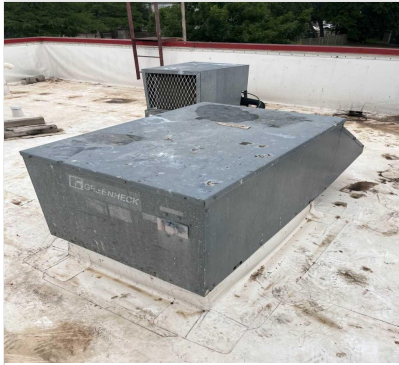
MAU-1

1. The MUA back supply style plenum is notorious for causing smoke capture issues and that is a major factor here. The pulley needs to be changed to reduce airflow by half to around 1000 CFM. It is a non heated/non conditioned MUA so this will also be better for comfort.

2. The MUA filter is clogged and is reducing airflow by about 50%. This needs to be cleaned. But, doing so will also cause the smoke capture to worsen. So it needs to be done at the same time as the pulley change.

Issue Name : MUA intake filters dirty
Description : MUA OA intake filters are dirty. Recommend replacing. Removed for testing.
Created By : National TAB **Assigned To :** National TAB - Dylan Crisman
Status : Open
Priority : Low **Asset Tag :**
Originated Date : 05/23/2024 - Dylan Crisman - National TAB
