Report: TAB REPORT
Function: Test, Adjust, & Balance
Date: 05/23/2024

PROJECT
05-20-24 FREDDY'S - EDMOND, OK (REVIVE)
1925 E 2ND ST
EDMOND, OK 73003

Project: 05-20-24 FREDDY'S - EDMOND, OK (REVIVE)

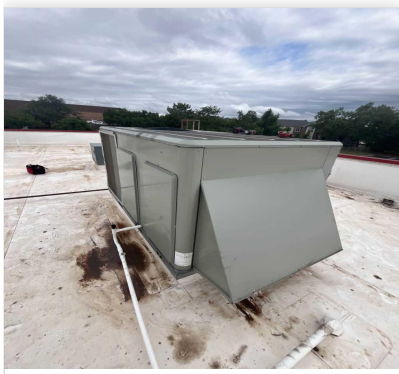
MAU-1

2. The MUA filter is clogged and is reducing airflow by about 50%. This needs to be cleaned. But, doing so will also cause the smoke capture to worsen. So it needs to be done at the same time as the pulley change.
