Report: TAB Survey
Function: Test, Adjust, & Balance
Date: 12/10/2025
Completed By: National TAB

PROJECT
12-08-25 CHILIS HAMILTON, NJ (TAB SURVEY)

125 Marketplace Boulevard

Hamilton , NJ 08691

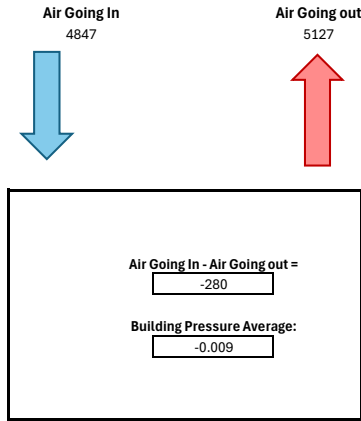
Air Balance Schedule

<p>What was found initially:</p>	<p>[1] FOUND ALL RTU OA INTAKES CLOSED UNITS UNOCCUPIED, BUILDING PRESSURE WAS EXCESSIVELY NEGATIVE -.13", [2] THERE IS A HOOD THAT NO LONGER HAS COOKING EQUIPMENT UNDERNEATH IT, [3] DISH MACHINE EXHAUST FAN IS NOT OPERATIONAL MOTOR IS HUMMING/ SIEZED</p>
<p>Changes made:</p>	<p>[1] REDUCED EF-5 FLOW, LOWERED EF-2 FLOW, INCREASED EF-1 FLOW, SET OUTSIDE AIR TO 1200CFM FOR RTUS AND JUMPER INSTALLED TO ENSURE THEY REMAIN OCCUPIED</p>
<p>Air balancing & performance related issues that need to be resolved:</p>	<p>[1] RECOMMEND REPAIRING/REPLACING EF-6 FOR THE DISH HOOD, [2] MUA DISCHARGE IS HEAVILY RESTRICTED AND FLOW COULD NOT BE INCREASED. [3] RR EXHAUST IS LOWER THAN RECOMMENDED FOR THE NUMBER OF TOILETS, MANAGER SAID IT DOESN'T REALLY SMELL BAD SO RECOMMEND LEAVING RR EXHAUST AS-IS [4] HOOD-5/EF-5 NO LONGER HAS ANY COOKING EQUIPMENT UNDERNEATH IT EF-5 HAS BEEN TURNED OF TO SAVE ENERGY AND REDUCE BUILDING EXHAUST.</p>

AIR GOING IN (+)	Target	Initial	Final
RTU-1 OA	1200	0	1176
RTU-2 OA	1200	0	1232
RTU-3 OA	1200	0	1188
RTU-4 OA	0		
RTU-5 OA	0		
RTU-6 OA	0		
MUA-1	1980	1251	1251
<hr/>			
AIR GOING OUT (-)			
EF-1	1350	1080	1215
EF-2	1125	1498	1261
EF-3	1575	1572	1572
EF-4	800	860	796
EF-5	0	788	0
EF-6 (DISH)	0	0	0
RR Exhaust EF-7 (Total)	525	273	283
NET AIRFLOW (TARGET +200 CFM)	205	-4820	-280
