PlanGrid Task Report - Oct 14, 2024

L04730_Homestead FSU (FL)

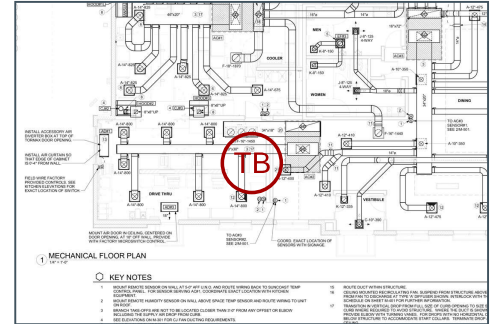
RTU 2 Diffuser 4 damper is rattling and moving around. The diffuser has been set to design and handle locked down, but the damper shaft & blade continue to oscillate. Damper will need to be serviced or replaced. Recommend setting damper to full open once resolved.

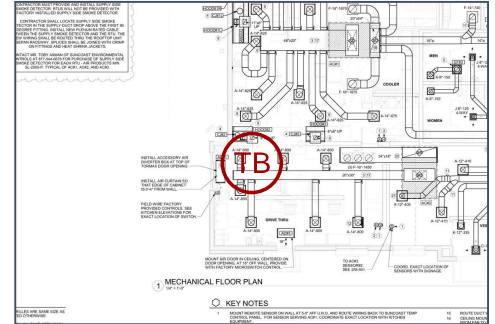
#55 [DUCT 999] [NEW] (MISC) - SGRD2-7 Noise

RTU 2 Diffuser 7 is outputting design airflow but making a noticeable rattling noise. Damper is adjusted to design and locked down, there is no movement on the damper shaft. Recommend MC investigate inside of ductwork to resolve the noise, without adjusting the damper.

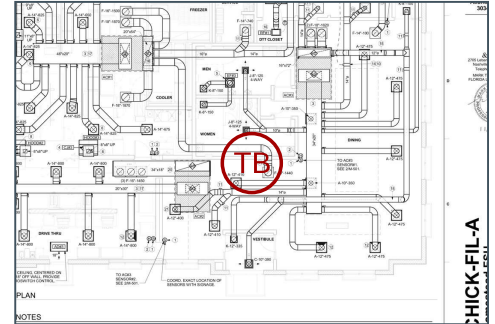
#54 [DUCT 011] [NEW] CRITICAL – Damper(s) bound.

Description
Return damper is bound in partially closed position. This will need to be freed and opened.

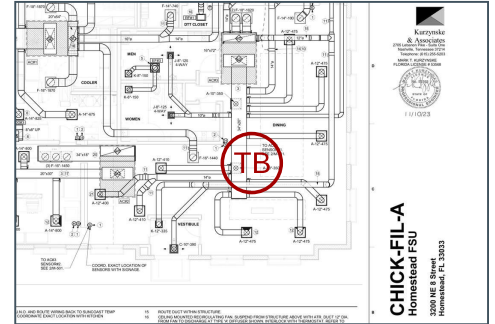
#49 [DUCT 010] [NEW] CRITICAL – Damper(s) missing hardware.

Description
SGRD3-5 Damper handle is missing hardware to lock the damper position in place.

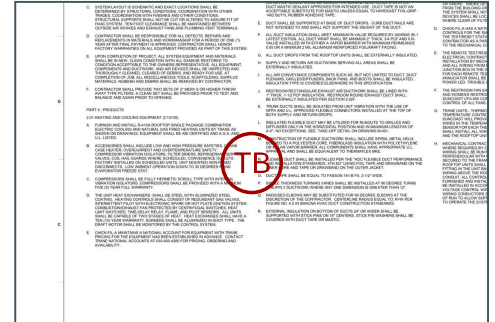
Ensure flex inner core is taped and banded, along with tape or banding on outer insulation jacket. Inner cores are not taped, only banded.

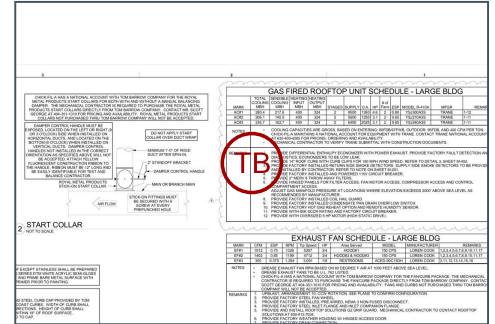
The mechanical plans call for standard 14" curbs to be used. Instead plenum curbs have been installed. If the units can be reset (and resealed) to resolve the leakage issues, CFA and the ME will need to approve this change.
