**All State Fire Midwest
1030 W. 23rd, Suite G
Independence, MO 64055**

**Report: Sierra Grill Duct Integrity Test
Function: Life Safety
Date: 12/29/2022**

**PROJECT
Sierra Grill**

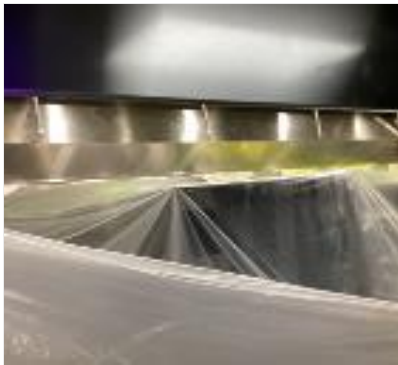
Processpressuretest1....

Method-process for pressure testing. 1600 psi pressurize water jet utilizing photo-lumencent amplifier and UV Light test at all joints in the main cook line.
