# Sierra Grill

**Name :** Sierra Grill Exhaust pressurized water test      **Status :** NotSubmitted  
**Assigned Organization :** All State Fire Midwest      **Asset :**  
**Requesting Organization :** All State Fire Midwest

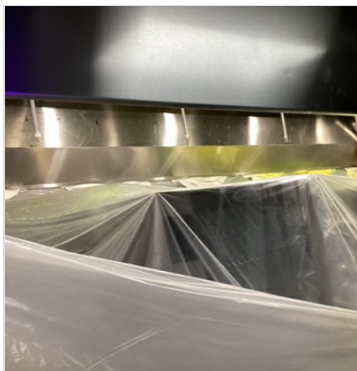
**Processpressuretest1.jpg**

Method-process for pressure testing. 1600 psi pressurize water jet utilizing photo-lumencent amplifier and UV Light test at all joints in the main cook line.
