## Sierra Grill

**Name :** Sierra Grill Exhaust pressurized water test      **Status :** NotSubmitted  
**Assigned Organization :** All State Fire Midwest      **Asset :**  
**Requesting Organization :** All State Fire Midwest

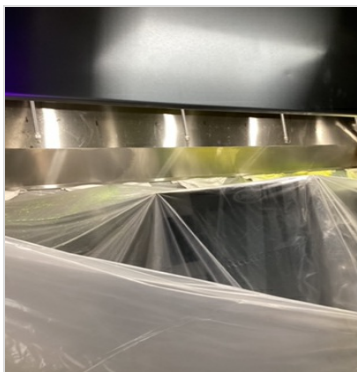
Processpressuretest1.jpg

Method-process for pressure testing. 1600 psi pressurize water jet utilizing photo-lumencent amplifier and UV Light test at all joints in the main cook line.
