Report: Preliminary TAB
Function: Test, Adjust, & Balance
Date: 08/18/2024

08-12-24 WAWA #5446 MERRITT ISLAND, FL

Wawa
260 West Baltimore Pike
Wawa, PA 19063

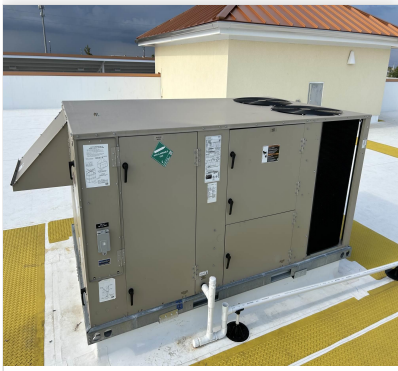
RTU-1

Issue Name : RTU 1 - Alarm 194
Description : Alarm 194 - Critical loss of condenser airflow. Water is dripping into the discharge duct and from the supply diffusers. Recommend HVAC inspection.
Created By : National TAB **Assigned To :** National TAB - Will Turnbough
Status : Open
Priority : Urgent **Asset Tag :** RTU1
Originated Date : 08/15/2024 - Mark Johnson - National TAB

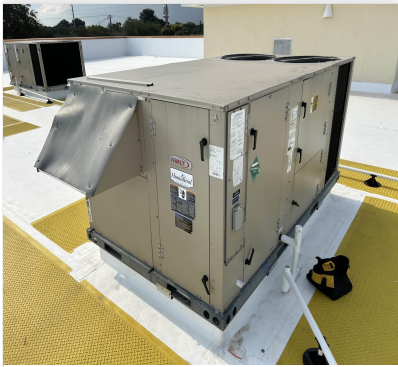
RTU-2

Issue Name : RTU 2 - Incorrect OA Hood Cover
Description : RTU 2 is missing the metal cover for the OA intake hood. A vinyl sheet has been fastened in its place. Recommend repairing with metal plate.
Created By : National TAB **Assigned To :** National TAB - Will Turnbough
Status : Open
Priority : Medium **Asset Tag :** RTU2
Originated Date : 08/15/2024 - Mark Johnson - National TAB

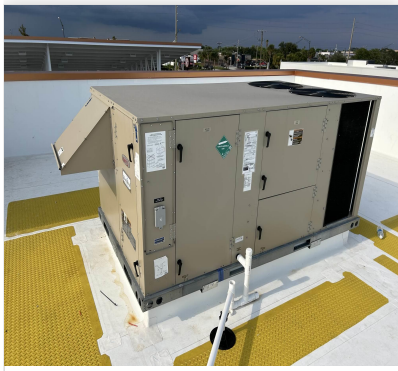
RTU-3

Issue Name : RTU 3 - Water Leaking From Diffusers
Description : There is excess moisture leaking around the discharge compartment in RTU 3. Water droplets are leaking from most diffusers served by this unit. No Core alarms present. Recommend HVAC inspection.
Created By : National TAB **Assigned To :** National TAB - Will Turnbough
Status : Open
Priority : Urgent **Asset Tag :** RTU3
Originated Date : 08/15/2024 - Mark Johnson - National TAB

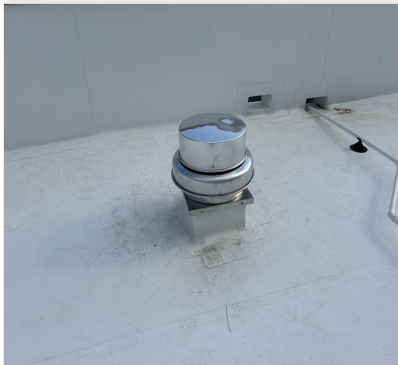
Issue Name : EF-1 - Minimum Speed Controller Not Functional
Description : The maximum speed controller (small potentiometer under sticker) appears to be shorted and not functional. Exhaust flow is stuck at 1636 CFM (142% of design) and cannot be lowered with the speed dial without causing the motor to overamp. Recommend replacing potentiometer.

EF-1 remains high due to broken minimum speed potentiometer. Positive building pressure may be due to tolerance in OA and exhaust readings (net airflow close to neutral).
