**Report: Brightview-DOAS1 Analysis**

**Function: Test, Adjust, & Balance**

## BVE - Brightview Senior Living (Eatontown, NJ)

Project: BVE - Brightview Senior Living (Eatontown, NJ)

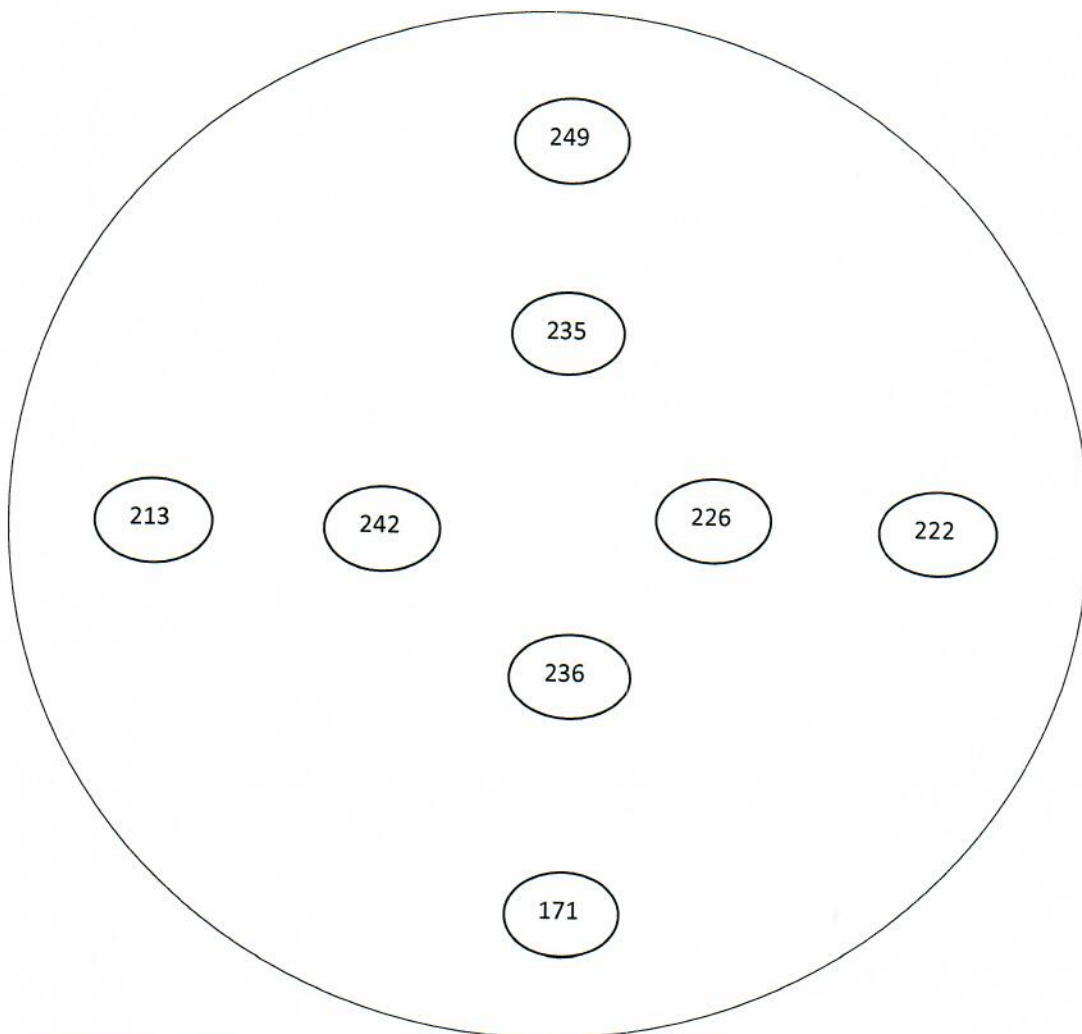
PROJECT:	Brightview Senior Living	SYSTEM:	DOAS-1
LOCATION - ZONE:	Attic	SERVICE:	Exhaust Register 8
ALTITUDE:		DENSITY:	
		FACTOR:

DUCT	REQUIRED	ACTUAL
S.P.: 0.02"	SCFM:	SCFM:
SIZE: 8"	FPM: 229	FPM: 223
AREA: 0.35Ft <sup>2</sup>	CFM: 80	CFM: 78
TEMP:

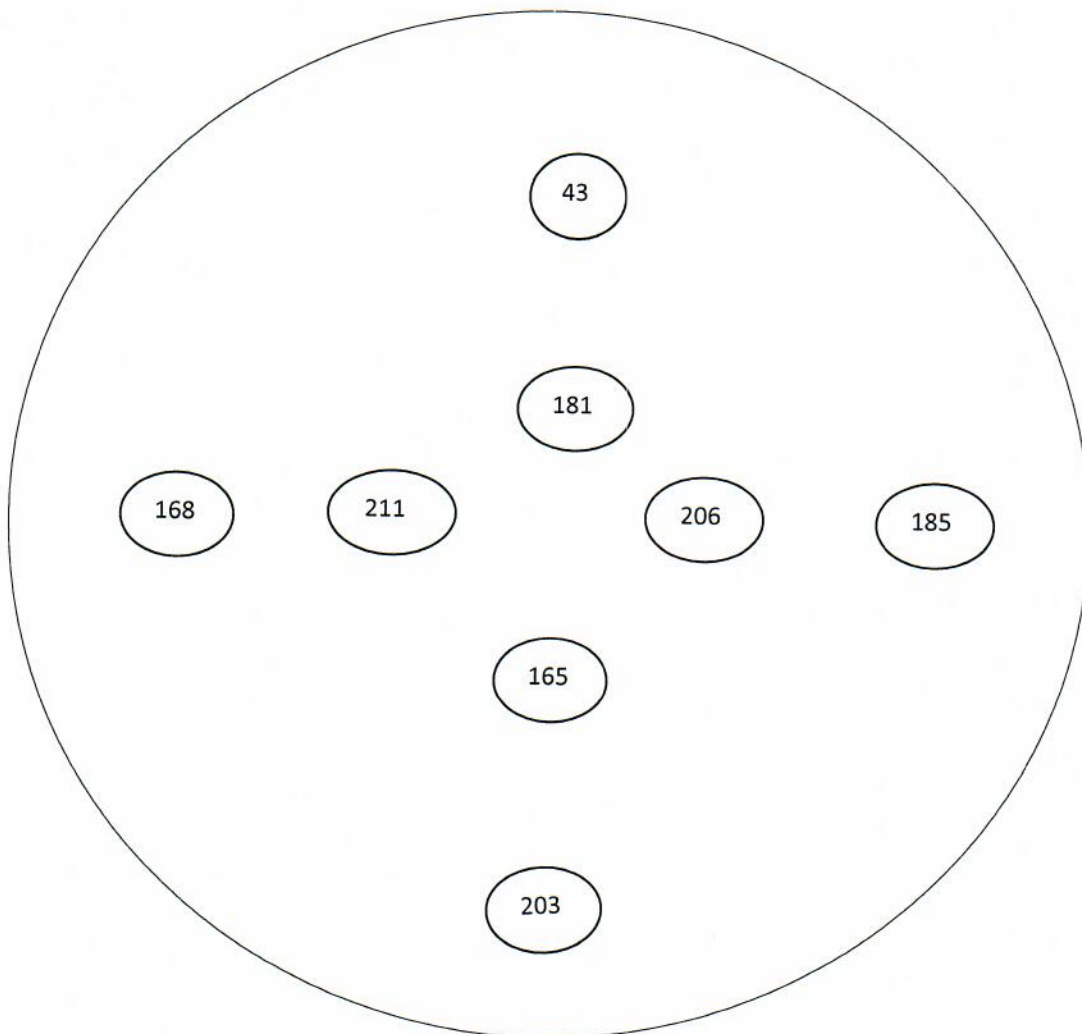
PROJECT:	Brightview Senior Living	SYSTEM:	DOAS 1
LOCATION - ZONE:	Attic	SERVICE:	Exhaust Register 10
ALTITUDE:		DENSITY:	
		FACTOR:

DUCT	REQUIRED	ACTUAL
S.P.: 0.008"	SCFM:	SCFM:
SIZE: 8"	FPM: 214	FPM: 170
AREA: 0.35Ft^2	CFM: 75	CFM: 59
TEMP:
