Report: Brightview-DOAS1 Analysis

Function: Test, Adjust, & Balance

Date: 09/22/2025

BVE - Brightview Senior Living (Eatontown, NJ)

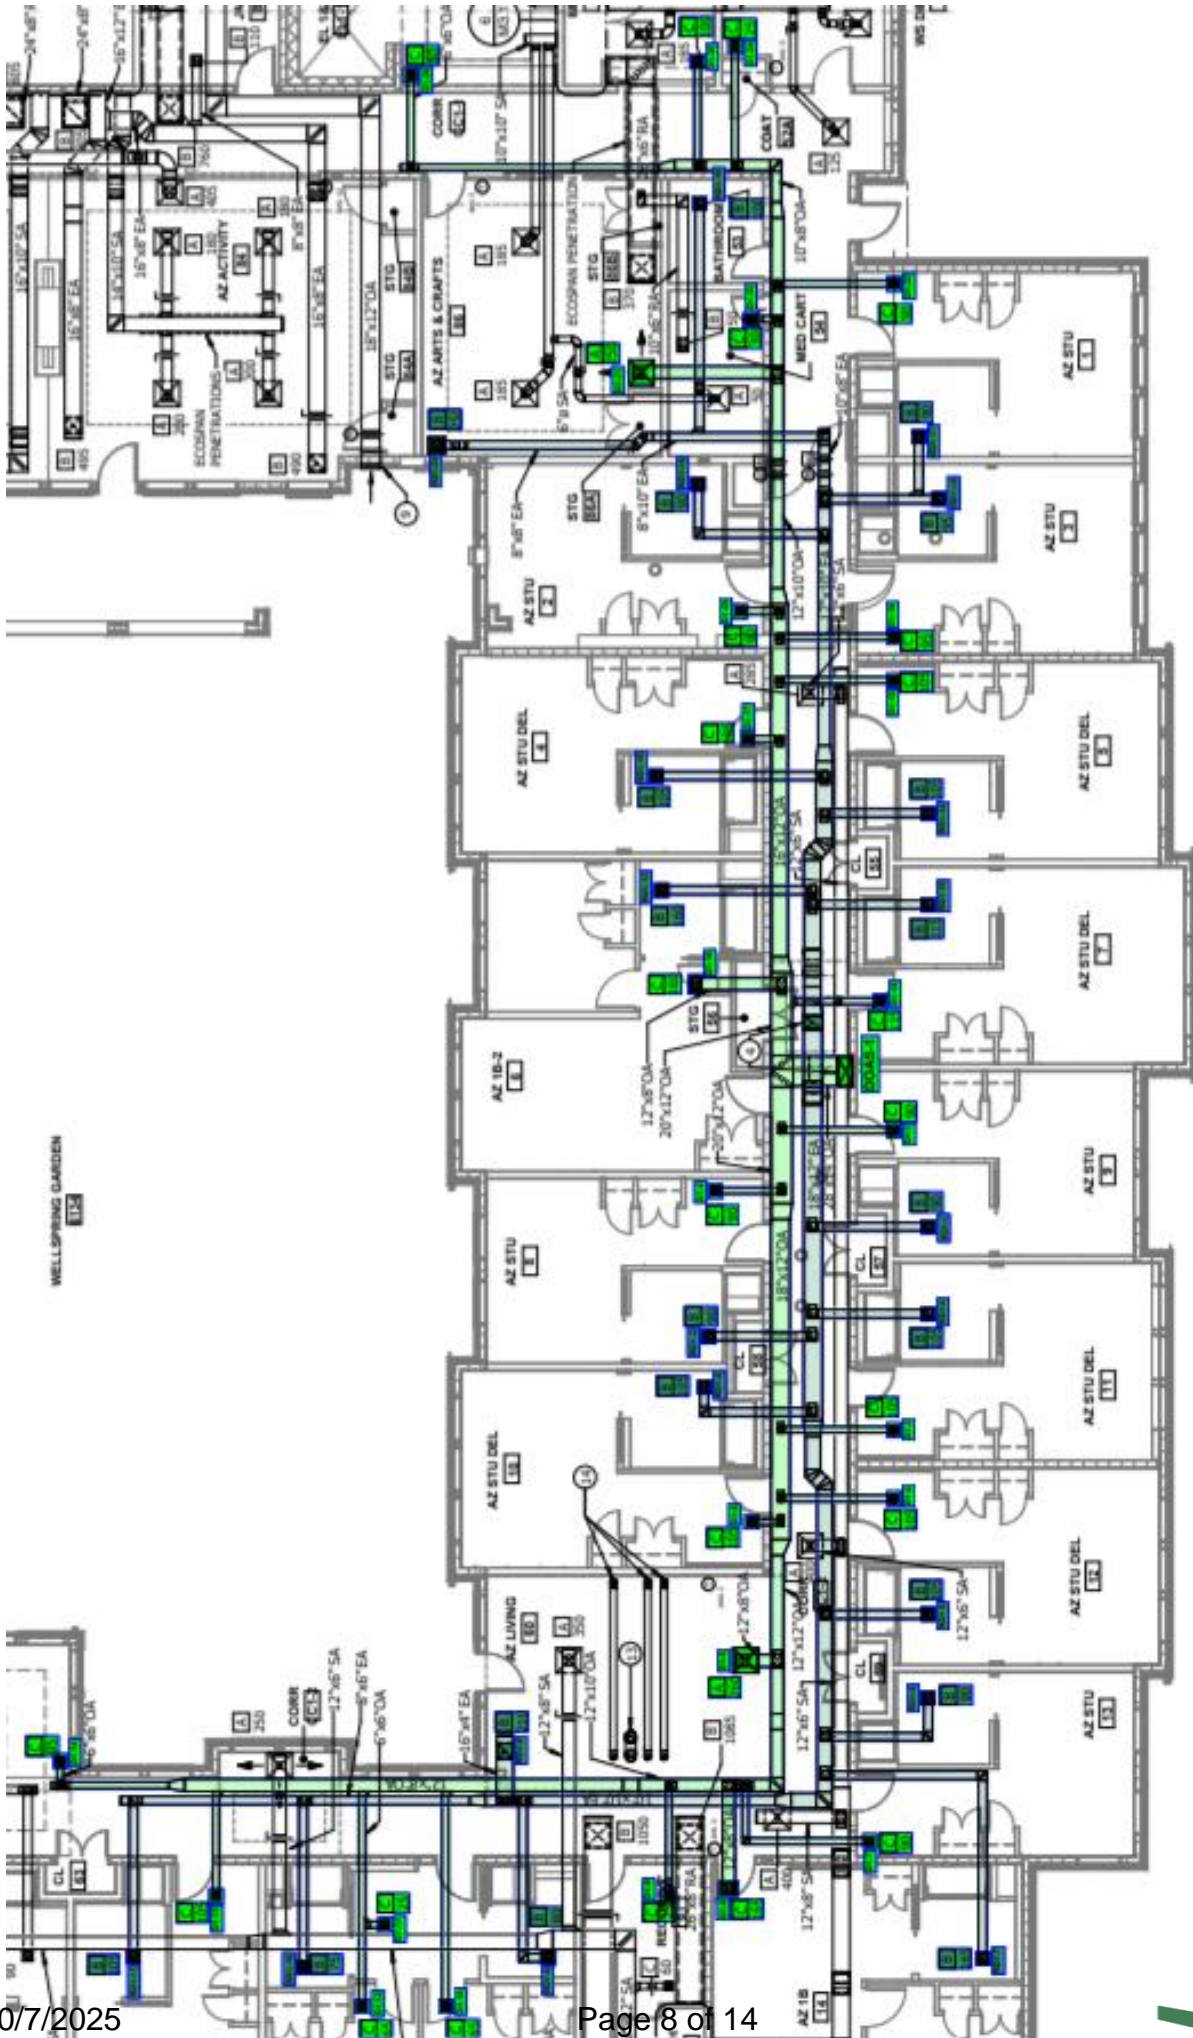
ROUND DUCT TRAVERSE FORM

PROJECT:	Brightview Senior Living	SYSTEM:	DOAS 1
LOCATION - ZONE:	Attic	SERVICE:	Supply Register 11/12
ALTITUDE:		DENSITY:	
		FACTOR:

[1] TRAVERSE TAKEN FROM ATTIC, NO SIGNS OF LEAKAGE ALONG DUCTWORK.
