Report: Brightview-DOAS1 Analysis

Function: Test, Adjust, & Balance

Date: 09/22/2025

BVE - Brightview Senior Living (Eatontown, NJ)

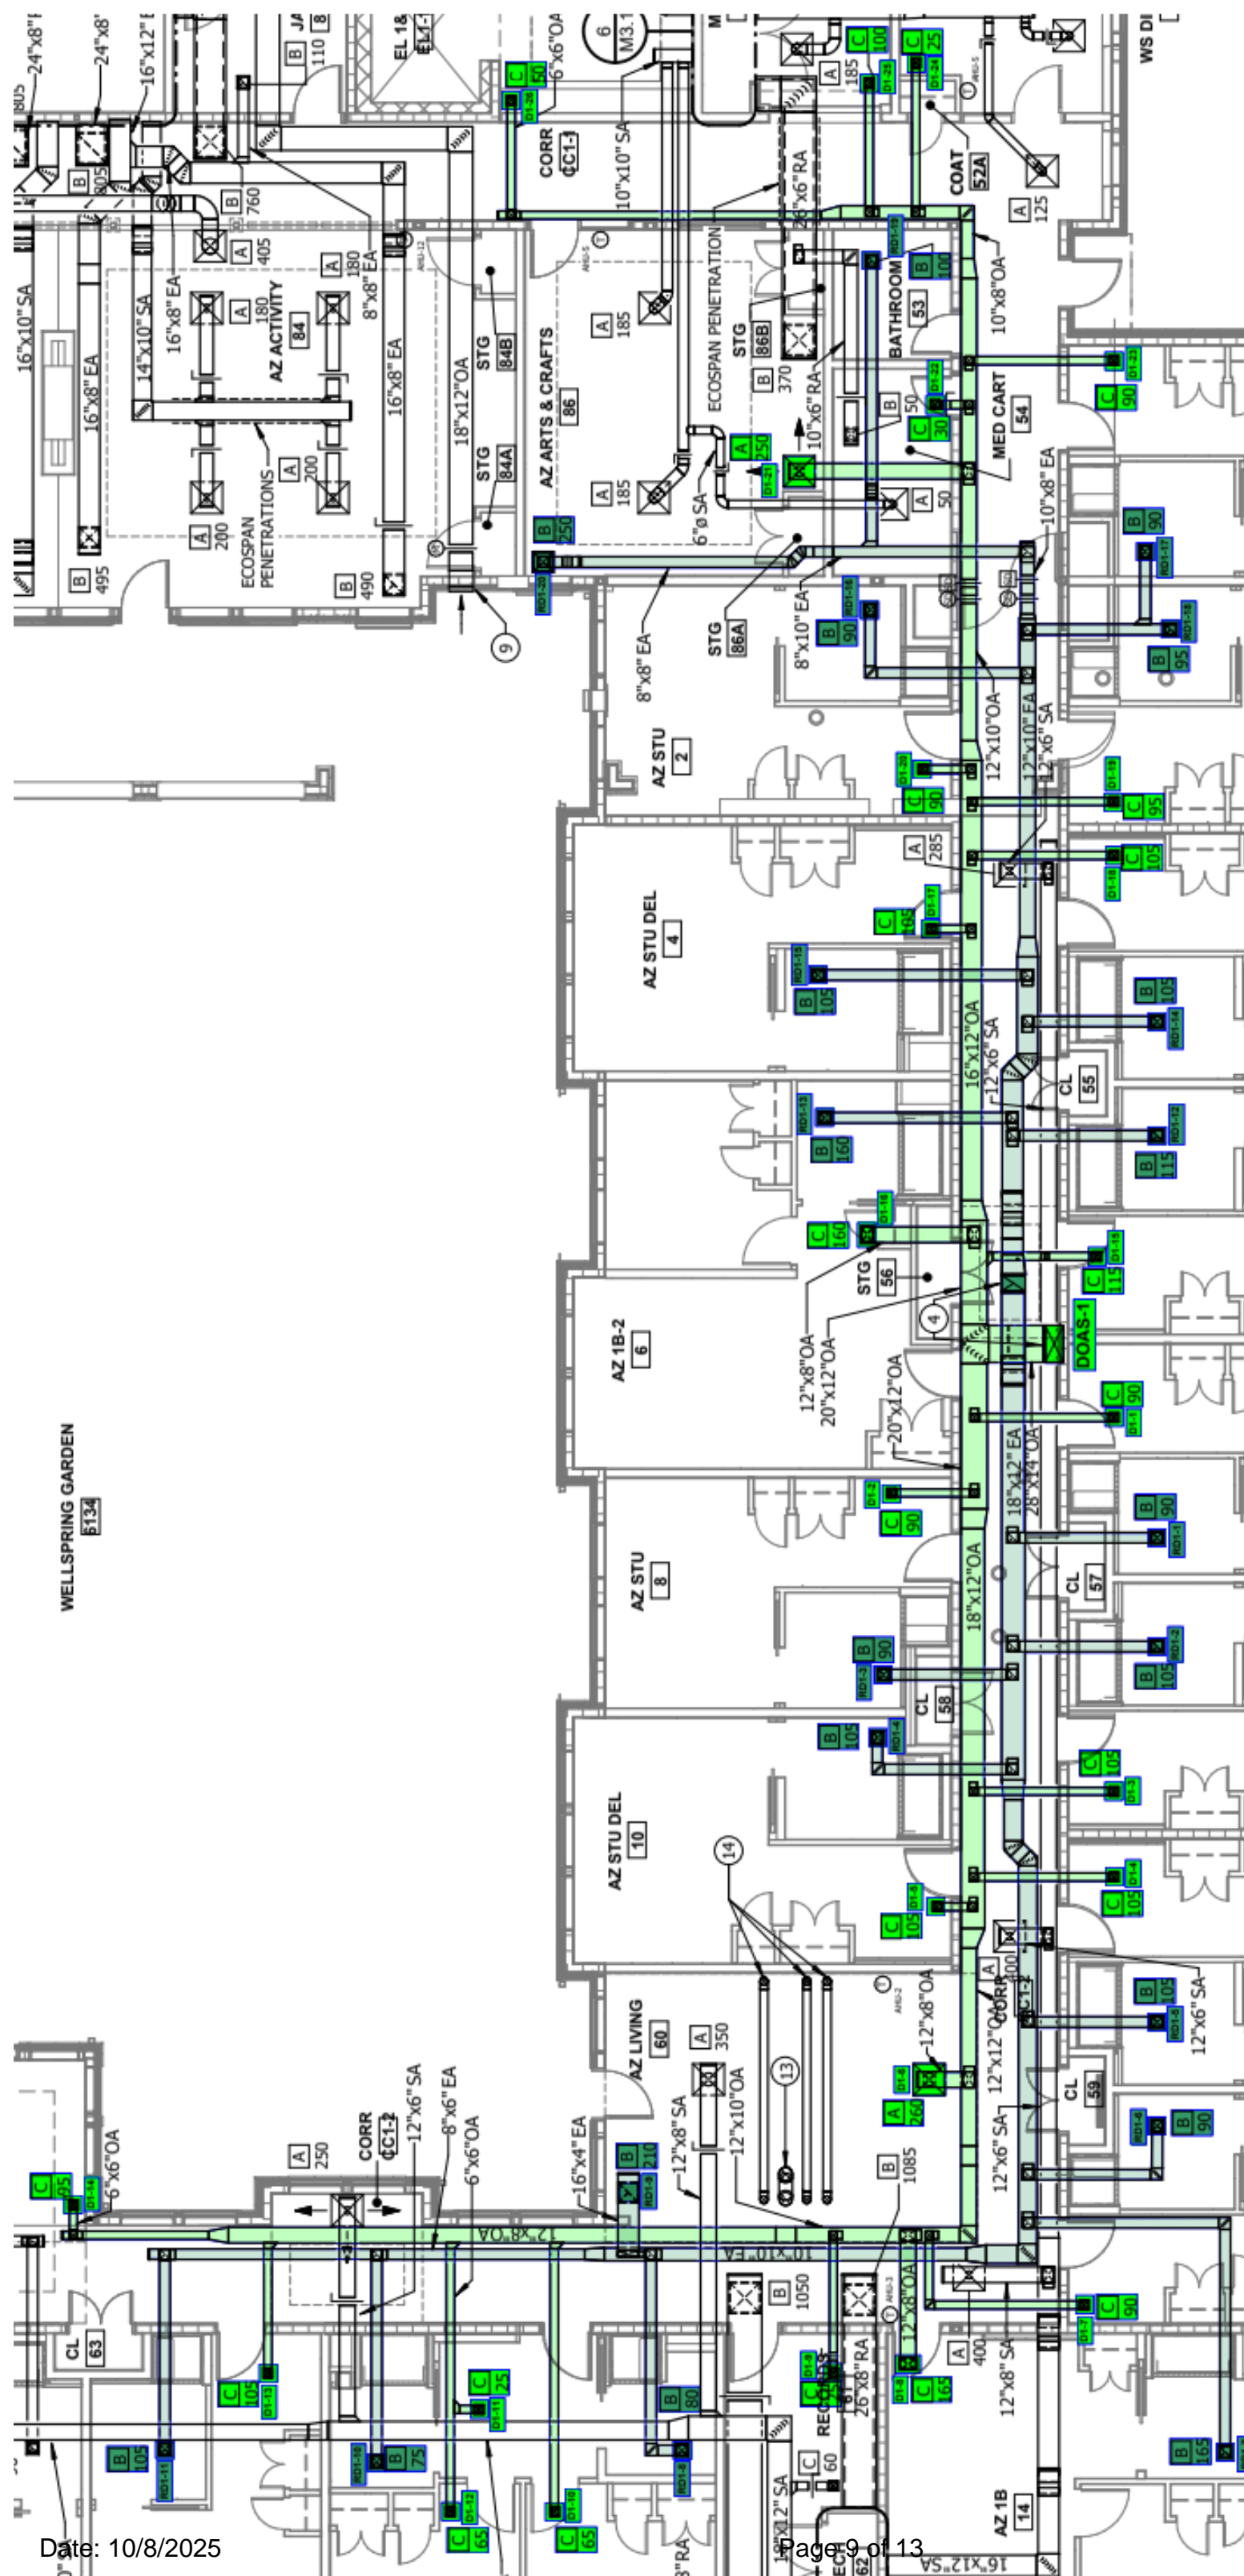
SQUARE DUCT TRAVERSE FORM

REMARKS:
 [1] TRAVERSE TAKEN FROM ATTIC, NO SIGNS OF LEAKAGE ALONG DUCTWORK.

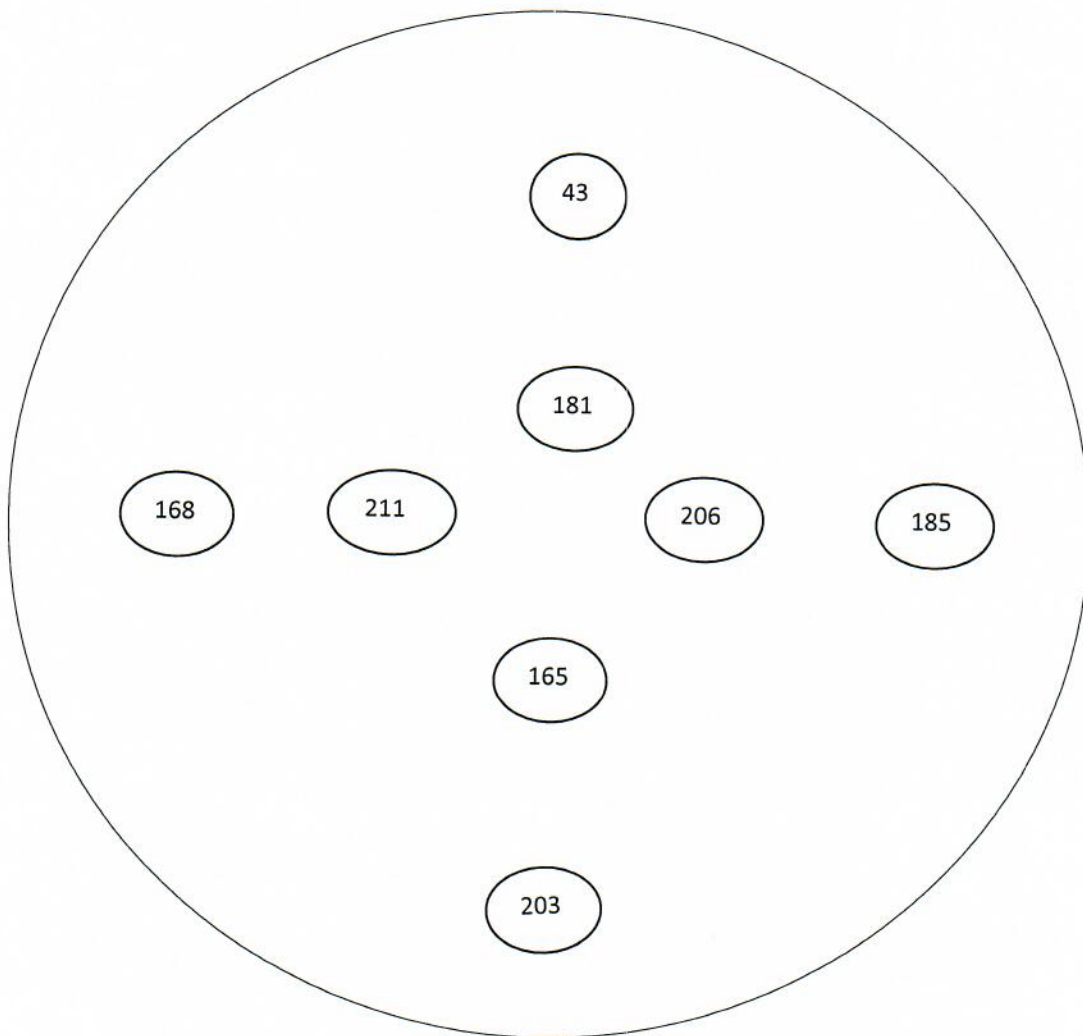
PROJECT:	Brightview Senior Living	SYSTEM:	DOAS 1
LOCATION - ZONE:	Attic	SERVICE:	Exhaust Register 10
ALTITUDE:		DENSITY:	
		FACTOR:

DUCT	REQUIRED	ACTUAL
S.P.: 0.008"	SCFM:	SCFM:
SIZE: 8"	FPM: 214	FPM: 170
AREA: 0.35Ft ²	CFM: 75	CFM: 59
TEMP:
