Report: Brightview-DOAS1 Analysis

Function: Test, Adjust, & Balance

Date: 09/22/2025

BVE - Brightview Senior Living (Eatontown, NJ)

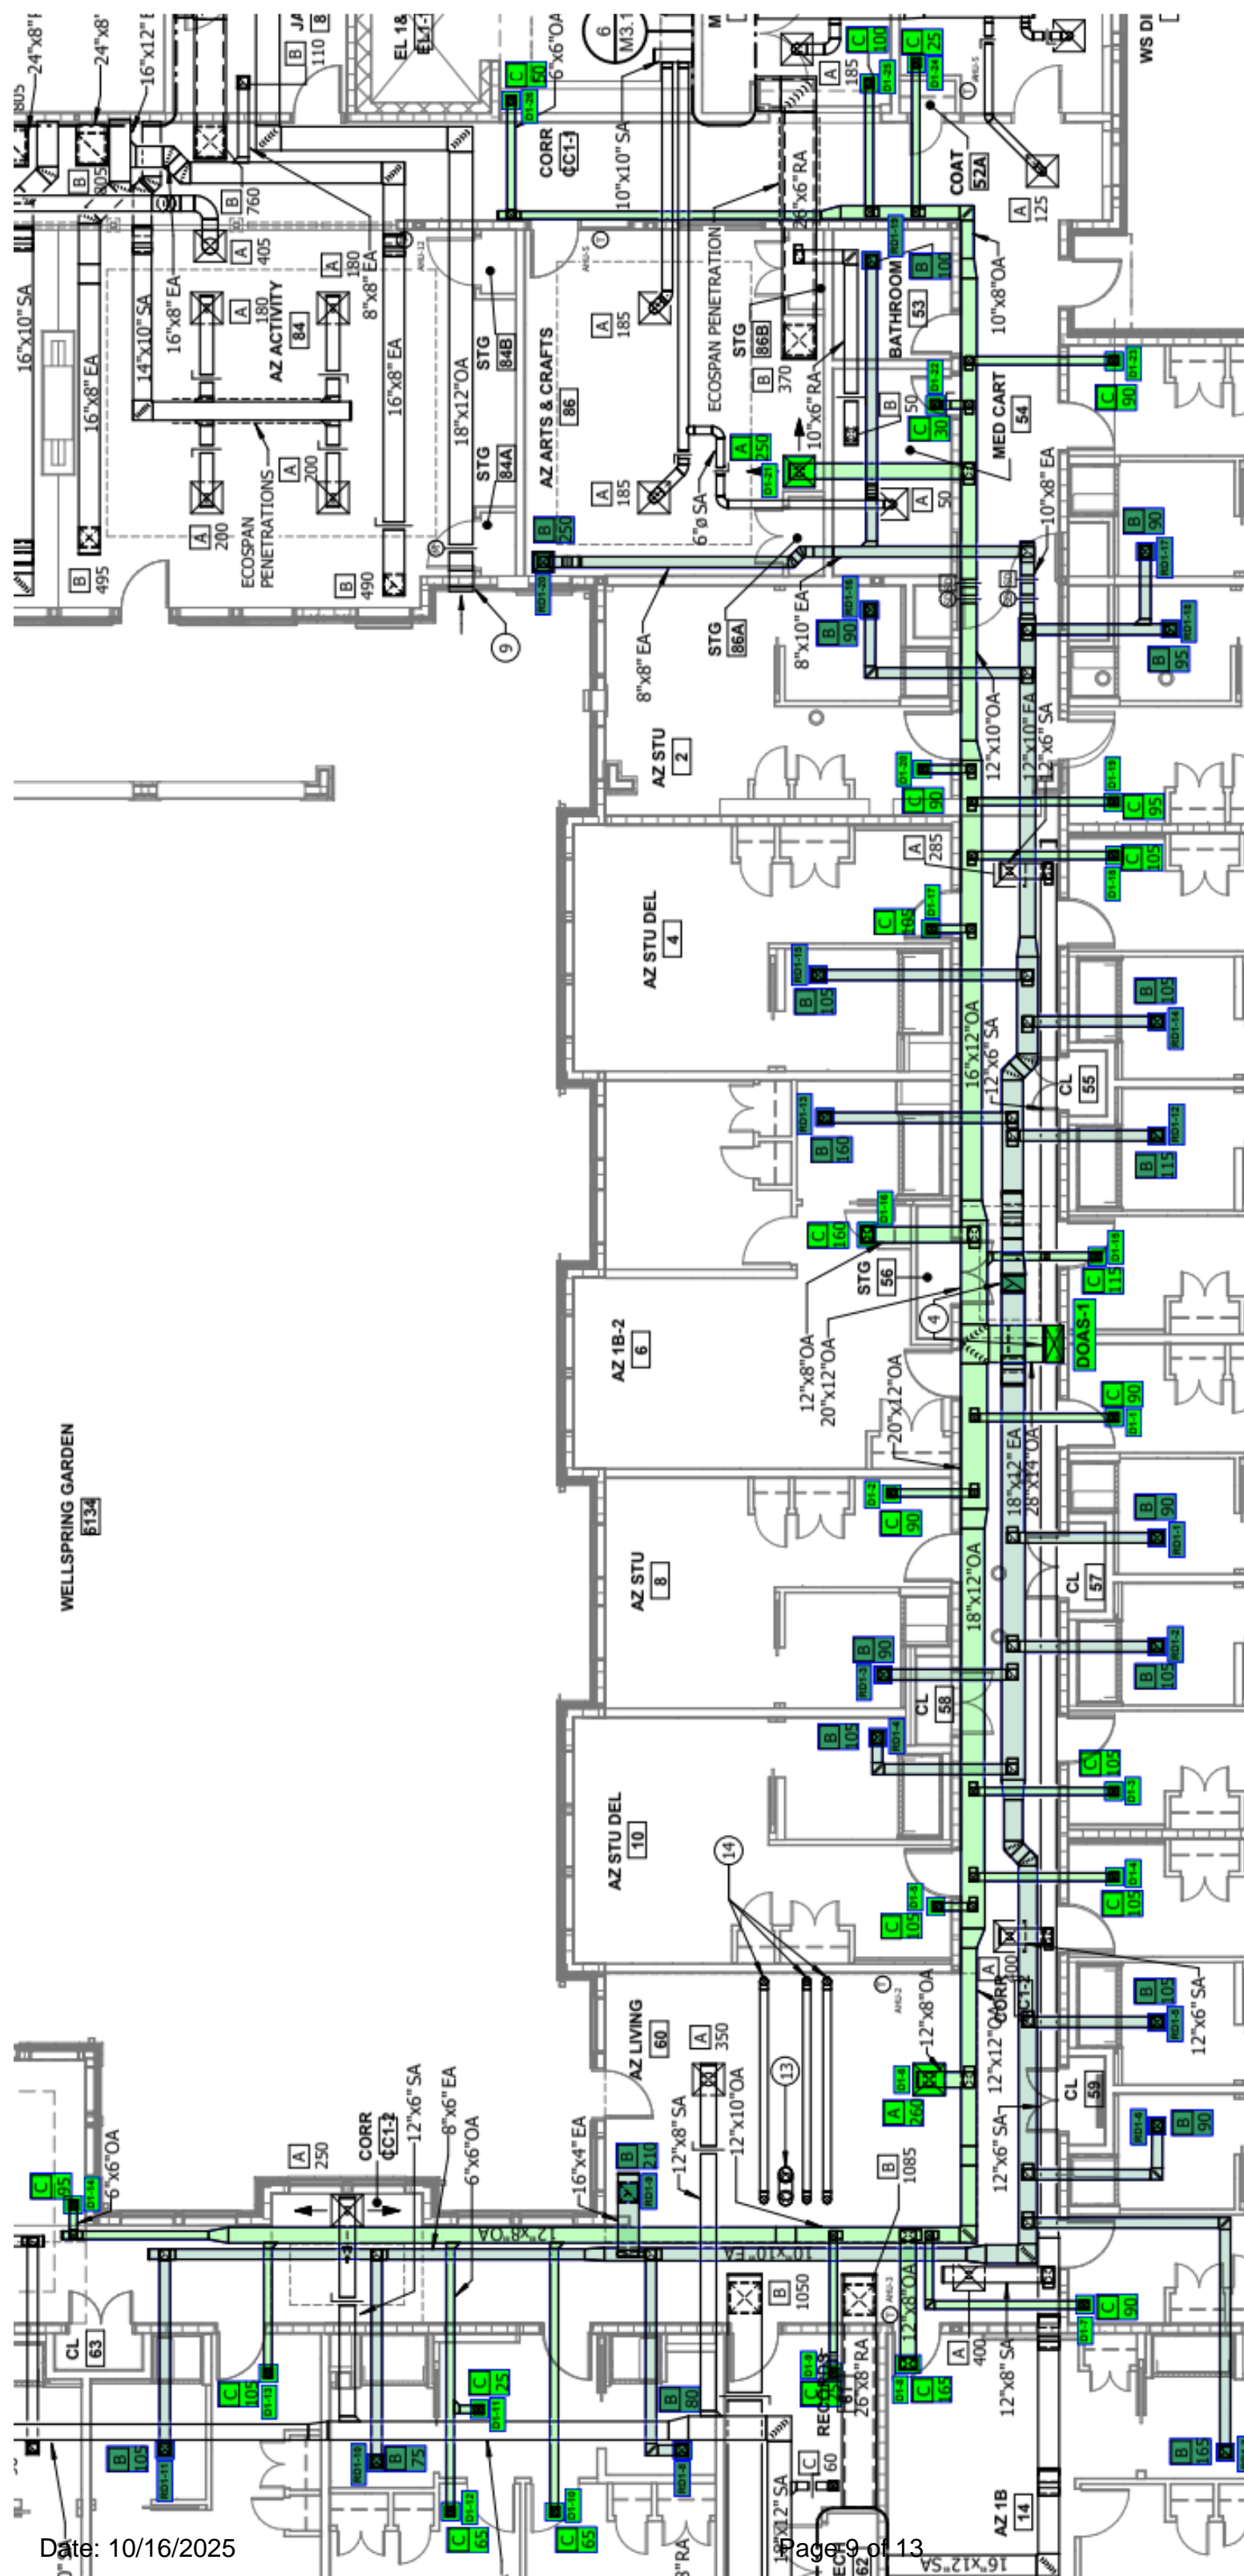
SQUARE DUCT TRAVERSE FORM

PROJECT Brightview Senior Living SYSTEM DOAS-1
 LOCATION Eatontown, NJ SERVICE Exhaust Register 7
 ALTITUDE - DENSITY - FACTOR -

DUCT	REQUIRED	ACTUAL
S.P. <u>0.013"</u> TEMP <u>-</u>	SCFM <u>-</u>	SCFM <u>-</u>
SIZE <u>11"X6"</u>	FPM <u>360</u>	FPM <u>207</u>
AREA <u>0.458Ft^2</u>	CFM <u>165</u>	CFM <u>95</u>

REMARKS:
 [1] TRAVERSE TAKEN FROM ATTIC, NO SIGNS OF LEAKAGE ALONG DUCTWORK.
