Report: TAB Report
Function: Test, Adjust, & Balance
Date: 05/31/2024

PROJECT
06-03-24 WAWA #5434 PALATKA, FL

Project: 06-03-24 WAWA #5434 PALATKA, FL

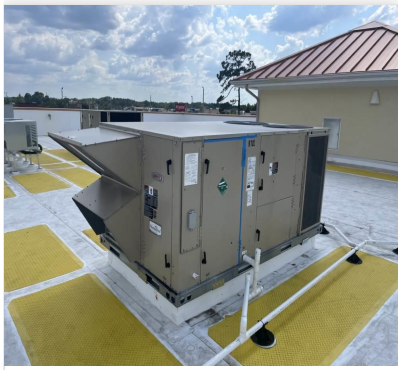
RTU-2

Issue Name : RTU 2 Missing One Final Filter
Description : RTU 2 is missing one of the final filters. Recommend replacing.
Created By : National TAB **Assigned To :** National TAB - Will Turnbough
Status : Open
Priority : Medium **Asset Tag :**
Originated Date : 06/05/2024 - Stephen Tassinaro - National TAB

**MissingFilter
06/05/2024**

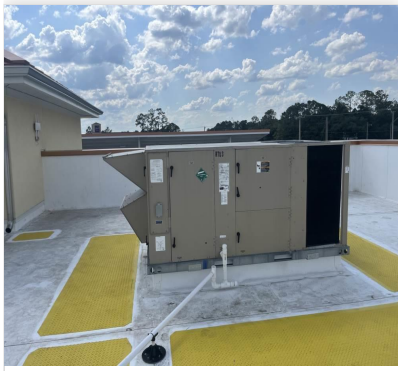
RTU-3

RTU 1 - CORE APP NOT RESPONSIVE RTU 2 - EAT 70F - LAT 59F RTU 3 - FAIL - Comp 1 Low Pressure - EAT 77F - LAT 68F
