Report: Test and Balance

Date: 4/28/2021

PROJECT
ARBYS #1191 FORT SMITH, AR (TOWSON)

4915 TOWSON
FT SMITH, AR

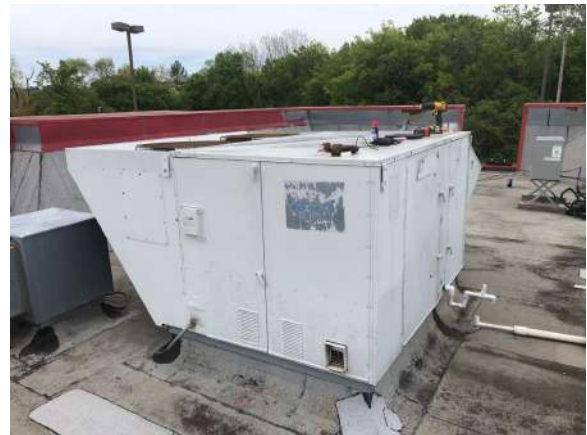
RTU2

RTU-2 (KITCHEN)	
HIGH	Evaporator coil is very dirty and needs to be cleaned.
HIGH	Blower is very dirty and needs to be cleaned.
HIGH	The motor pulley is bound up and cannot be adjusted. Recommend breaking pulley free and the closing (maximizing) the pulley to increase airflow. Ensure that the amperage to the motor does not exceed the full load rating.
LOW	Unit has noticeable vibration and appears to be coming from motor compartment. Not audible from inside space but recommend monitoring/resolving.
LOW	Evaporator coil has damage to the fans which is likely impacting airflow. Recommend straightening if possible.
INFO ONLY	Airflow is currently 230 CFM/ton (3788 CFM). After making changes above it is anticipated that airflow should increase significantly. If airflow remains low a pulley change may be feasible since there is a large amount of amperage left on the motor.
EF-1 (FRYERS)/FRYER HOOD

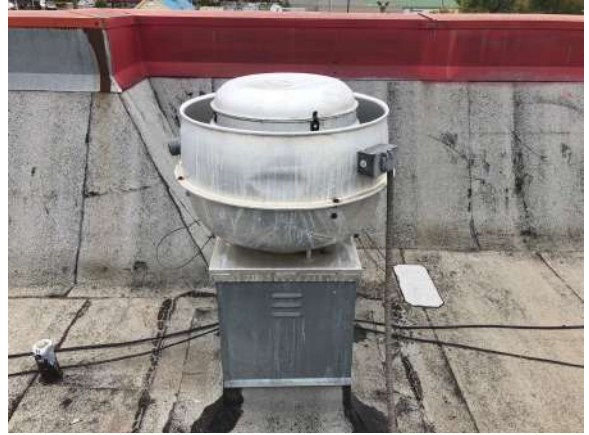
EF1

HIGH	Fan sits on vented curb and the grease duct is not run all the way up to the fan. The current arrangement allows for leakage through the curb. It also allows for a ledge for grease to pool which is a fire hazard. Recommend running the grease duct all the way up to the base of the fan. During testing, the vents were temporarily taped.
INFO ONLY	Airflow is currently 687 CFM which is lower than recommended for this size hood. However with the vents taped off, the hood was performing well. Not recommended to change fans at this time. If fan change is performed in future, recommend larger fan
INFO ONLY	Filters were initially dirty. Had Operations clean.
EF-2 (OVEN HOOD)/OVEN HOOD	
HIGH	Fan sits on vented curb and the grease duct is not run all the way up to the fan. The current arrangement allows for leakage through the curb. It also allows for a ledge for grease to pool which is a fire hazard. Recommend running the grease duct all the way up to the base of the fan. During testing, the vents were temporarily taped.

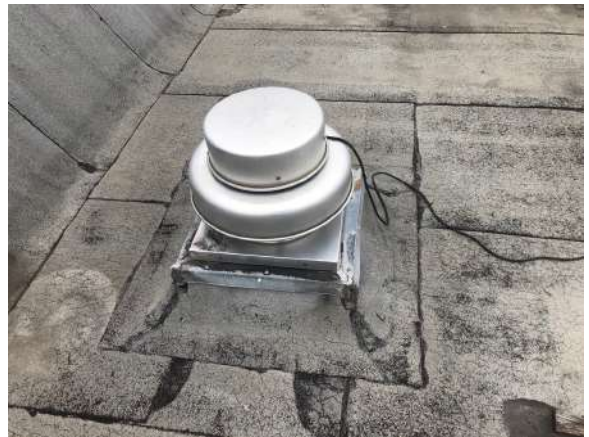
EF3

EF-3 (RESTROOM)	
HIGH	Ductwork is not run from the fan to the grilles in the space. The fan pulls from the ceiling space. The airflow at the grilles was around 200 CFM total but based on a fan curve, the total airflow for the fan is around 1000 CFM. Recommend running ductwork to this fan. The fan is currently wired for high speed and once ductwork is connected it is recommended to wire the fan for low speed.
MUA (FRYER HOOD)	
HIGH	MUA outlet at hood is a front face discharge style. This style of MUA is not recommended as it discharges unconditioned outside air into the kitchen space. If supply air can be increased on both RTU's, then it is possible to completely turn off the MUA. This should have a significant impact on space comfort.

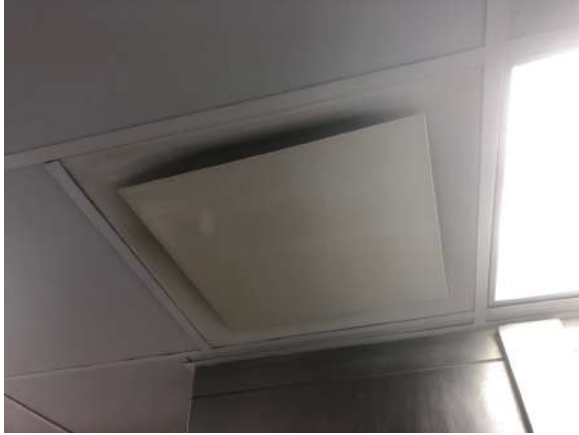
Typ Kitchen Diffuser

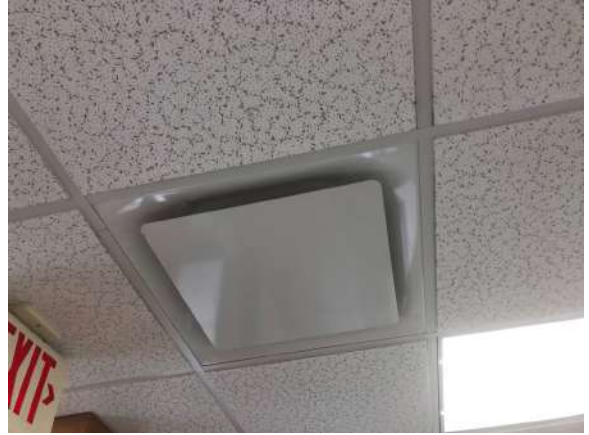
Typ Dining Diffuser
