Summary

Purpose of the visit to Lazy Dog in Montclair, CA was to investigate a couple of complaints. First, MUA was tripping off on a high pressure alarm. Second, there were hood capture complaints.

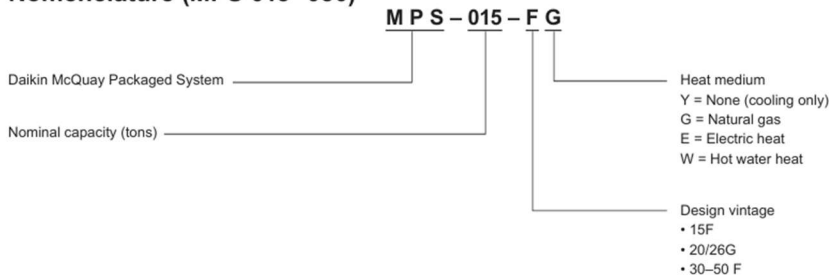
Nomenclature (MPS 015–050)

The unit is a 35 ton unit based on the model number. The manual also states that the rated airflow for a 35 ton unit is 8750 CFM.
