FOR THE NEXT TAB TECH

This job site was completely not read when I can here the first time, recommend looking through the issue list for a complete overview of the issues last time.

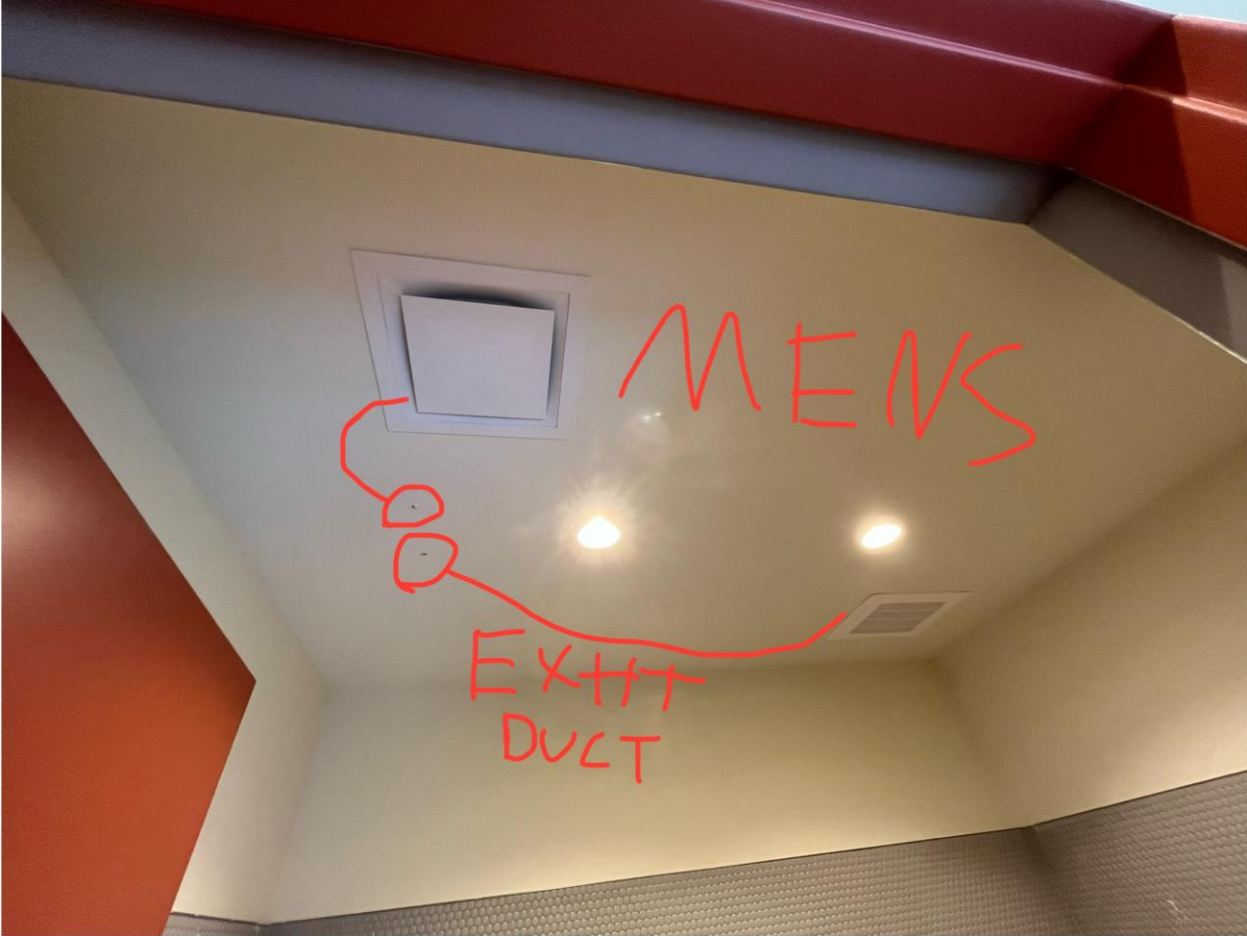
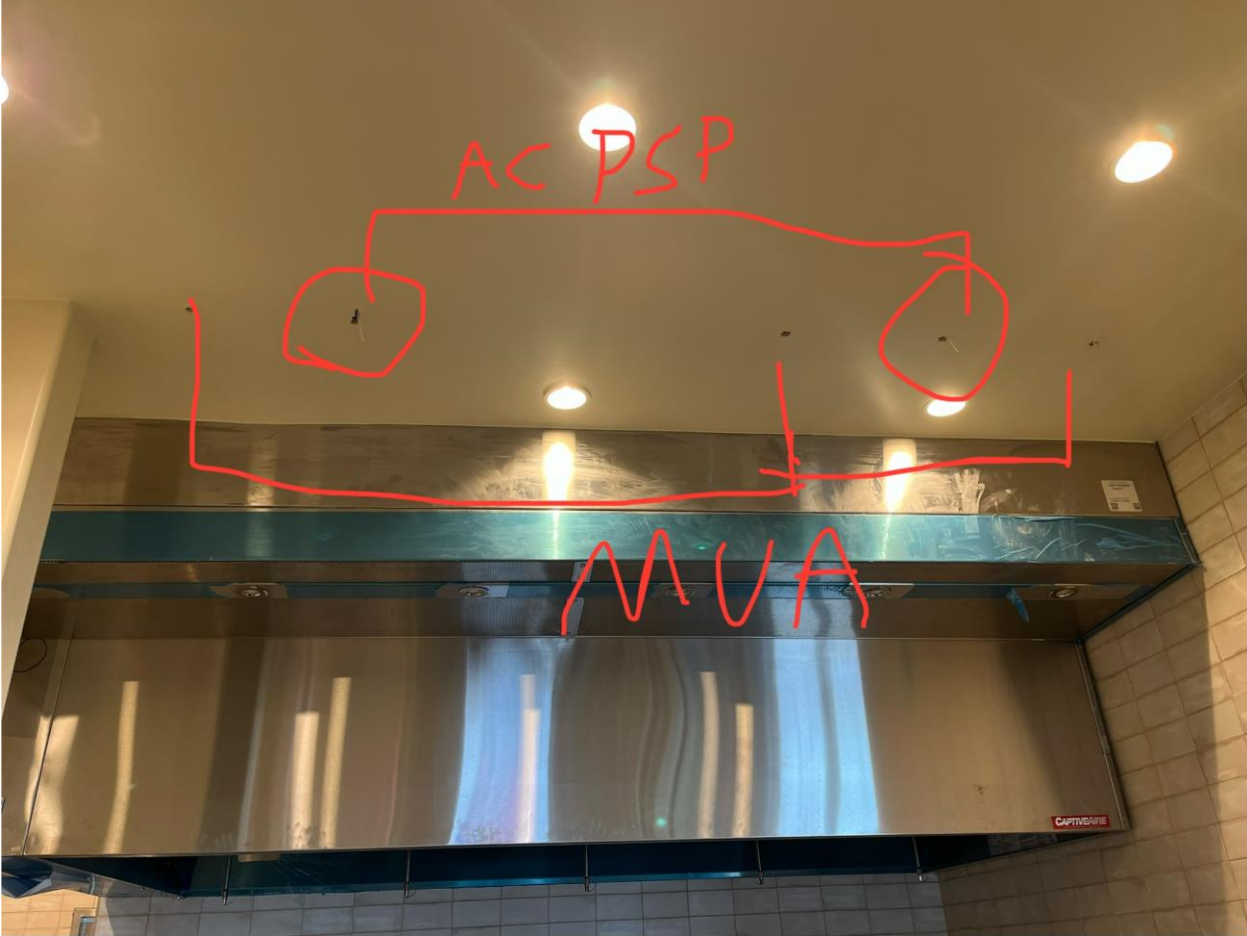
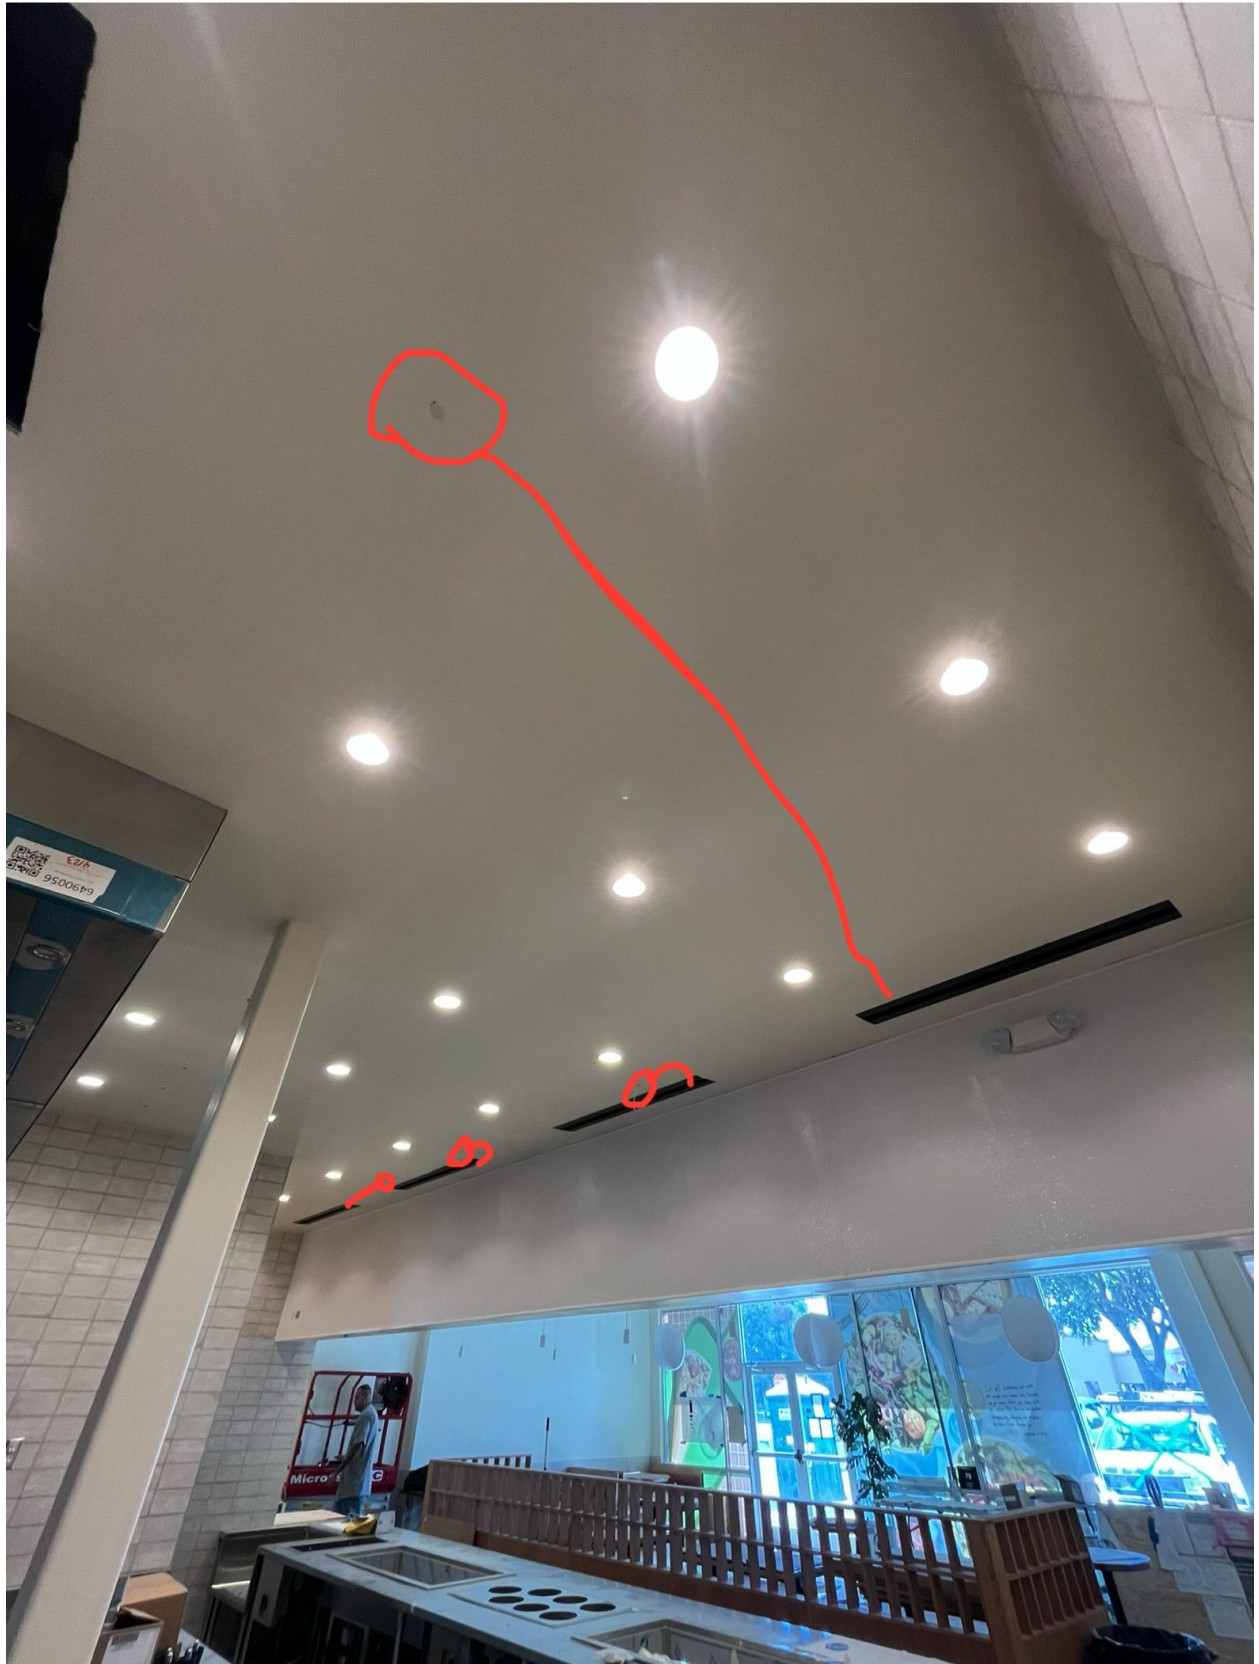
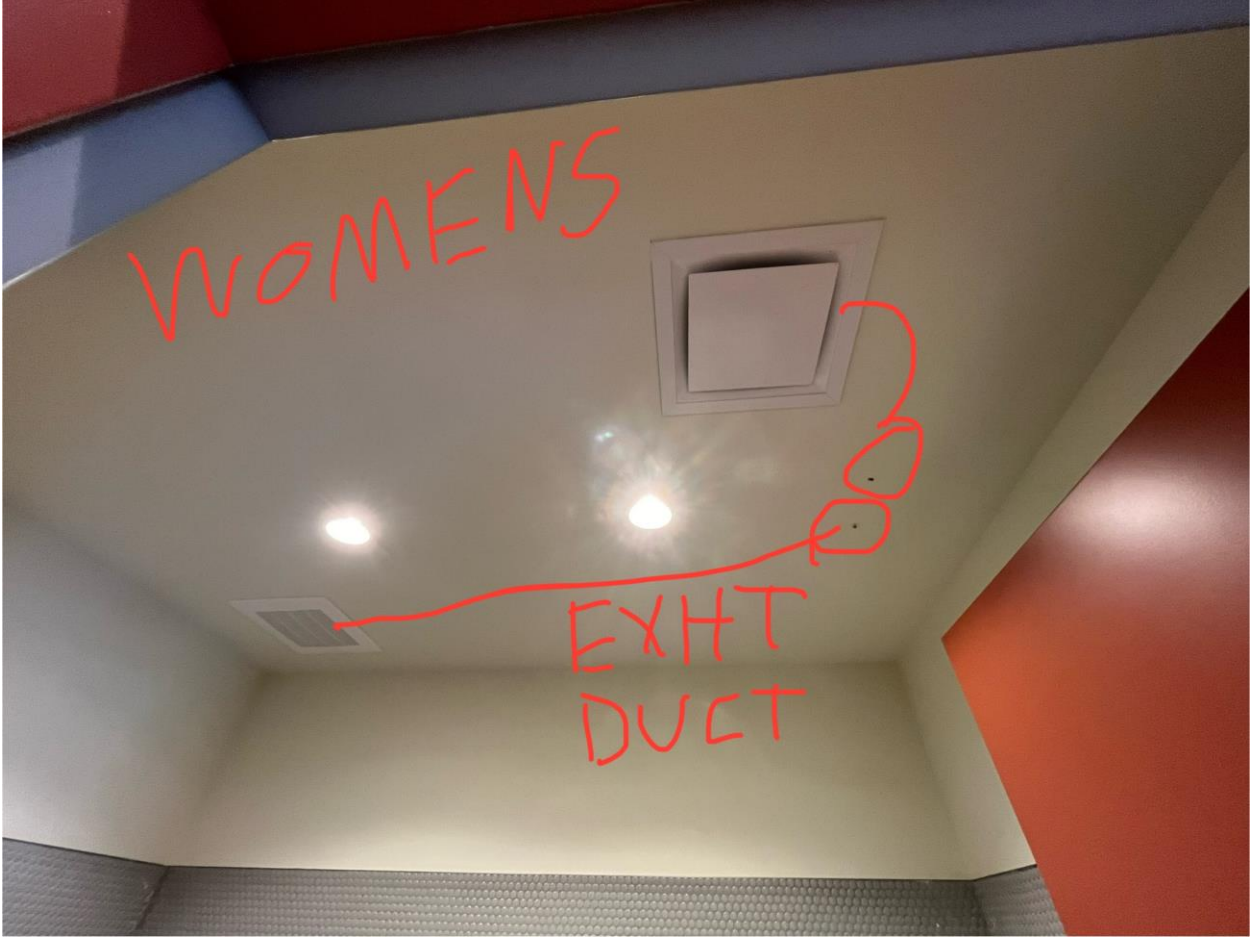
Attached to this document are pictures of which damper cables go to which diffusers.
