**Report: TAB REPORT**  
**Function: Test, Adjust, & Balance**  
**Date: 08/05/2024**

**PROJECT**  
**07-01-24 CAVA CAMBRIDGE, MA (HARVARD SQUARE)**  
22 Brattle Street  
CAMBRIDGE, MA

Project: 07-01-24 CAVA CAMBRIDGE, MA (HARVARD SQUARE)

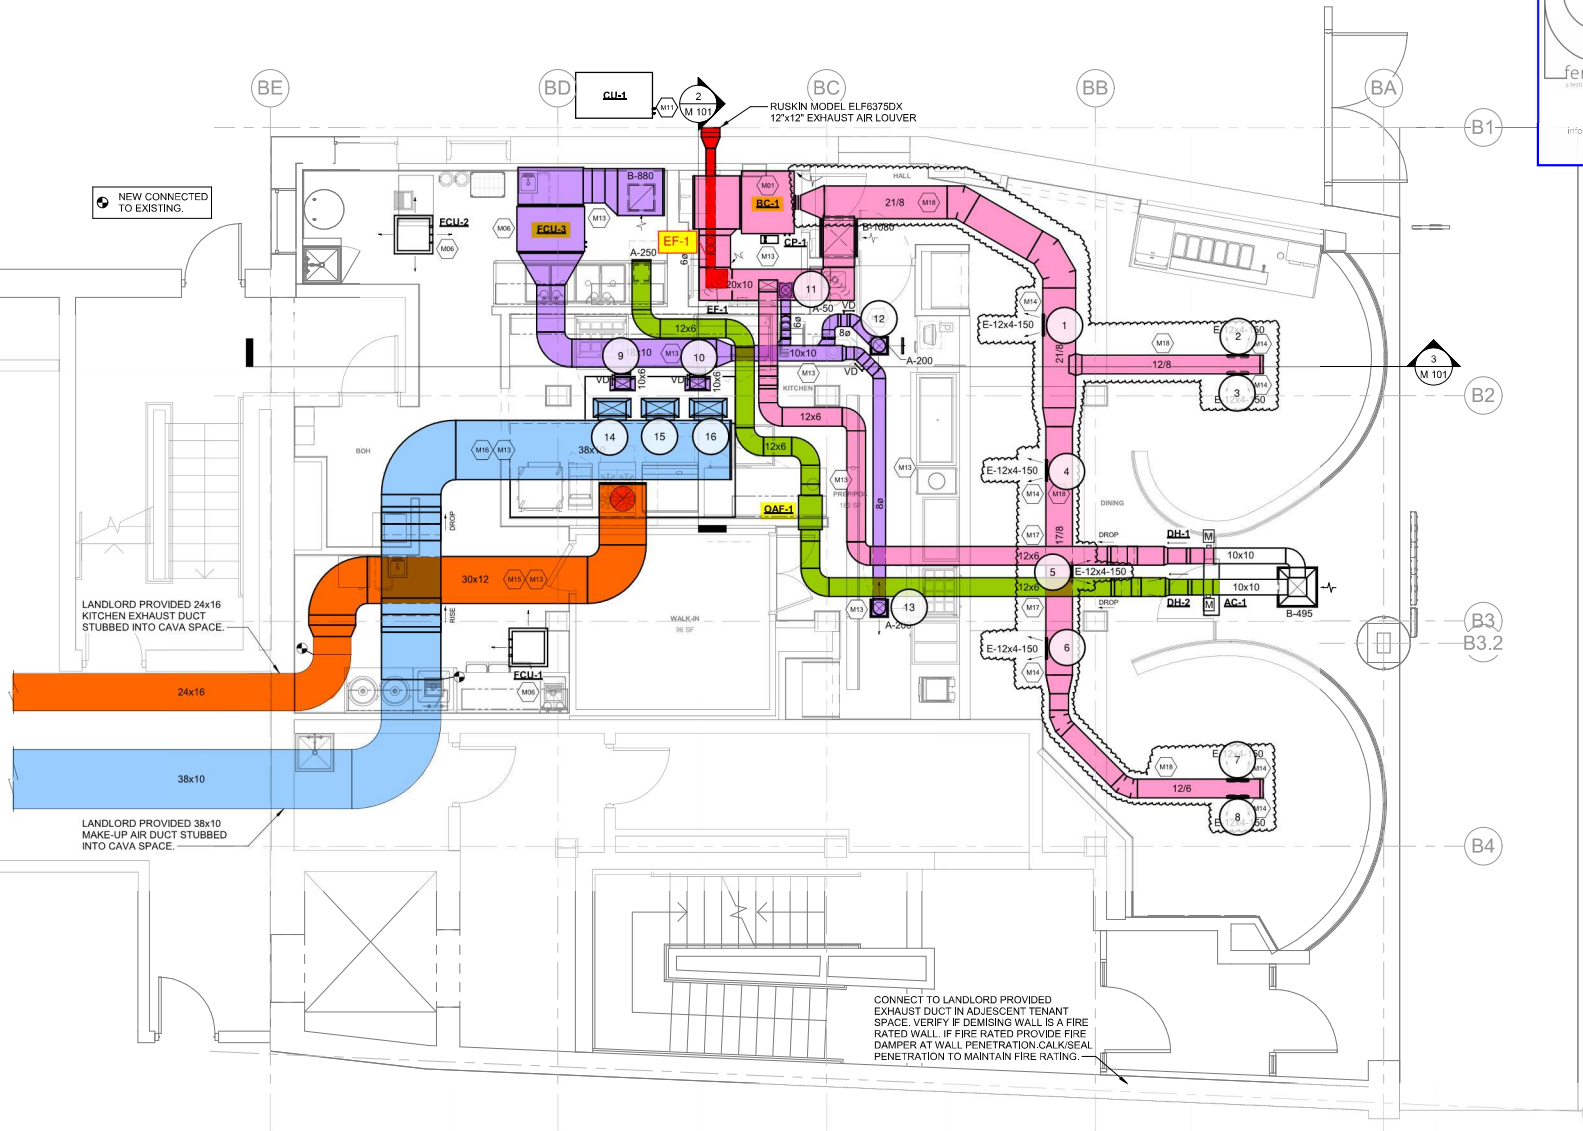
**MECHANICAL DUCT PLAN**  
 1/4" = 1'-0"

**MECHANICAL EQUIPMENT, DUCT AND PIPING MOUNTING NOTE**  
 REFER TO LANDLORD'S BASE BUILDING STRUCTURAL DRAWINGS SHEET S5.13, DETAIL #5 FOR  
 INSTALLATION OF SECONDARY FRAMING IN THE EXISTING TERRAZZOTA CONCRETE  
 CONSTRUCTED BUILDING FOR THE SUSPENSION MECHANICAL EQUIPMENT, PIPING AND  
 DUCTWORK.

Section	Page #
Summary	3
Assets	4
GRD Layout	9
