Report: TAB Report
Function: Test, Adjust, & Balance
Date: 10/24/2025
Completed By: National TAB

PROJECT
11-03-25 QT #0754 ROSWELL, GA

Project: 11-03-25 QT #0754 ROSWELL, GA

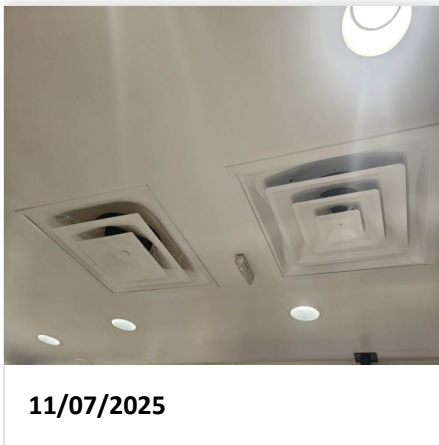
Project Issue File Details

Issue Name : RTU 3: INCORRECT KITCHEN DIFFUSER STYLE
Description : Kitchen diffusers 3-1, 3-2, 3-3, and 3-4 are substitutes until the correct Titus Diffusers can be installed.
Created By : National TAB **Assigned To :** National TAB - Dan Hertenstein
Status : Open
Priority : High **Asset Tag :**
Originated Date : 11/07/2025 - Sagar Patel - National TAB

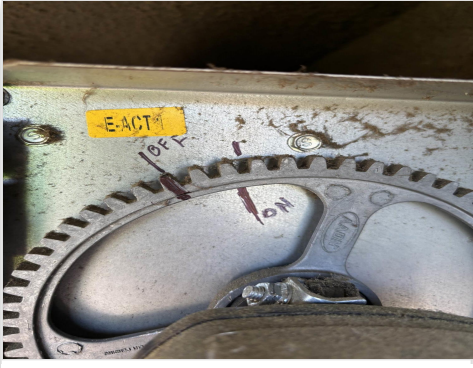
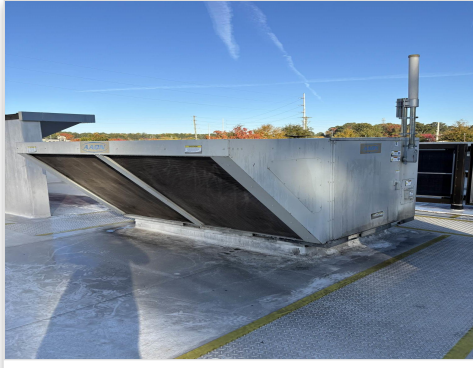
Unit Data - PHOTO LOG

Unit Data		
	Design	Actual
MFG	NA	AAON
Serial Num	-	201610-ANEK14781
Model Num	NA	RN-013-8-0-EA0A-152
Num OA Filters 1	-	1
OA Filter Size 1	-	45X22
Num Final Filter 1	-	4
Final Filter Size 1	-	20X25X2

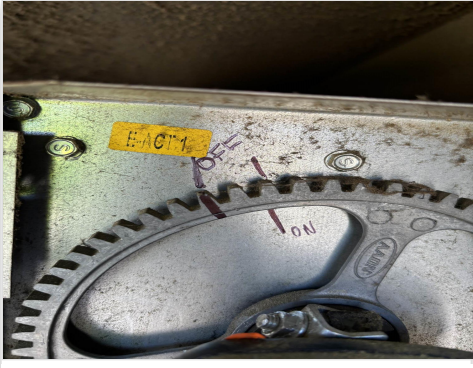
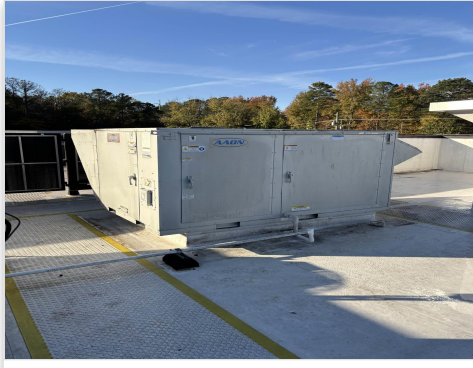
Unit Data - PHOTO LOG

Unit Data		
	Design	Actual
MFG	NA	AAON
Serial Num	-	201610-ANEK14782
Model Num	NA	RN-013-8-0-EA0A-152
Num OA Filters 1	-	1
OA Filter Size 1	-	45X22
Num Final Filter 1	-	4
Final Filter Size 1	-	20X25X2

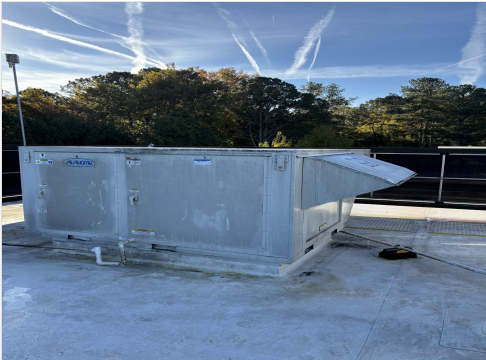
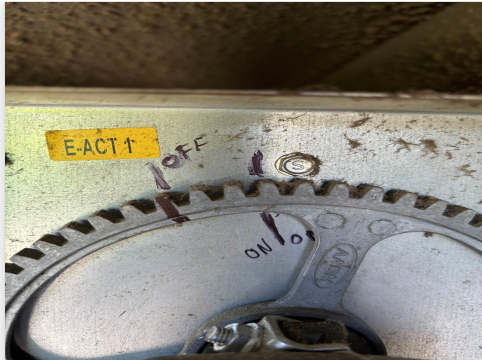
Unit Data - PHOTO LOG

Unit Data		
	Design	Actual
MFG	NA	AAON
Serial Num	-	201610-ANEK14780
Model Num	NA	RN-013-8-0-EA0A-152
Num OA Filters 1	-	1
OA Filter Size 1	-	45X22
Num Final Filter 1	-	4
Final Filter Size 1	-	20X25X2

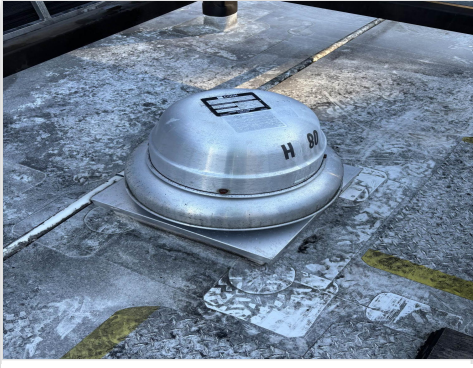
Unit Data - PHOTO LOG

Unit Data		
	Design	Actual
MFG	NA	LOREN COOK COMPANY
Model Num	NA	90 ACEH 90015DH
Serial Num	-	050SG54788- 00/0000701
Type	-	UPBLAST
Configuration	-	VERTICAL

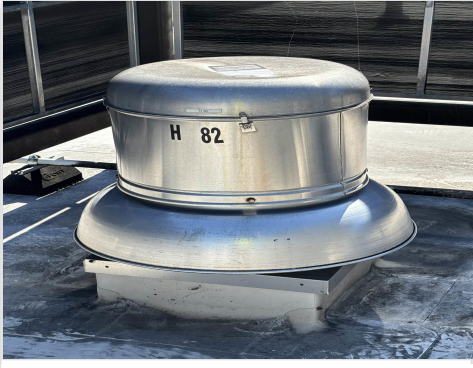
Unit Data - PHOTO LOG

Unit Data		
	Design	Actual
MFG	NA	LOREN COOK COMPANY
Model Num	NA	120 ACE 120013D 33
Serial Num	-	050SG54788-00/0002101
Type	-	DOWBLAST
Configuration	-	VERTICAL

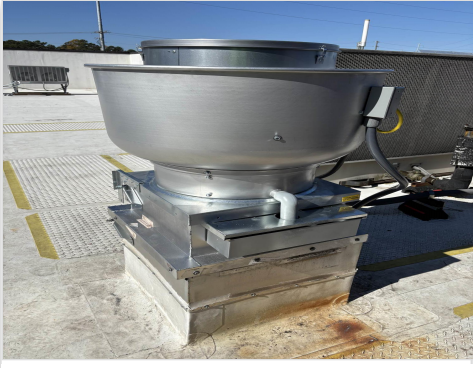
Unit Data - PHOTO LOG

Unit Data		
	Design	Actual
MFG	NA	CAPTIVEAIRE
Model Num	NA	DU50HFA
Serial Num	-	765723
Type	UPBLAST	UPBLAST
Configuration	VERTICAL	VERTICAL

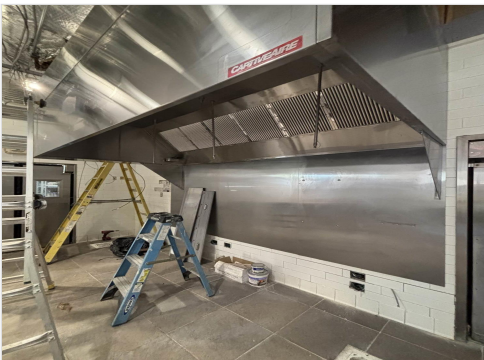
Unit Data - PHOTO LOG

Unit Data		
	Design	Actual
MFG	CAPTIVEAIRE	CAPTIVEAIRE
Model Num	6030ND-2-F	6030ND-2-F
Job / Serial Num	-	7657523
Type	-	TYPE 1 CANOPY
Hood length	-	108"
Hood Width	-	60"
