**Report: TAB Report**  
**Function: Test, Adjust, & Balance**  
**Date: 03/06/2025**  
**Completed By: National TAB**

**PROJECT**  
**03-03-25 WAWA #5416 ESTERO, FL**

Project: 03-03-25 WAWA #5416 ESTERO, FL

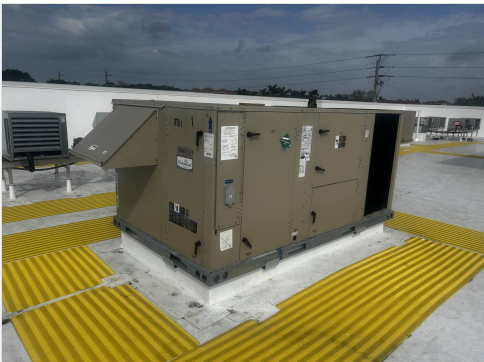
## Unit Data - PHOTO LOG

Asset: RTU1

Unit Data		
	Design	Actual
MFG	LENNOX	LENNOX
Serial Num	-	5624L02317
Model Num	LCT102H4E	LCT102H4EG2Y
Type	RTU	RTU
Configuration	VERTICAL	VERTICAL
Num OA Filters 1	-	1
OA Filter Size 1	-	16"X24"
Num Final Filter 1	-	4
Final Filter Size 1	-	20"X25"X2

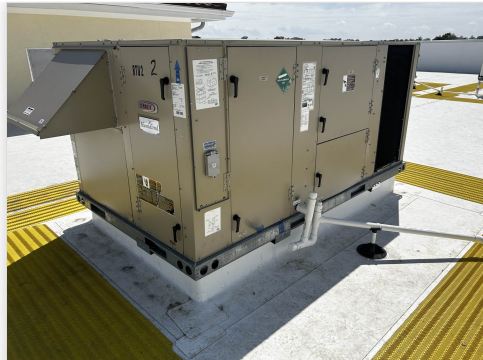
## Unit Data - PHOTO LOG

Asset: RTU2

Unit Data		
	Design	Actual
MFG	LENNOX	LENNOX
Serial Num	-	5624L02312
Model Num	LCT150H4E	LCT150H4EN2Y
Type	RTU	RTU
Configuration	VERTICAL	VERTICAL
Num OA Filters 1	-	1
OA Filter Size 1	-	16"X24"
Num Final Filter 1	-	4
Final Filter Size 1	-	20"X25"X2"

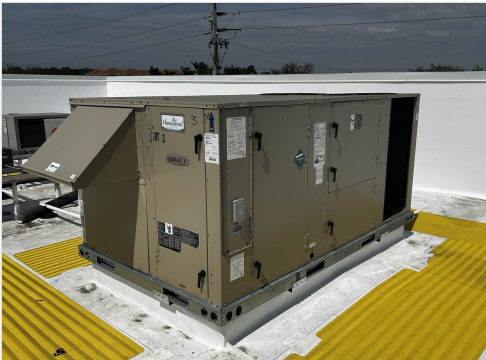
## Unit Data - PHOTO LOG

Asset: RTU3

Unit Data		
	Design	Actual
MFG	LENNOX	LENNOX
Serial Num	-	5624K04831
Model Num	LCT092H4E	LCT092H4EG1Y
Type	RTU	RTU
Configuration	VERTICAL	VERTICAL
Num OA Filters 1	-	1
OA Filter Size 1	-	16"X24"
Num Final Filter 1	-	4
Final Filter Size 1	-	20"X25"X2"

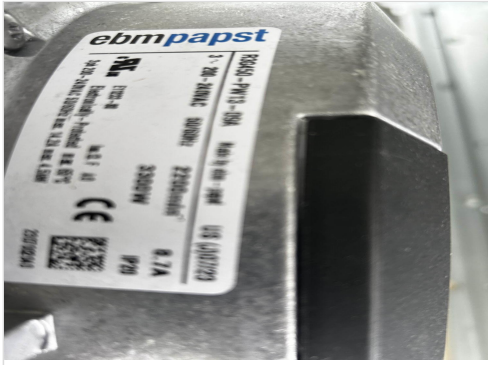
## Motor Data - PHOTO LOG

Motor Data		
	Design	Actual
Motor MFG	-	EBMPAPST
Frame	-	IP20
Horsepower	3.75	3.8
Motor Rpm	-	2200
Phase	3	3
Rated Voltage	208	200-240
Rated Amperage	-	8.7
Service Factor	-	NL

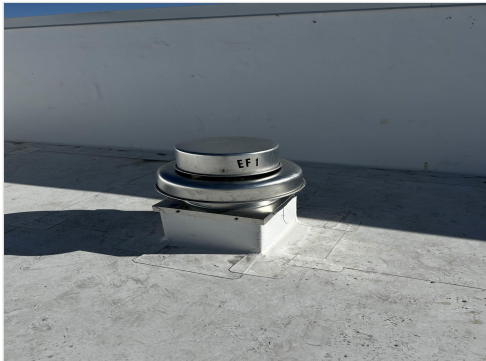
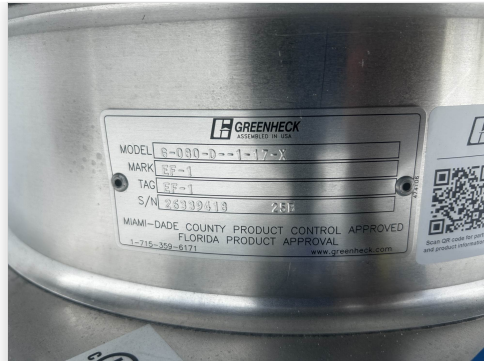
## Unit Data - PHOTO LOG

Asset: EF1

Unit Data		
	Design	Actual
MFG	GREENHECK	GREENHECK
Model Num	G-080	G-080-D--1-17-X
Serial Num	-	26339418 2B
Type	DOWNBLAST	DOWNBLAST
Configuration	VERTICAL	VERTICAL

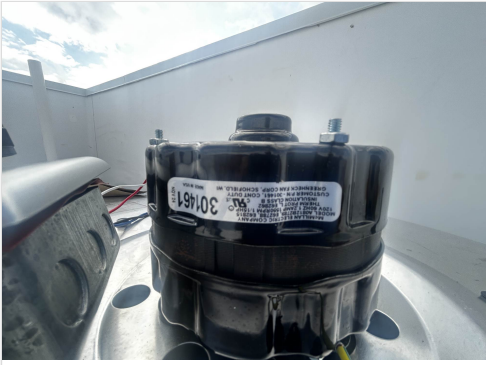
## Motor Data - PHOTO LOG

Motor Data		
	Design	Actual
Motor MFG	-	GREENHECK
Horsepower	1/10	1/15
Motor Rpm	-	1550
Phase	1	1
Voltage (rated)	120	120
Amperage (rated)	-	1.2

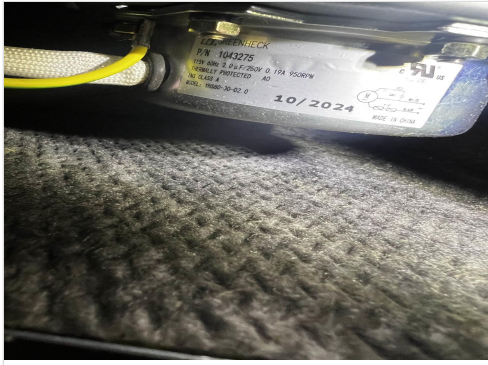
## Motor Data - PHOTO LOG

Motor Data		
	Design	Actual
Motor MFG	-	GREENHECK
Frame	-	NL
Horsepower	21	NL
Motor Rpm	-	950
Phase	1	1
Voltage (rated)	120	115
Amperage (rated)	-	0.19
