Report: HVAC TAB FINDINGS
Function: Test, Adjust, & Balance
Date: 10/14/2024
Completed By: National TAB

PROJECT
Shindig Restaurant (Indianapolis, IN)

Project: Shindig Restaurant (Indianapolis, IN)

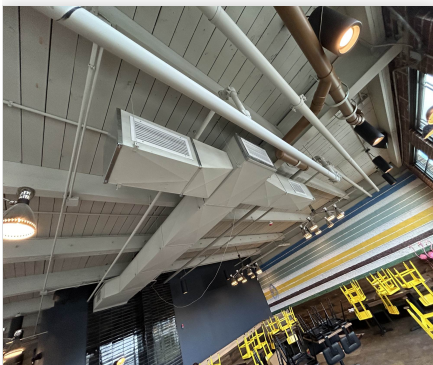
Issue Name : Rtu 1 diffusers
Description : Diffuser layout for Rtu 1 doesn't match design. Design calls for 4 diffusers by front of building, 3 are installed.
Created By : National TAB **Assigned To :** National TAB - Joe Hertenstein
Status : Open
Priority : Urgent **Asset Tag :**
Originated Date : 10/14/2024 - Gabe Merk - National TAB

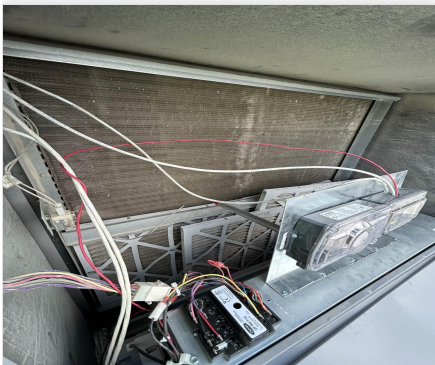
Issue Name : Rtu 3 filters
Description : Incorrect filters installed in rtu3. Instead of installing 4-20"x20"x2" filters, 8-20"x20"x1" filters were installed. This will need to be addressed for TAB.
Created By : National TAB **Assigned To :** National TAB - Joe Hertenstein
Status : Open
Priority : Urgent **Asset Tag :**
Originated Date : 10/14/2024 - Gabe Merk - National TAB

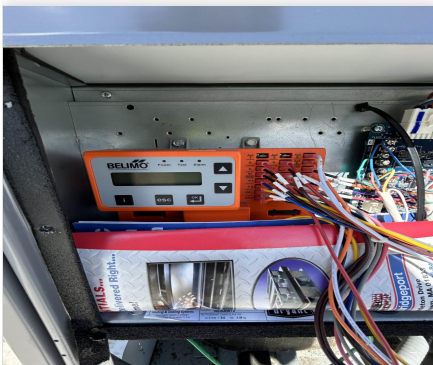
Issue Name : Rtu 7 economizer
Description : Economizer for rtu7 not wired properly. Unable to set and adjust outdoor air intake.
Created By : National TAB **Assigned To :** National TAB - Joe Hertenstein
Status : Open
Priority : Urgent **Asset Tag :**
Originated Date : 10/14/2024 - Gabe Merk - National TAB

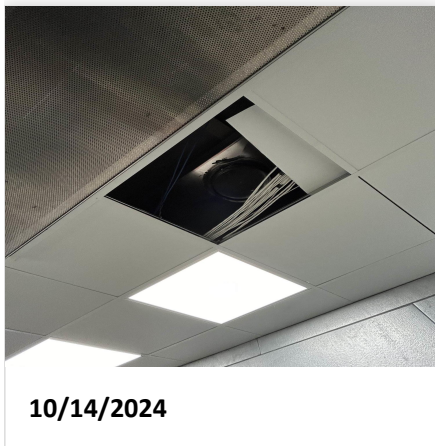
Issue Name : RTU5 missing diffuser
Description : Rtu 5 is missing diffuser 3. Unable to balance system properly until install.
Created By : National TAB **Assigned To :** National TAB - Joe Hertenstein
Status : Open
Priority : Urgent **Asset Tag :**
Originated Date : 10/14/2024 - Gabe Merk - National TAB

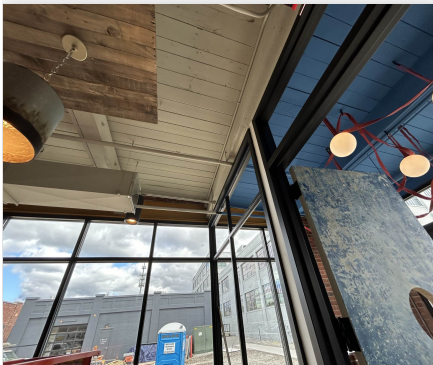
Issue Name : Vestibule supply
Description : Rtu 4 is designed to supply the vestibule. However, the ductwork has not been ran to the vestibule.
Created By : National TAB **Assigned To :** National TAB - Joe Hertenstein
Status : Open
Priority : Urgent **Asset Tag :**
Originated Date : 10/14/2024 - Gabe Merk - National TAB
