Report: TAB Punch-List
Function: Test, Adjust, & Balance
Date: 07/08/2025
Completed By: National TAB

PROJECT
Liberty Collective (Liberty Twp, OH)

Project: Liberty Collective (Liberty Twp, OH)

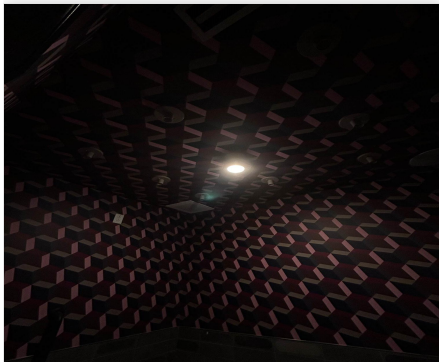
Project Issue File Details

Issue Name : EFS 2 and 3
Description : EFS 2 and 3 are single speed and are both pulling 2.5x design flow. Unable to reduce flow to design.
Created By : National TAB **Assigned To :** National TAB - Nick Payne
Status : Open
Priority : **Medium** **Asset Tag :**
Originated Date : 07/09/2025 - Gabe Merk - National TAB
