Report: TAB Report
Function: Test, Adjust, & Balance
Date: 12/18/2025
Completed By: National TAB

PROJECT
03-16-26 QT #1138 SIMPSONVILLE, SC

Project: 03-16-26 QT #1138 SIMPSONVILLE, SC

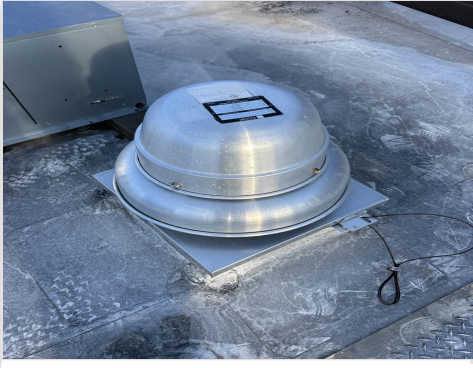
Unit Data - PHOTO LOG

Asset: EF1

AREA:WOMEN'S RR

Test Data		
	Design	Actual
CFM	225	223
Fan RPM	-	DD
Fan Rotation	-	CCW
Motor RPM	-	DD
System SetPt	-	50%
RL Voltage	-	NA
RL Amperage	-	NA
Total ESP	-	0.15"
Fan Inlet SP	-	-0.15"
Fan Discharge SP	-	ATMO

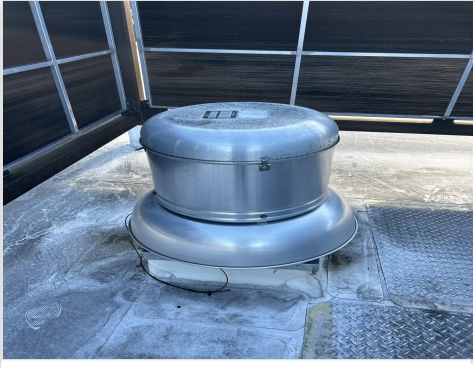
Unit Data - PHOTO LOG

Asset: EF2

AREA: MEN'S RR/COMBI

Test Data		
	Design	Actual
CFM	375	466
Fan RPM	-	DD
Fan Rotation	-	CCW
Motor RPM	-	DD
System SetPt	-	ON
RL Voltage	-	NA
RL Amperage	-	NA
Total ESP	-	0.19"
Fan Inlet SP	-	-0.19"
Fan Discharge SP	-	ATMO

Notes:
SEE ISSUES

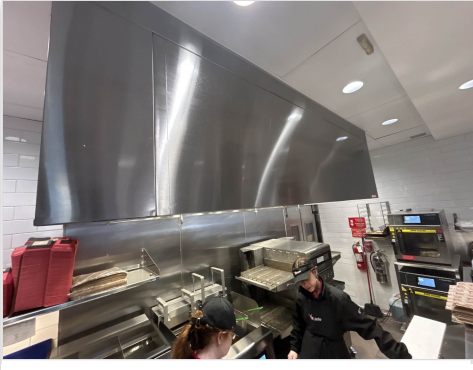
Unit Data - PHOTO LOG

Asset: HD1

AREA:GRIDDLE

Test Data Exhaust		
	Design	Actual
Filter Type	CAPTRATE SOLO FILTER	CAPTRATE SOLO FILTER
Filter Size 1	20X16	20X16
Filter Qty 1	6	6
Filter AK factor size 1	2.08	2.08
Filter Total AK Area	12.48	12.48
Filter1 FPM	-	108
Filter2 FPM	-	110
Filter3 FPM	-	108
Filter4 FPM	-	115
Filter5 FPM	-	114
Filter6 FPM	-	109
Filter Ave FPM(corr)	-	110
CFM	1350	1372
