Report: TAB Report
Function: Test, Adjust, & Balance
Date: 03/25/2026
Completed By: National TAB

PROJECT
03-16-26 NIKE #72 - VACAVILLE, CA

Project: 03-16-26 NIKE #72 - VACAVILLE, CA

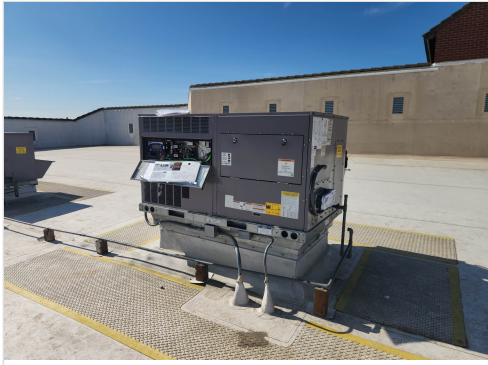
Unit Data - PHOTO LOG

Asset: HP-1

Notes:
UNIT DOWN ON 310 CIRA FAULT

Issue Name : RTU-1 IS DOWN ON 310 CIRA FAULT
Description : RTU-1 is down on 310 cira fault, recommended to have unit serviced
Created By : National TAB **Assigned To :** National TAB - Brianna Biggs
Status : Open
Priority : Urgent **Asset Tag :**
Originated Date : 03/25/2026 - Zack Eismin - National TAB

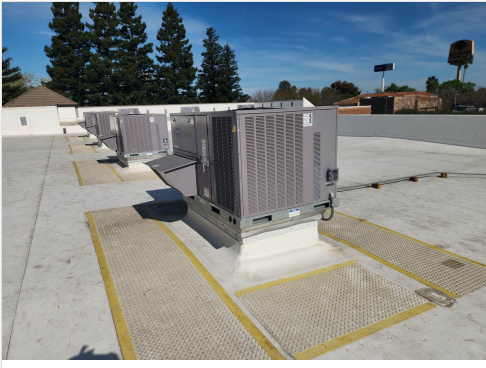
Unit Data - PHOTO LOG

Asset: HP-2

Test Data		
	Design	Actual
SF CFM	2000	1947
SF RPM	-	2340
MOTOR RPM	-	2340
RA CFM	1700	1662
OA CFM	300	285
RL Voltage	-	208/208/208
RL Amperage	-	9.08/9.08/9.08
SF System SetPt	-	95%
Min OA Damper Position	-	20%
Min OA Damper Type	-	MOTORIZED

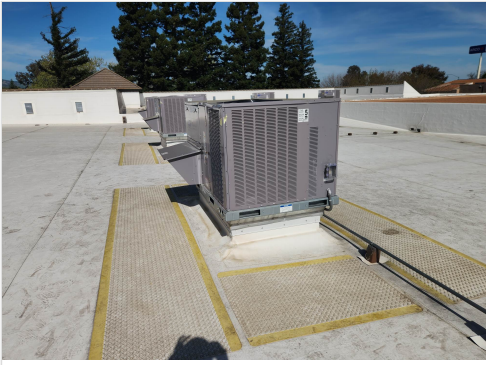
Unit Data - PHOTO LOG

Asset: HP-3

Test Data		
	Design	Actual
SF CFM	2000	1971
SF RPM	-	2340
MOTOR RPM	-	2340
RA CFM	1700	1660
OA CFM	300	311
RL Voltage	-	208/208/208
RL Amperage	-	9.1/9.1/9.11
SF System SetPt	-	2340
Min OA Damper Position	-	20%
Min OA Damper Type	-	MOTORIZED

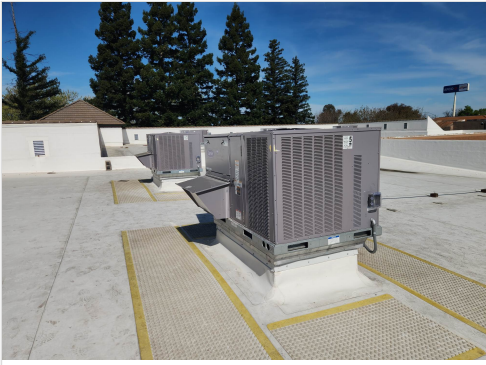
Unit Data - PHOTO LOG

Asset: HP-4

Test Data		
	Design	Actual
SF CFM	2000	1983
SF RPM	-	2340
MOTOR RPM	-	2340
RA CFM	1700	1686
OA CFM	300	297
RL Voltage	-	208/208/208
RL Amperage	-	9.07/9.07/9.1
SF System SetPt	-	2340
Min OA Damper Position	-	20%
Min OA Damper Type	-	MOTORIZED

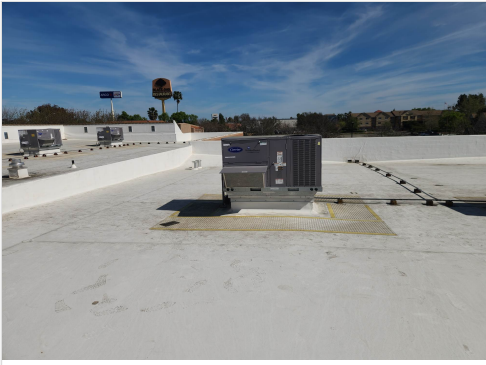
Unit Data - PHOTO LOG

Asset: HP-5

Test Data		
	Design	Actual
SF CFM	2000	1974
SF RPM	-	2340
MOTOR RPM	-	2340
RA CFM	1700	1693
OA CFM	300	281
RL Voltage	-	208/208/208
RL Amperage	-	9.09/9.09/9.1
SF System SetPt	-	2340
Min OA Damper Position	-	20%
Min OA Damper Type	-	MOTORIZED

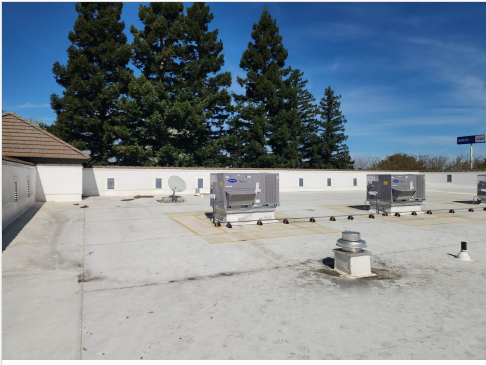
Unit Data - PHOTO LOG

Asset: HP-6

Test Data		
	Design	Actual
SF CFM	2000	1979
SF RPM	-	2340
MOTOR RPM	-	2340
RA CFM	1700	1672
OA CFM	300	307
RL Voltage	-	208/208/208
RL Amperage	-	9.08/9.08/9.08
SF System SetPt	-	2340
Min OA Damper Position	-	20%
Min OA Damper Type	-	MOTORIZED

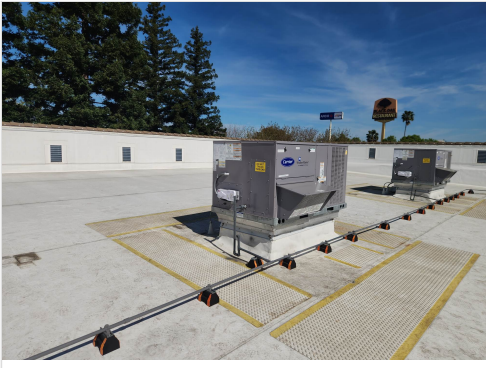
Unit Data - PHOTO LOG

Asset: HP-7

Test Data		
	Design	Actual
SF CFM	2000	1991
SF RPM	-	2340
MOTOR RPM	-	2340
RA CFM	1700	1688
OA CFM	300	303
RL Voltage	-	208/208/208
RL Amperage	-	9.07/9.08/9.07
SF System SetPt	-	2340
Min OA Damper Position	-	20%
Min OA Damper Type	-	MOTORIZED

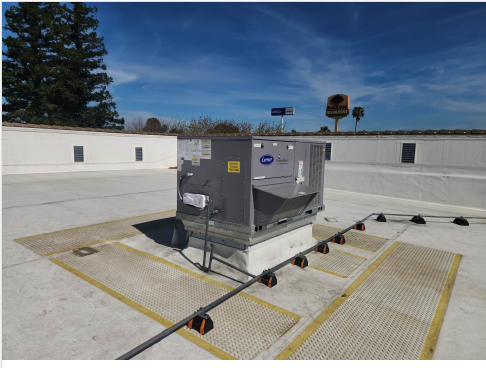
Unit Data - PHOTO LOG

Asset: HP-8

Test Data		
	Design	Actual
SF CFM	2000	1988
SF RPM	-	2340
MOTOR RPM	-	2340
RA CFM	1700	1685
OA CFM	300	303
RL Voltage	-	208/208/208
RL Amperage	-	9.1/9.1/9.1
SF System SetPt	-	2340
Min OA Damper Position	-	20%
Min OA Damper Type	-	MOTORIZED

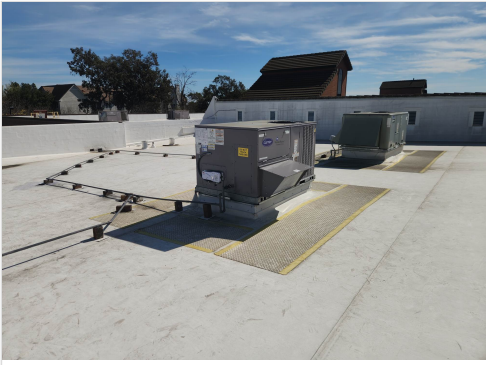
Unit Data - PHOTO LOG

Asset: HP-9

Test Data		
	Design	Actual
SF CFM	2000	1966
SF RPM	-	2340
MOTOR RPM	-	2340
RA CFM	1700	1649
OA CFM	300	307
RL Voltage	-	208/208/208
RL Amperage	-	9.02/9.02/9.02
SF System SetPt	-	2340
Min OA Damper Position	-	20%
Min OA Damper Type	-	MOTORIZED
