**Report: ISSUE REPORT
Function: Test, Adjust, & Balance
Date: 11/11/2022**

**PROJECT
11-07 CULVERS - COLUMBIA CITY, IN**

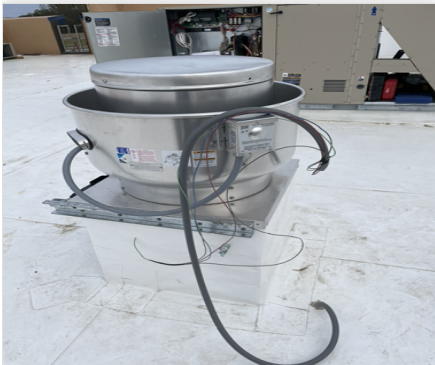
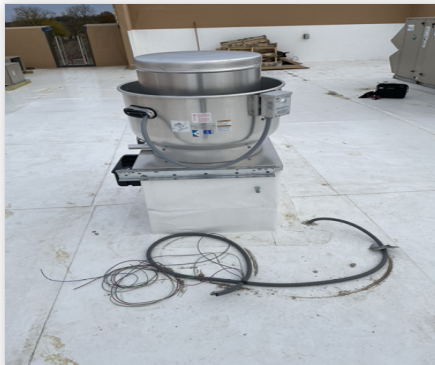
Issue Name : Exhaust fans not hooked up to HMIs

Description : Both hood exhausts are not yet hooked up to an HMI, have loose wires up top, and do not have switches for the disconnects yet.

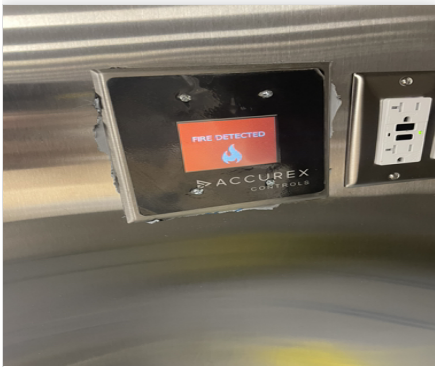
Issue Name : FIRE ALARM ON HOODS

Description : THE HMI FOR THE ACCUREX HOOD HAS A FIRE DETECTED ALARM. ELECTRICAL NOT ON SITE TO FIX.

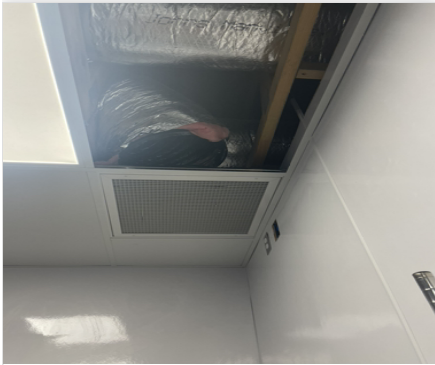
Issue Name : LOOSE RETURN DUCT

Description : For RTU2 one of the return ducts is loose.

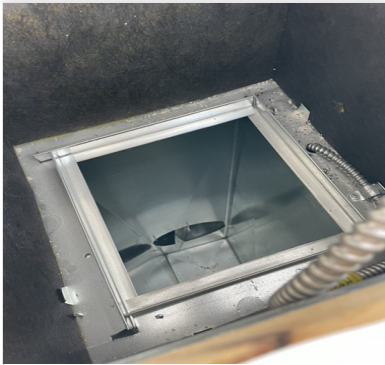
Issue Name : PRV-1 DOES NOT HAVE BACKDRAFT DAMPER

Description : NO BACKDRAFT DAMPER FOR THE BATHROOM FAN PRV-1.

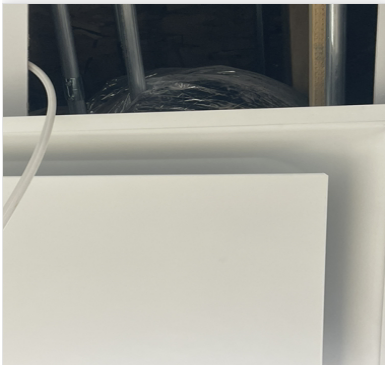
Issue Name : RTU2 has restricted flex on some diffusers

Description : A number of the diffusers on RTU2 have to be fit between wood and metal piping right above the tile, restricting the flow. It doesn't appear that there is any better way for the flex to be positioned since there is so much material in the way. All of these diffusers that are restricted are outside of the kitchen so most of the air is focused in the kitchen and will lead to balancing that will not be up to design.

- **11/11/2022** **National TAB - Jack Bain**
 - Specifically diffusers 2-10, 2-11, and 2-13
