**Report: Punch List**  
**Function: Test, Adjust, & Balance**  
**Date: 12/09/2025**  
**Completed By: National TAB**

**PROJECT**  
**12-08-25 FREDDYS MIDDLETOWN, DE**

Project: 12-08-25 FREDDYS MIDDLETOWN, DE

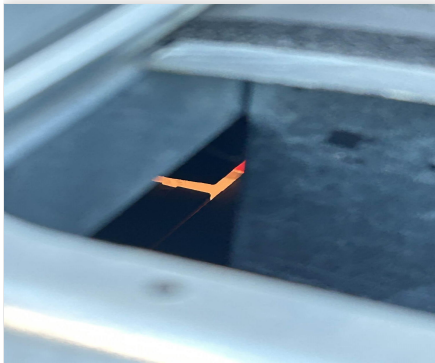
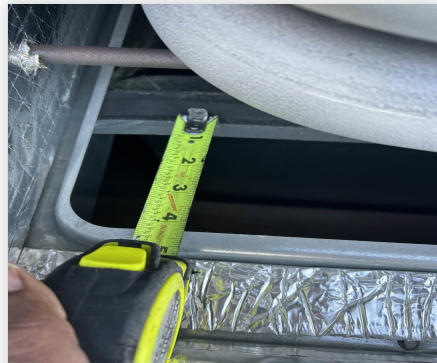
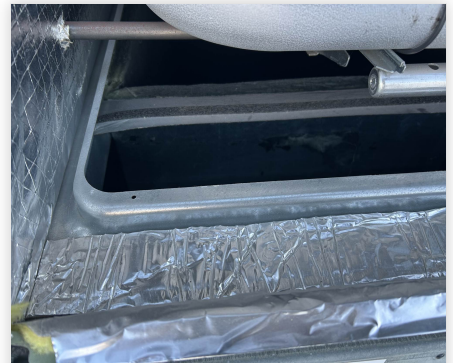
**Issue Name :** RTU 1 low flow  
**Description :** RTU 1 supply drop has a 4" opening and is not properly attached to discharge. Unit is losing air inside the ceiling. Unable to properly balance.  
**Created By :** National TAB                      **Assigned To :** National TAB - Dan Hertenstein  
**Status :** Open  
**Priority :** Urgent                                      **Asset Tag :** RTU1  
**Originated Date :** 12/09/2025 - Jearod Ferrette - National TAB
