**Report: TAB Report**  
**Function: Test, Adjust, & Balance**  
**Date: 01/21/2026**  
**Completed By: National TAB**

## 01-12-26 QT #1125 SPARTANSBURG, SC

QUIKTRIP  
4705 SOUTH 129TH EAST AVENUE  
TULSA, OK 74134

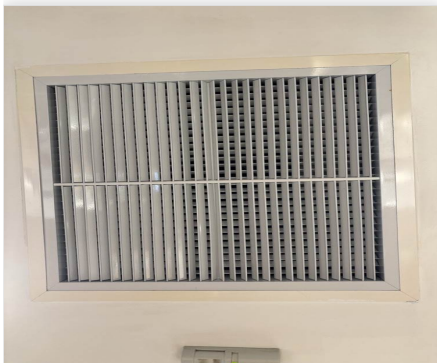
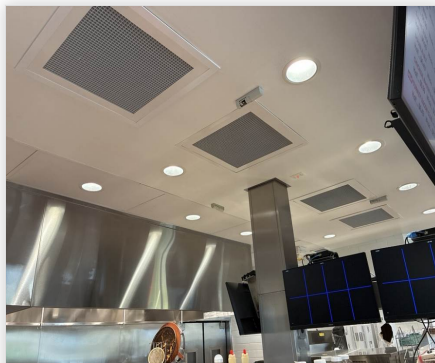
**Issue Name :** Incorrect Kitchen Diffusers  
**Description :** The kitchen diffusers 3-1 through 3-4 are the incorrect type. They need to be the Titus S1 diffuser with the installed dampers to control the airflow.  
**Created By :** National TAB                      **Assigned To :** National TAB - Dan Hertenstein  
**Status :** Open  
**Priority :** Low                                      **Asset Tag :** RT-3  
**Originated Date :** 01/13/2026 - Alex Bauer - National TAB

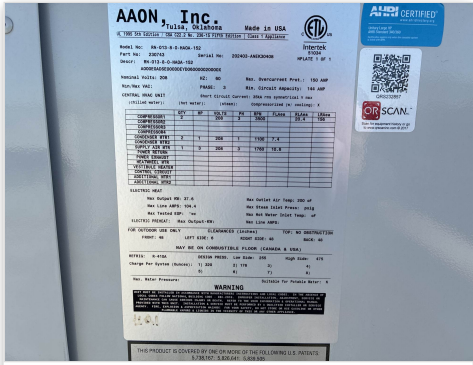
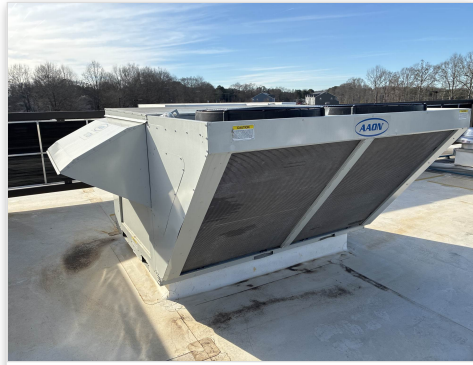
# Unit Data - PHOTO LOG

Unit Data	
	Actual
MFG	AAON
Serial Num	202403-ANEK30408
Model Num	RN-013-8-0-HA0A-152
Num OA Filters 1	1
OA Filter Size 1	22.5X44.5
Num Final Filter 1	2
Final Filter Size 1	19.5X46.5

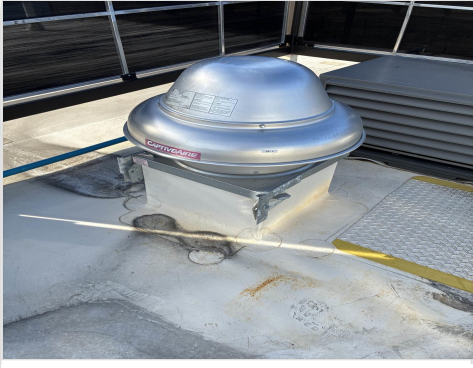
**Unit Data - PHOTO LOG**

Unit Data	
	Actual
MFG	CAPTIVEAIRE
Model Num	DR50HFA
Serial Num	6712325
Type	DOWNBLAST
Configuration	VERTICAL

Notes:  
No damper for EF1-4.

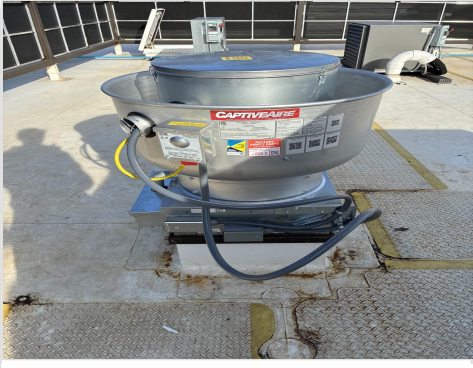
## Unit Data - PHOTO LOG

Unit Data	
	Actual
MFG	CAPTIVEAIRE
Model Num	DU50HFA
Serial Num	8189416
Type	UPBLAST
Configuration	VERTICAL

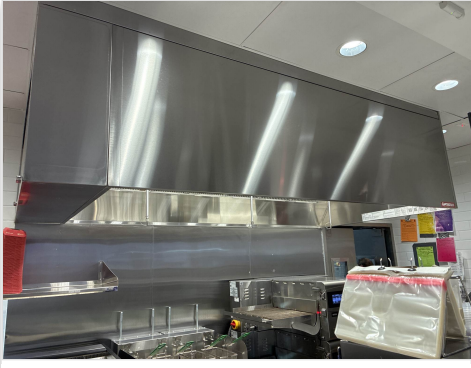
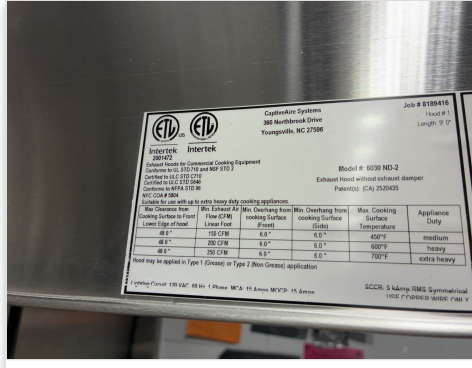
# Unit Data - PHOTO LOG

Unit Data		
	Design	Actual
MFG	CAPTIVEAIRE	CAPTIVEAIRE
Model Num	6030ND-2-F	6030ND-2
Job / Serial Num	-	8189416
Type	-	TYPE I CANOPY
Hood length	-	120"
Hood Width	-	60"
