**Report: PUNCHLIST**  
**Function: Test, Adjust, & Balance**  
**Date: 10/20/2025**  
**Completed By: National TAB**

## Wyler Hyundai Beavercreek (Dayton, OH)

- RTU-1B diffuser 13 grille not installed
- RTU-7 closed OA and return damper

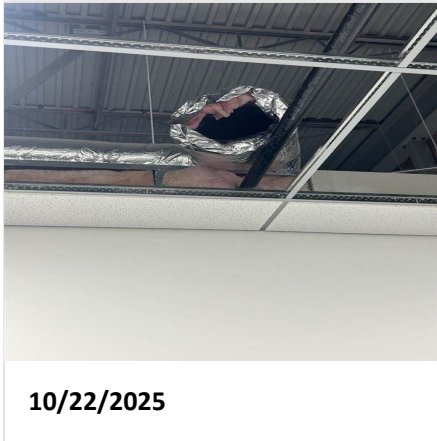
**Issue Name :** RTU-1B diffuser 13 grille not installed  
**Description :** The grille off diffuser 13 is not installed. Unable to balance  
**Created By :** National TAB                      **Assigned To :** National TAB - Corey Dick  
**Status :** Open  
**Priority :** Urgent                                      **Asset Tag :**  
**Originated Date :** 10/22/2025 - Aaron Cosby - National TAB

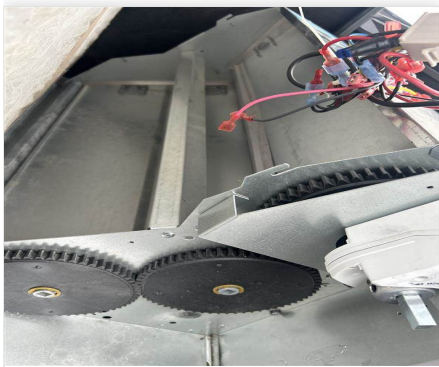
**Issue Name :** RTU-7 closed OA and return damper  
**Description :** RTU-7 has no incoming air because the return air and outside air dampers in the unit are stuck shut. They are unresponsive to economizer controls  
**Created By :** National TAB                      **Assigned To :** National TAB - Corey Dick  
**Status :** Open  
**Priority :** Urgent                                      **Asset Tag :**  
**Originated Date :** 10/22/2025 - Aaron Cosby - National TAB
