Report: TAB Report
Function: Test, Adjust, & Balance
Date: 01/05/2026
Completed By: National TAB

PROJECT
01-05-26 QT #1717 DUNWOODY, GA

Project: 01-05-26 QT #1717 DUNWOODY, GA

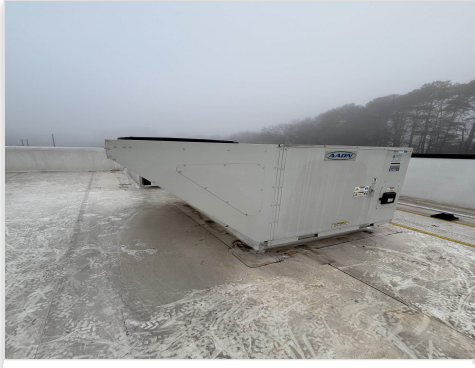
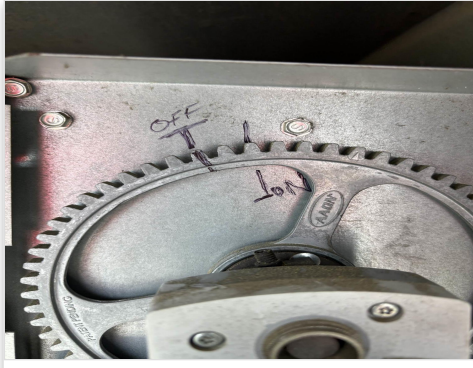
Unit Data - PHOTO LOG

Unit Data	
	Actual
MFG	AAON
Serial Num	20221-ANEK25573
Model Num	RN-013-8-0-EA0A-152
Num OA Filters 1	1
OA Filter Size 1	22X45
Num Final Filter 1	4
Final Filter Size 1	20X25X2

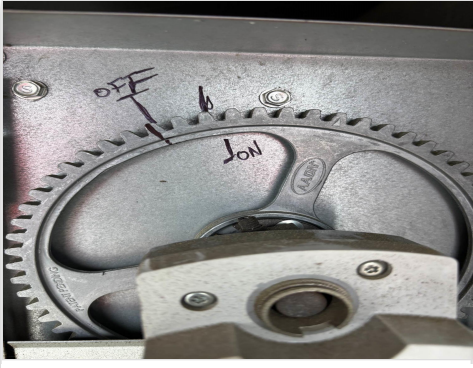
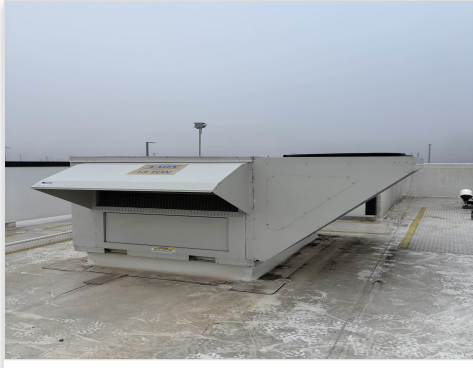
Unit Data - PHOTO LOG

Unit Data	
	Actual
MFG	AAON
Serial Num	20221-ANEK25574
Model Num	RN-013-8-0-EA0A-152
Num OA Filters 1	1
OA Filter Size 1	22X45
Num Final Filter 1	4
Final Filter Size 1	20X25X2

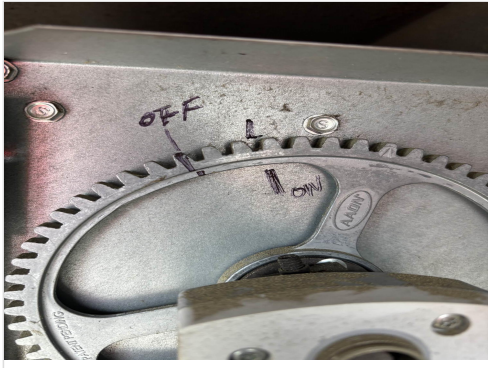
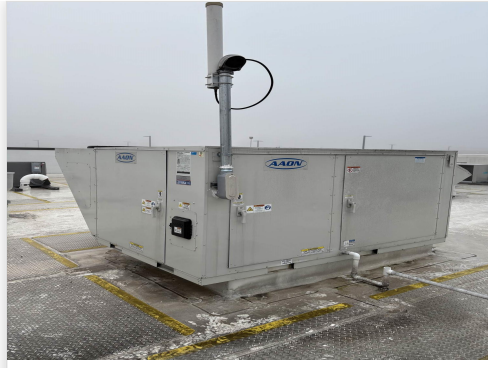
Unit Data - PHOTO LOG

Unit Data	
	Actual
MFG	AAON
Serial Num	202211-ANEK25575
Model Num	RN-013-8-0-EA0A-152
Num OA Filters 1	1
OA Filter Size 1	22X45
Num Final Filter 1	4
Final Filter Size 1	20X25X2

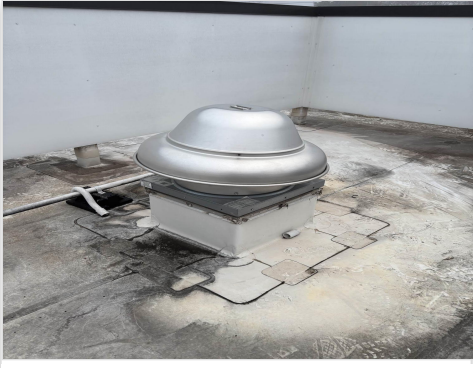
Unit Data - PHOTO LOG

Unit Data		
	Design	Actual
MFG	NA	CAPTIVEAIRE
Model Num	NA	DR50HFA
Serial Num	-	5663506
Type	-	DOWNBLAST
Configuration	-	VERTICAL

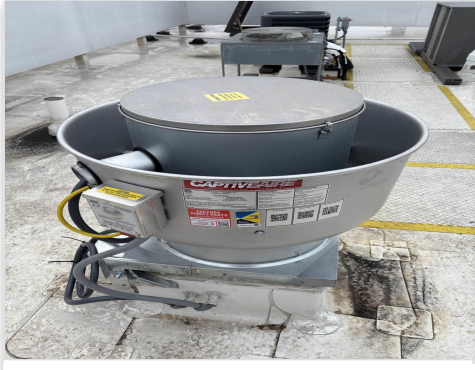
Unit Data - PHOTO LOG

Unit Data		
	Design	Actual
MFG	NA	CAPTIVEAIRE
Model Num	NA	DU50HFA
Serial Num	-	7657525
Type	UPBLAST	UPBLAST
Configuration	VERTICAL	VERTICAL

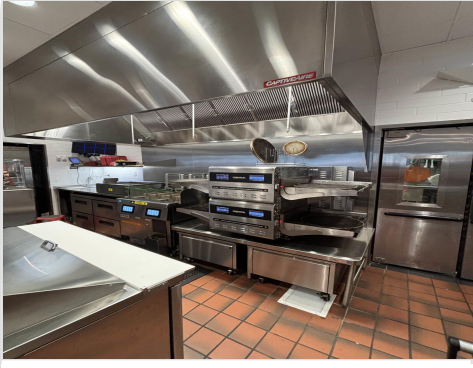
Unit Data - PHOTO LOG

Design	Actual
MFG	CAPTIVEAIRE	CAPTIVEAIRE
Model Num	6030ND-2-F	6030ND-2-F
Job / Serial Num	-	7657525
Type	-	TYPE I CANOPY
Hood length	-	108"
Hood Width	-	60"
