PlanGrid Task Report - Mar 20, 2025

#4 [CNTL 503] [NEW] DTT Stat not operational.

#3 [CNTL 509] [NEW] Ansul pull labeling.

#2 [EXHA 505] [NEW] Exhaust fan 1500F gasketing.

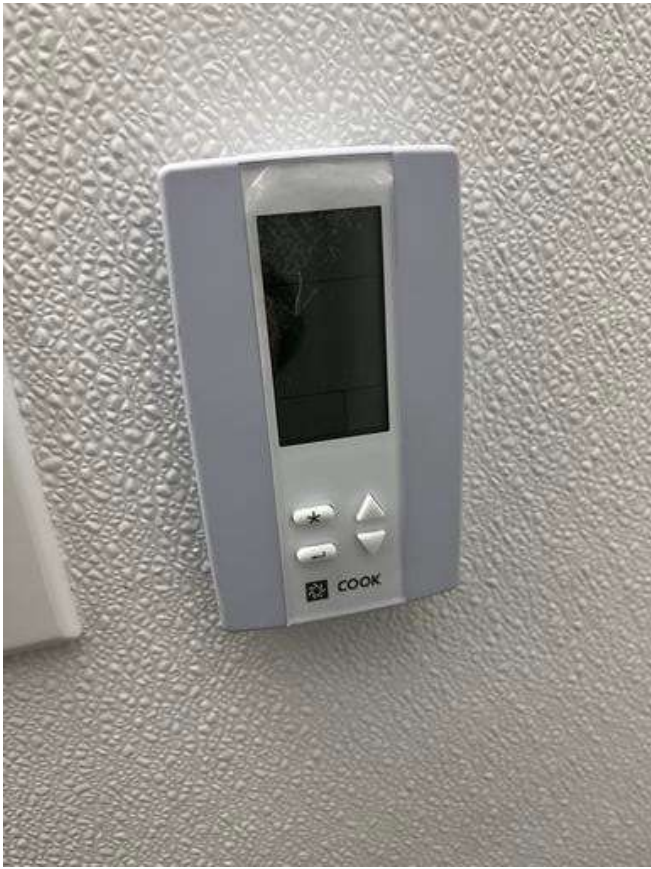
IMG_9698

Status Open	Start Date Mar 18, 2025
Type Planned Work	Created Mar 18, 2025 2:52 PM ianf@nationaltab.com
Description DTT thermostat / fan is not powered, operational, or does not turn on / off according to set point at time of TAB inspection.	Last Updated Mar 18, 2025 2:55 PM

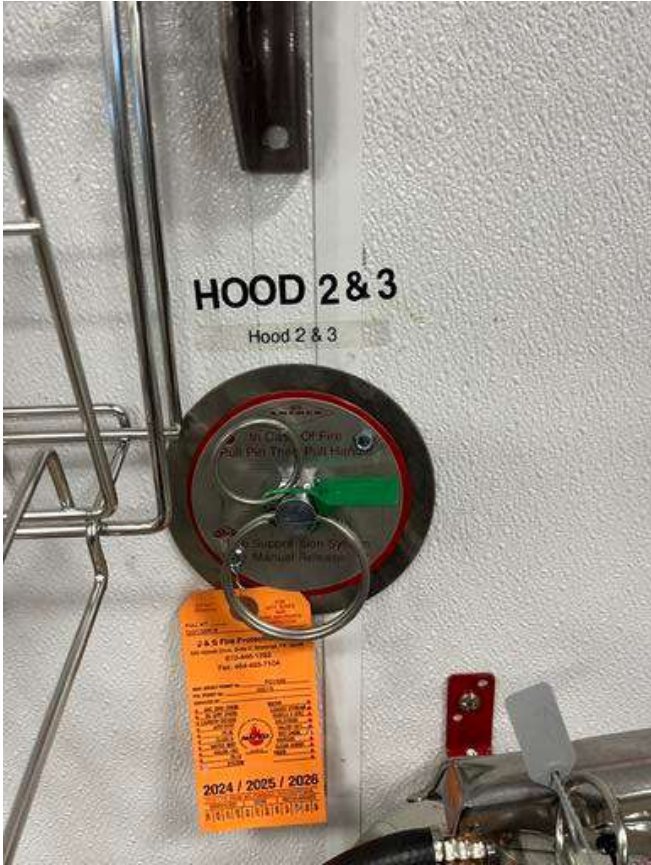
IMG_9704
Ian Fuller
Mar 18, 2025 2:55 PM

Status	Start Date
Open	Mar 18, 2025
Type	Created
Planned Work	Mar 18, 2025 2:52 PM ianf@nationaltab.com
Description	Last Updated
Need to be labeled with red bakelite label with 1/4" high white letters indicating the hoods served.	Mar 18, 2025 2:55 PM

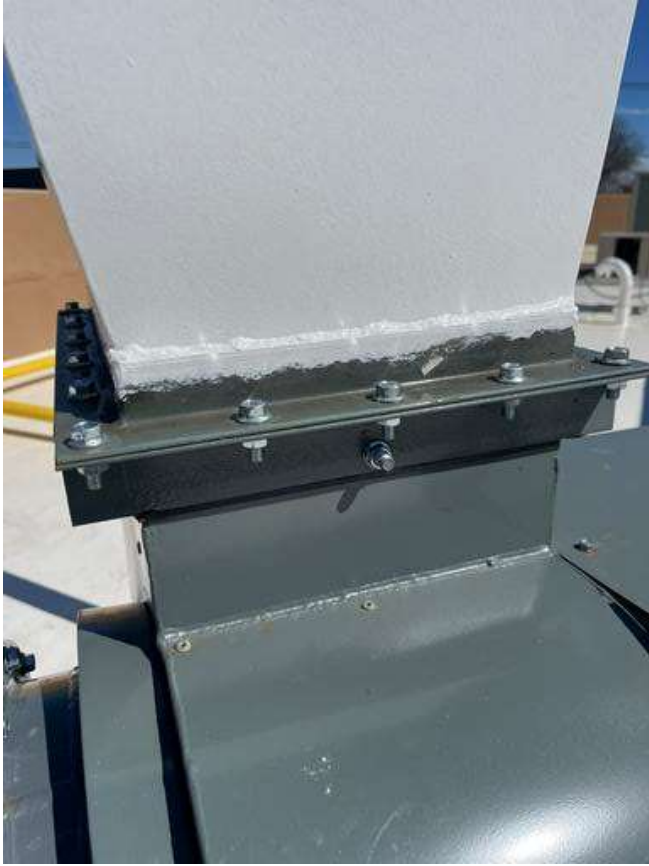
IMG_9729

Status	Start Date
Open	Mar 18, 2025
Type	Created
Planned Work	Mar 18, 2025 2:52 PM ianf@nationaltab.com
Description	Last Updated
Exhaust fan is missing 1500°F rated field provided/ installed gasketing at intake and/or discharge companion flange connections.	Mar 18, 2025 2:56 PM
