# Issue List

### 05-29-23 CULVERS - GRAIN VALLEY, MO

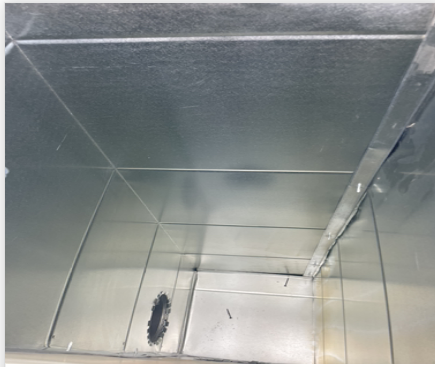
**Issue Name :** PRV1 no backdraft damper installed  
**Description :** INFO ONLY: PRV1 does not have a backdraft damper which is required for restroom exhaust fans. This does not affect the scope of the tab  
**Created By :** National TAB                      **Assigned To :** National TAB - Jacob Davidson  
**Status :** Open  
**Originated Date :** 05/22/2023 - Jacob Davidson - National TAB

**PRV1**  
05/22/2023

**Nodamper**  
05/22/2023

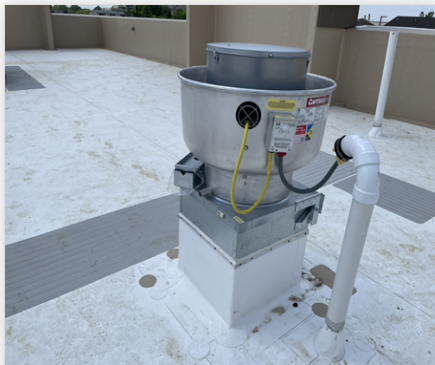
**Description :** INFO ONLY Grease capture cups are not installed on either PRV2 or PRV3. In addition, the hinge kit on PRV3 is supposed to be installed opposite of the grease spout and is installed to the side of it. This will not affect TAB.

**PRV3**  
05/22/2023

**PRV2**  
05/22/2023

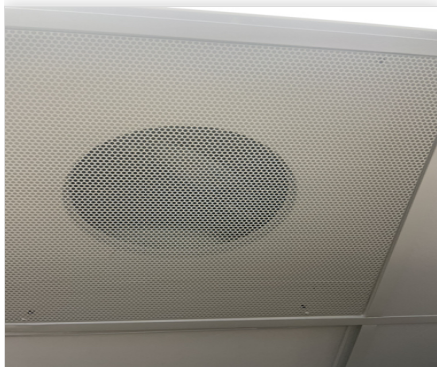
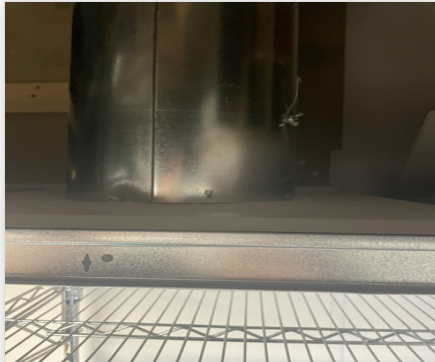
**Description :** Cookline diffusers have dampers in the face of the diffusers instead of at the takeoff. This has been known to cause smoke capture issues in the past for the hoods.

**Face**  
05/22/2023

**Damper**  
05/22/2023
