Report: TAB Report
Function: Test, Adjust, & Balance
Date: 03/17/2026
Completed By: National TAB

PROJECT
03-30-26 CHIPOTLE #5159 NICHOLASVILLE,
KY

Project: 03-30-26 CHIPOTLE #5159 NICHOLASVILLE, KY

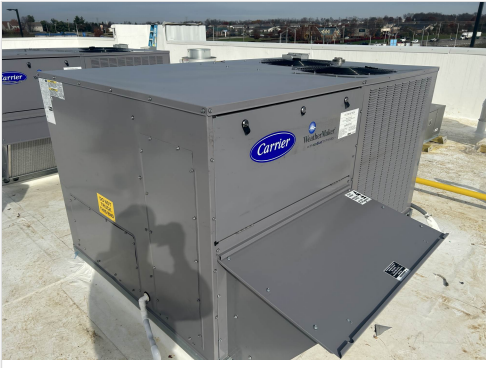
Unit Data - PHOTO LOG

Unit Data		
	Design	Actual
MFG	CARRIER	CARRIER
Serial Num	-	0424P63058
Model Num	48FC_N12	48FC_N12
Type	RTU	RTU
Configuration	VERTICAL	VERTICAL
Num OA Filters 1	-	1
OA Filter Size 1	-	36"X18"
Num Final Filter 1	-	4
Final Filter Size 1	-	20"X20"X2"

Test Data		
	Design	Actual
SF CFM	3500	3655
SF RPM	-	1592
RA CFM	3000	3123
OA CFM	500	532
RL Voltage	208	216/216/215
RL Amperage	-	8.4/8.4/8.5
SF Rotation	-	CCW
SF System SetPt	-	9.1
Min OA Damper Position	-	2.15V
Min OA Damper Type	-	ECONOMIZER

Pressures are high due to the Ecoblue fan. Leakage and proper sealing were checked for all the ducts and drops but no issues were found

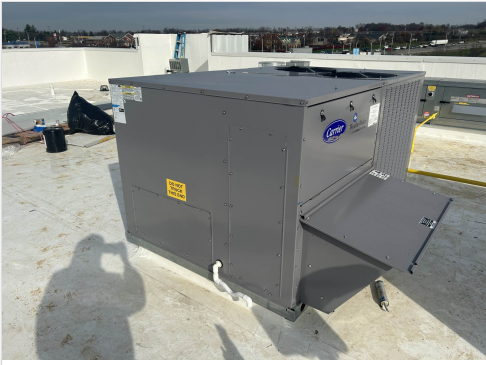
Unit Data - PHOTO LOG

Unit Data		
	Design	Actual
MFG	CARRIER	CARRIER
Serial Num	-	0424P63057
Model Num	48FC_N12	48FC_N12
Type	RTU	RTU
Configuration	VERTICAL	VERTICAL
Num OA Filters 1	-	1
OA Filter Size 1	-	36"X18"
Num Final Filter 1	-	4
Final Filter Size 1	-	20"X20"X2"

Test Data		
	Design	Actual
SF CFM	4000	4650
SF RPM	-	1697
RA CFM	3000	3594
OA CFM	1000	1056
RL Voltage	208	214/215/214
RL Amperage	-	9.1/9.6/9.4
SF Rotation	-	CCW
SF System SetPt	-	9.7
Min OA Damper Position	-	4.0V
Min OA Damper Type	-	ECONOMIZER

Pressures are high due to the Ecoblue fan. Leakage and proper sealing were checked for all the ducts and drops but no issues were found. Unit was left at 4650/4000 to leave room to diffuser balance effectively.

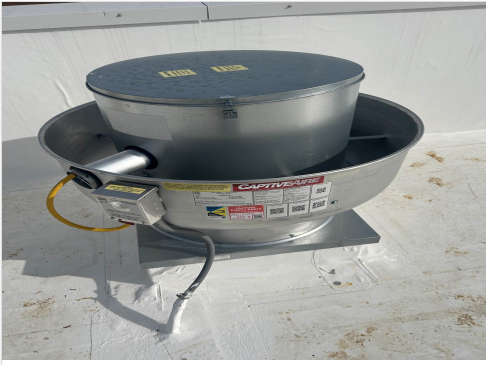
Unit Data - PHOTO LOG

Unit Data		
	Design	Actual
MFG	CAPTIVEAIRE	CAPTIVEAIRE
Model Num	DU180HFA	DU180HFA
Serial Num	-	7371181
Type	UPBLAST	UPBLAST
Configuration	VERTICAL	VERTICAL

Test Data		
	Design	Actual
CFM	2550	2697
Fan RPM	-	1530
Fan Rotation	-	GOOD
System SetPt	-	53HZ
RL Voltage	208	215/215/216
RL Amperage	-	3.8/NA/NA
Total ESP	1.2"	0.70"
Fan Inlet SP	-	-0.70"
Fan Discharge SP	-	ATM

Only one line able to be amped because of wire congestion

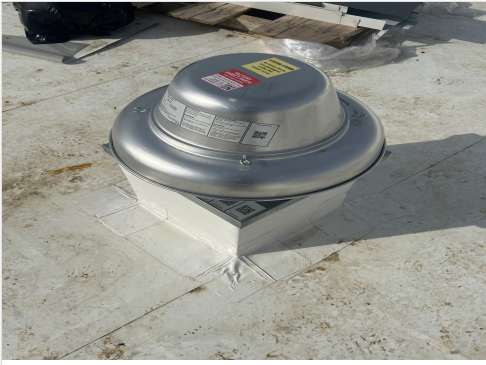
Unit Data - PHOTO LOG

Unit Data		
	Design	Actual
MFG	CAPTIVEAIRE	CAPTIVEAIRE
Model Num	DR12HFA	DR12HFA
Serial Num	-	7371181
Type	DOWNBLAST	DOWNBLAST
Configuration	VERTICAL	VERTICAL

Test Data		
	Design	Actual
CFM	150	158
Fan RPM	-	1300
Fan Rotation	-	CCW
System SetPt	-	66%
RL Voltage	120	115
RL Amperage	-	0.2
Total ESP	.6"	0.08"
Fan Inlet SP	-	-0.08"
Fan Discharge SP	-	ATM

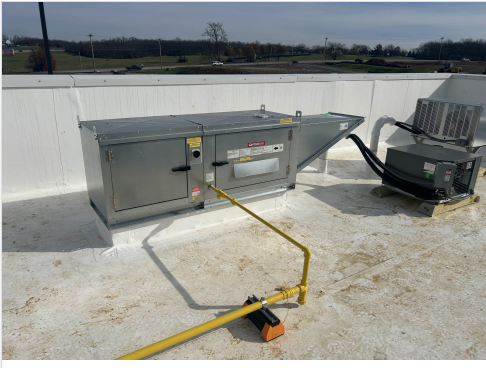
Unit Data - PHOTO LOG

Unit Data		
	Design	Actual
MFG	CAPTIVEAIRE	CAPTIVEAIRE
Model Num	A1-D.250-15D	A1-D.250-15D
Serial Num	-	73711181
Type	MAU	MAU
Configuration	VERTICAL	VERTICAL

Test Data		
	Design	Actual
CFM	1300	1277
SF RPM	-	2440
SF System SetPt	-	61.5HZ
RL Voltage	208	216/216/217
RL Amperage	-	3.0 VFD
Total ESP	-	0.40"
Fan Discharge SP	-	0.40"

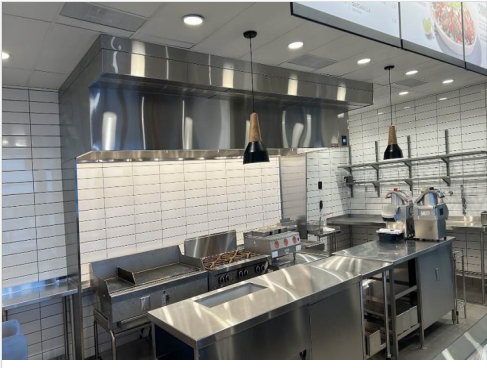
Unit Data - PHOTO LOG

Unit Data		
	Design	Actual
MFG	CAPTIVEAIRE	CAPTIVEAIRE
Model Num	5424 ND-2-ACPSP-F	5424 ND-2-ACPSP-F
Job / Serial Num	-	7371181
Type	TYPE 1 CANOPY	TYPE 1 CANOPY
Hood length	153"	153"
Hood Width	51"	51"
Supply Plenum Type	-	ACPSP
Supply Plenum Width	9"	9"
Supply Plenum Length	165"	165"

Test Data Exhaust		
	Design	Actual
Filter Type	CAPTRATE SOLO	CAPTRATE SOLO
Filter Size 1	16X16	16"X16"
Filter Qty 1	9	9
Filter AK factor size 1	1.62	1.62
Filter Total AK Area	14.58	14.58
Filter1 FPM	-	166
Filter2 FPM	-	169
Filter3 FPM	-	186
Filter4 FPM	-	187
Filter5 FPM	-	192
Filter6 FPM	-	198
Filter7 FPM	-	192
Filter8 FPM	-	181
Filter9 FPM	-	194
Filter Ave FPM(corr)	-	185
CFM	2550	2697

Test Data Supply		
	Design	Actual
Total Area	10.31	10.31
Kv factor (Vel)	0.81	0.81
Num of Readings	-	9
Reading1 FPM	-	109
Reading2 FPM	-	100
Reading3 FPM	-	119
Reading4 FPM	-	142
Reading5 FPM	-	157
Reading6 FPM	-	171
Reading7 FPM	-	169
Reading8 FPM	-	207
Reading9 FPM	-	208
Ave FPM(corr)	-	153
CFM	1300	1277
