**Report: FINAL TAB REPORT
Function: Test, Adjust, & Balance
Date: 10/05/2022**

**PROJECT
10-03 HAWAIIAN BROS - O'FALLON, IL**

Project: 10-03 HAWAIIAN BROS - O'FALLON, IL

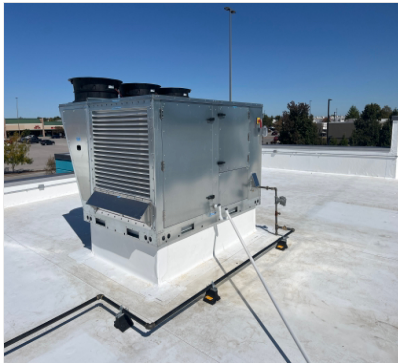
RTU-1

Unit Data		
	Design	Actual
MFG	CAPTIVE-AIRE	CAPTIVE-AIRE
Serial Num	-	5448882
Model Num	CASRTU30I.250-20-20T-DOAS	CASRTU3-I.250-20-20T-DOAS
Type	DOAS	DOAS
Configuration	VERTICAL	VERTICAL
Num OA Filters 1	-	4
OA Filter Size 1	-	23x14
Num Final Filter 1	-	8
Final Filter Size 1	-	20x25x2

Test Data		
	Design	Actual
SF CFM	3200	3190
SF RPM	-	1234 @ 63.0 HZ
RA CFM	1350	1332
OA CFM	1850	1858
RL Voltage	-	214/214/214
RL Amperage	-	7.8 AVE
SF Rotation	-	CCW, CORRECT
RA Damper Position	-	54%
Min OA Damper Position	-	46%
Min OA Damper Type	-	ECONOMIZER

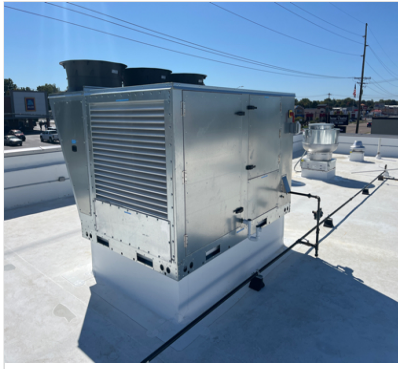
RTU-2

Unit Data		
	Design	Actual
MFG	CAPTIVE-AIRE	CAPTIVE-AIRE
Serial Num	-	5448882
Model Num	CASRTU3-I.300-20-20T-DOAS	CASRTU3-I.300-20-20T-DOAS
Type	DOAS	DOAS
Configuration	VERTICAL	VERTICAL
Num OA Filters 1	-	4
OA Filter Size 1	-	23x14
Num Final Filter 1	-	8
Final Filter Size 1	-	20x25x2

Test Data		
	Design	Actual
SF CFM	3200	3197
SF RPM	-	1097 @ 56.0 HZ
RA CFM	0	0
OA CFM	3200	3197
RL Voltage	-	215/214/214
RL Amperage	-	6.4 AVE
SF Rotation	-	CCW, CORRECT
RA Damper Position	-	0%
Min OA Damper Position	-	100%
Min OA Damper Type	-	ECONOMIZER

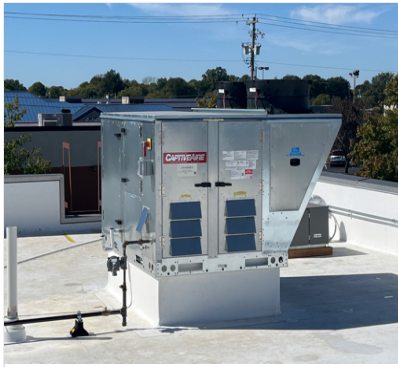
RTU-3

Unit Data		
	Design	Actual
MFG	CAPTIVE-AIRE	CAPTIVE-AIRE
Serial Num	-	5448882
Model Num	CASRTU2-I.150-18-10T-DOAS	CASRTU2-I.150-18-10T-DOAS
Type	DOAS	DOAS
Configuration	VERTICAL	VERTICAL
Num OA Filters 1	-	2
OA Filter Size 1	-	18x23
Num Final Filter 1	-	8
Final Filter Size 1	-	16x20x2

Test Data		
	Design	Actual
SF CFM	2800	2891
SF RPM	-	1808 @ 62.0 HZ
RA CFM	1475	1552
OA CFM	1325	1339
RL Voltage	-	215/215/214
RL Amperage	-	11.9 AVE
SF Rotation	-	CCW, CORRECT
RA Damper Position	-	60%
Min OA Damper Position	-	40%
Min OA Damper Type	-	ECONOMIZER

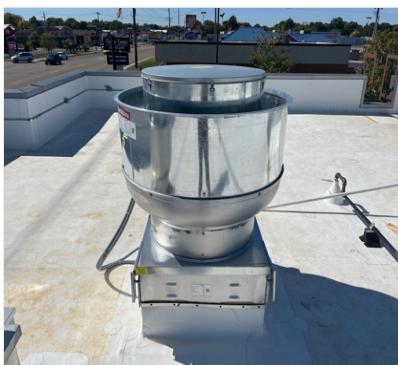
EF-1

Unit Data		
	Design	Actual
MFG	CAPTIVE-AIRE	CAPTIVE-AIRE
Model Num	DU240HFA	DU240HFA
Serial Num	-	5448882
Type	UPBLAST	UPBLAST
Configuration	VERTICAL	VERTICAL

Test Data		
	Design	Actual
CFM	4025	3916
Fan RPM	894	1162
Fan Rotation	-	CW, CORRECT
Motor RPM	-	1162
System SetPt	-	59.6 HZ
RL Voltage	-	215/215/215
RL Amperage	-	9.5 AVE
Total ESP	1.50"	1.65"
Fan Inlet SP	-	-1.65"
Fan Discharge SP	-	ATM

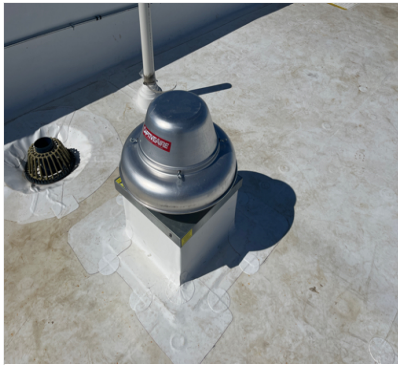
EF-3

Unit Data		
	Design	Actual
MFG	CAPTIVE-AIRE	CAPTIVE-AIRE
Model Num	DR12HFA	DR12HFA
Serial Num	-	5448882
Type	DOWNBLAST	DOWNBLAST
Configuration	HORIZONTAL	VERTICAL

Test Data		
	Design	Actual
CFM	200	189
Fan RPM	1070	1230
Fan Rotation	-	CCW, CORRECT
Motor RPM	-	1230
System SetPt	-	65%
RL Voltage	-	119
RL Amperage	-	0.74
Total ESP	0.38"	0.39"
Fan Inlet SP	-	-0.39"
Fan Discharge SP	-	ATM

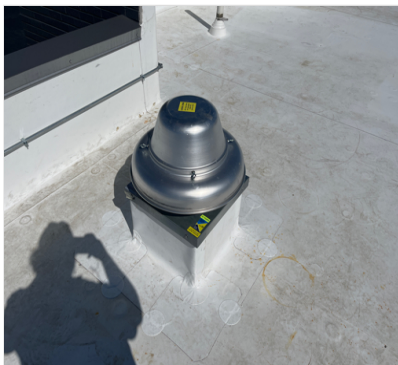
EF-4

Unit Data		
	Design	Actual
MFG	CAPTIVE-AIRE	CAPTIVE-AIRE
Model Num	DR12HFA	DR12HFA
Serial Num	-	5448882
Type	DOWNBLAST	DOWNBLAST
Configuration	VERTICAL	VERTICAL

Test Data		
	Design	Actual
CFM	150	147
Fan RPM	1190	1037
Fan Rotation	-	CCW, CORRECT
Motor RPM	-	1037
System SetPt	-	56%
RL Voltage	-	120
RL Amperage	-	0.44
Total ESP	0.50"	0.23"
Fan Inlet SP	-	-0.23"
Fan Discharge SP	-	ATM

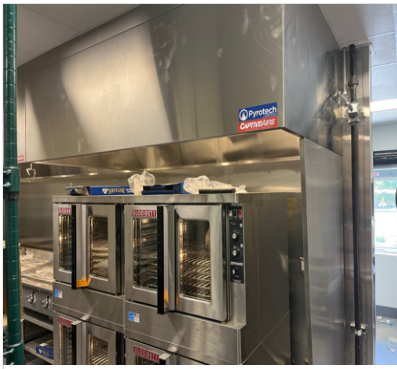
HOOD-1

Unit Data		
	Design	Actual
MFG	CAPTIVEAIRE	CAPTIVEAIRE
Model Num	5424 ND-2	5424 ND-2
Job / Serial Num	-	5448882
Type	TYPE I LOW PROXIMITY	TYPE I
Hood length	89"	89"
Hood Width	54"	54"

Test Data Exhaust		
	Design	Actual
Filter Type	CAPTRATE SOLO	CAPTRATE SOLO
Filter Size 1	16X16	16X16
Filter Qty 1	5	5
Filter AK factor size 1	1.62	1.62
Filter Total AK Area	8.1	8.1
Filter1 FPM	-	129
Filter2 FPM	-	110
Filter3 FPM	-	121
Filter4 FPM	-	143
Filter5 FPM	-	132
Filter Ave FPM(corr)	-	127
CFM	1115	1029

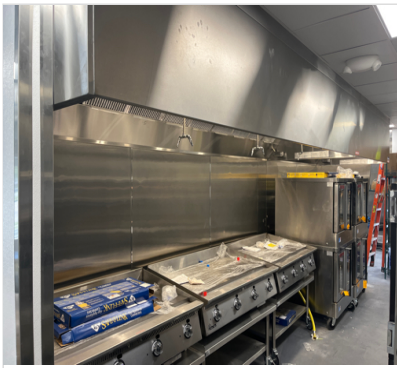
HOOD-2

Unit Data		
	Design	Actual
MFG	CAPTIVEAIRE	CAPTIVEAIRE
Model Num	5424 ND-2	5424 ND-2
Job / Serial Num	-	5448882
Type	TYPE I LOW PROXIMITY	TYPE I
Hood length	155"	155"
Hood Width	54"	54"

Test Data Exhaust		
	Design	Actual
Filter Type	CAPTRATE SOLO	CAPTRATE SOLO
Filter Size 1	16X16	16X16
Filter Qty 1	9	9
Filter AK factor size 1	1.62	1.62
Filter Total AK Area	14.58	14.58
Filter1 FPM	-	203
Filter2 FPM	-	191
Filter3 FPM	-	196
Filter4 FPM	-	200
Filter5 FPM	-	200
Filter6 FPM	-	192
Filter7 FPM	-	192
Filter8 FPM	-	188
Filter9 FPM	-	222
Filter Ave FPM(corr)	-	198
CFM	2910	2887

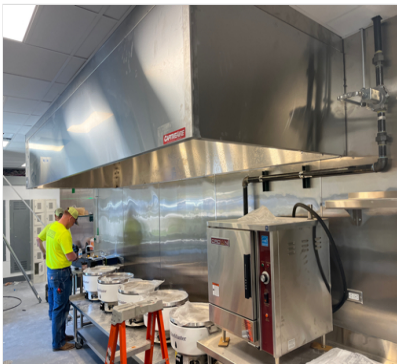
HOOD-3

Unit Data		
	Design	Actual
MFG	CAPTIVEAIRE	CAPTIVEAIRE
Model Num	5424 VHB-ND	5424 VHB-ND
Serial Num	-	5448882
Type	TYPE II LOW PROXIMITY	TYPE II
Hood length	162"	162"
Hood Width	54"	54"

Test Data		
	Design	Actual
Exhaust CFM	2025	2020
