Report: Issues
Function: Test, Adjust, & Balance
Date: 04/11/2023

PROJECT
CW 2999 - UTSW (DALLAS, TX)

Cypress Waters

Issue Name : VHR-3-23

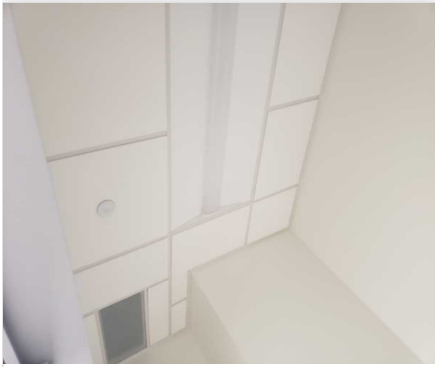
20230411_143610.jpeg

Issue Name : VRH-3-17

Description : Unit is missing diffusers 4. Unit cannot be balanced until this is added.

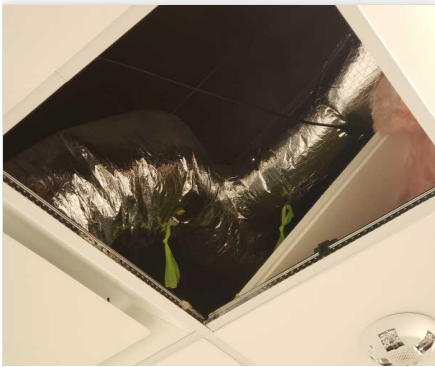
168088448637630061135...

Issue Name : VRH-3-27

Description : Fully dampened diffusers 5 and 6 are still high. Diffuser 2 is low due to the duct work branching off diffuser 1's duct.
