**Report: TAB Report**  
**Function: Test, Adjust, & Balance**  
**Date: 01/12/2026**  
**Completed By: National TAB**

**PROJECT**  
**01-12-26 QT #1703 BUFORD GA**

QUIKTRIP  
4705 SOUTH 129TH EAST AVENUE  
TULSA, OK 74134

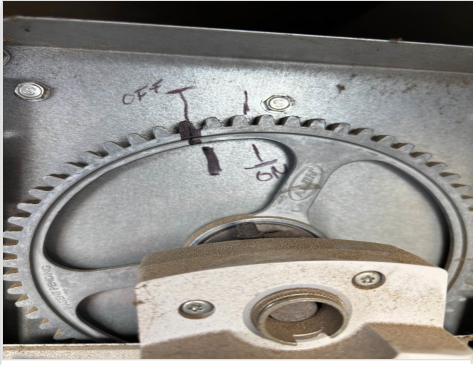
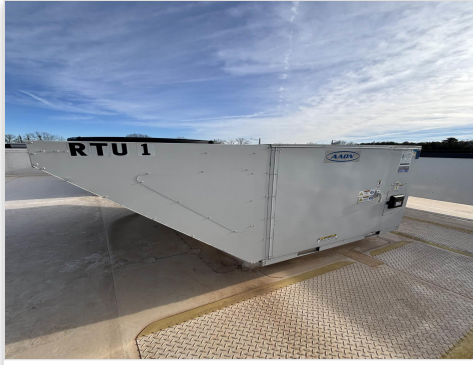
**Unit Data - PHOTO LOG**

Unit Data	
	Actual
MFG	AAON
Serial Num	202212-ANEK26097
Model Num	RN-013-8-0-EA0A-152
Num OA Filters 1	1
OA Filter Size 1	22X45
Num Final Filter 1	4
Final Filter Size 1	20X25X2

Test Data		
	Design	Actual
SF CFM	4200	4262
SF RPM	-	1291
OA CFM (Hoods On)	800	764
OA CFM (Hoods Off)	350	358
RL Voltage	-	145 VFD
RL Amperage	-	7.26 VFD
VFD Max SetPt	-	44 Hz
VFD Min SetPt	-	24 Hz
OA Damper Position (Hoods On)	-	46%
OA Damper Position (Hoods Off)	-	26%

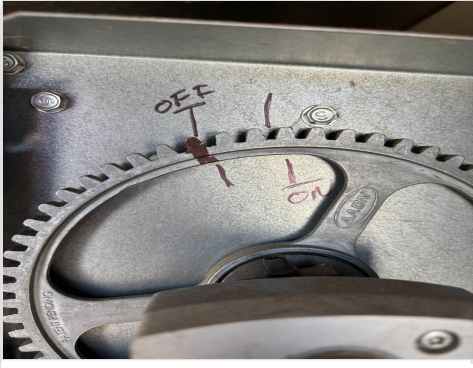
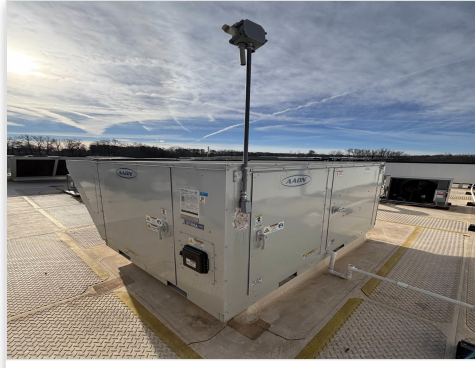
**Unit Data - PHOTO LOG**

Unit Data	
	Actual
MFG	AAON
Serial Num	202212-ANEK26098
Model Num	RN-013-8-0-EA0A-152
Num OA Filters 1	1
OA Filter Size 1	22X45
Num Final Filter 1	4
Final Filter Size 1	20X25X2

Test Data		
	Design	Actual
SF CFM	4200	4314
SF RPM	-	1291
OA CFM (Hoods On)	800	812
OA CFM (Hoods Off)	350	371
RL Voltage	-	145 VFD
RL Amperage	-	7.32 VFD
VFD Max SetPt	-	42 Hz
VFD Min SetPt	-	24 Hz
OA Damper Position (Hoods On)	-	46%
OA Damper Position (Hoods Off)	-	26%

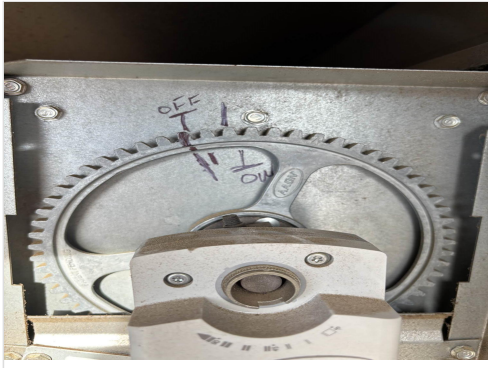
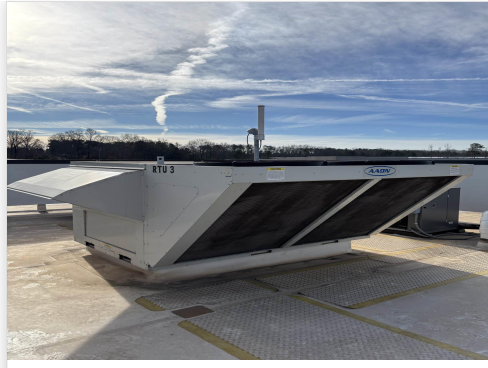
**Unit Data - PHOTO LOG**

Unit Data	
	Actual
MFG	AAON
Serial Num	202212-ANEK26099
Model Num	RN-013-8-0-EA0A-152
Num OA Filters 1	1
OA Filter Size 1	22X45
Num Final Filter 1	4
Final Filter Size 1	20X25X2

Test Data		
	Design	Actual
SF CFM	4200	4117
SF RPM	-	1349
OA CFM (Hoods On)	800	791
OA CFM (Hoods Off)	350	364
RL Voltage	-	158 VFD
RL Amperage	-	7.84 VFD
VFD Max SetPt	-	46 Hz
VFD Min SetPt	-	24 Hz
OA Damper Position (Hoods On)	-	46%
OA Damper Position (Hoods Off)	-	26%

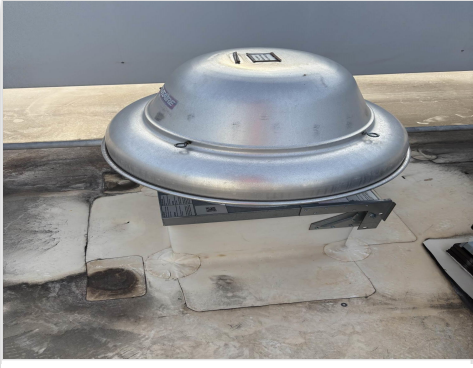
**Unit Data - PHOTO LOG**

Unit Data		
	Design	Actual
MFG	NA	CAPTIVEAIRE
Model Num	NA	DR50HFA
Serial Num	-	5757779
Type	-	DOWNBLAST
Configuration	-	VERTICAL

Test Data		
	Design	Actual
CFM	750	741
Fan Rotation	-	CCW
System SetPt	-	LOW
RL Voltage	-	[1]
RL Amperage	-	[1]
Total ESP	-	0.36"
Fan Inlet SP	-	-0.36"
Fan Discharge SP	-	ATM

[1] UNABLE TO READ VOLTS AND AMPS SAFELY

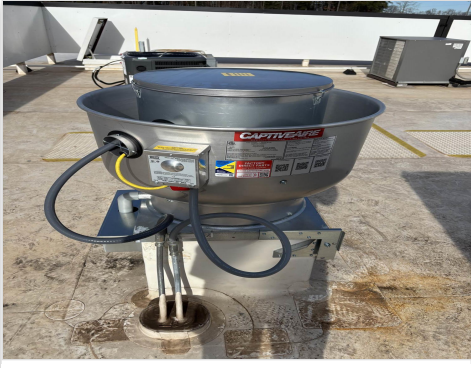
## Unit Data - PHOTO LOG

Unit Data		
	Design	Actual
MFG	NA	CAPTIVEAIRE
Model Num	NA	DU50HFA
Serial Num	-	7644846
Type	UPBLAST	UPBLAST
Configuration	VERTICAL	VERTICAL

Test Data		
	Design	Actual
CFM	1350	1373
Fan RPM	-	1213
Fan Rotation	-	CCW
Motor RPM	-	1213
System SetPt	-	52.8 Hz
RL Voltage	-	208
RL Amperage	-	1.7
Total ESP	-	0.37"
Fan Inlet SP	-	-0.37"
Fan Discharge SP	-	ATM

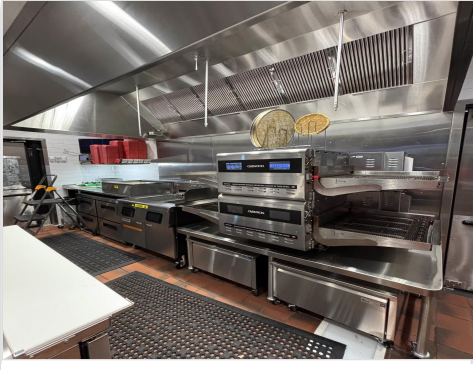
**Unit Data - PHOTO LOG**

Design	Actual
MFG	CAPTIVEAIRE	CAPTIVEAIRE
Model Num	6030ND-2-F	6030ND-2-F
Job / Serial Num	-	7644846
Type	-	TYPE I CANOPY
Hood length	-	108"
Hood Width	-	60"

Design	Actual
Filter Type	-	CAPTRATE SOLO FILTER
Filter Size 1	-	16X20
Filter Qty 1	-	6
Filter AK factor size 1	-	2.08
Filter Total AK Area	-	12.48
Filter1 FPM	-	98
Filter2 FPM	-	118
Filter3 FPM	-	124
Filter4 FPM	-	113
Filter5 FPM	-	103
Filter6 FPM	-	105
CFM	1350	1373
