Report: TAB REPORT
Function: Test, Adjust, & Balance
Date: 10/04/2024
Completed By: National TAB

PROJECT
09-30-24 SEPHORA 476 METAIRIE, LA

Project: 09-30-24 SEPHORA 476 METAIRIE, LA

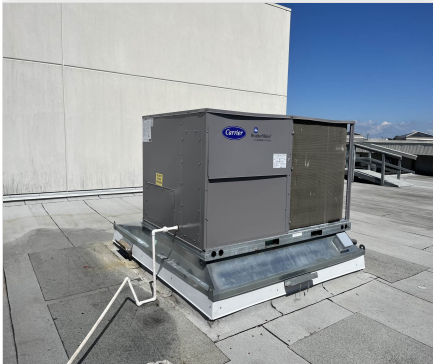
Issue Name : NO ECONOMIZERS
Description : NO ECONOMIZERS INSTALLED ON ANY OF THE UNITS.
Created By : National TAB **Assigned To :** National TAB - Dan Hertenstein
Status : Open
Priority : High **Asset Tag :**
Originated Date : 10/03/2024 - Oscar Ventura - National TAB

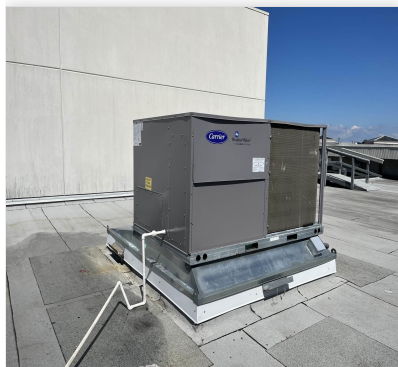
All Issues

ECONOMIZERS NOT INSTALLED.
