Report: TAB REPORT
Function: Test, Adjust, & Balance
Date: 10/04/2024
Completed By: National TAB

PROJECT
09-30-24 SEPHORA 476 METAIRIE, LA

Project: 09-30-24 SEPHORA 476 METAIRIE, LA

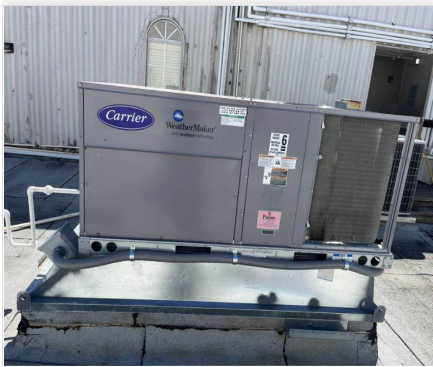
Issue Name : Missing Economizers
Description : All RTUs are missing economizers. Recommend installing.
Created By : National TAB **Assigned To :** National TAB - Dan Hertenstein
Status : Open
Priority : **Urgent** **Asset Tag :**
Originated Date : 10/08/2024 - Wesley John - National TAB
